Monitoring of the Cracks on Bell Tower of ST. Anastasia Cathedral in Zadar Croatia

Davor Uglešić, Uroš Bohinc. Monitoring of the Cracks on Bell Tower of ST. Anastasia Cathedral in Zadar Croatia. EWSHM - 7th European Workshop on Structural Health Monitoring, IFFSTTAR, Inria, Université de Nantes, Jul 2014, Nantes, France. hal-01022060

MONITORING OF CRACKS ON THE BELL TOWER OF ST. ANASTASIA CATHEDRAL IN ZADAR CROATIA

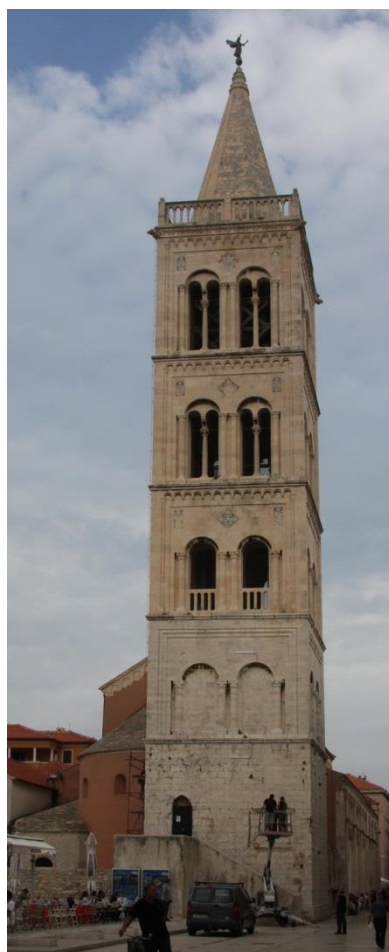
Figure 6: Bell tower

The bell tower of the cathedral in Zadar was built in two phases. The ground floor and first floor (height of 16.6 m) were built in the 15th century (Figure 1); while the rest (height 38.3 m - in total 54.9 m) was upgraded in 1885 and was designed by the English architect Thomas Graham Jackson (Figure 7). The bell tower was built with carved stones of limestone, the older part from the local quarries, while the newer part mainly from the quarry Vrnik near island of Korčula.

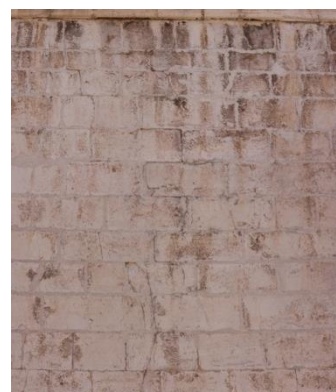
Figure 2: Southwest façade

Most damage is seen on the southeast façade of the bell tower, even more: there are almost no undamaged cut stone blocks on the ground floor and first floor (Figure 3). The longest continuous crack stretches from the ground floor to the cornice on the second floor. On the NW façade there are few cracks that extend from the ground floor to the cornice on the first floor and there are particularly prominent cracks along the eastern corner of the bell tower where some ashlar with broken off cants can be found (Figure 5). On the SW façade there are three cracks and the longer

one stretches from the ground to the first floor (Figure 2). On the SE façade there is a crack that starts in the upper half of the ground floor and extends to the first floor.

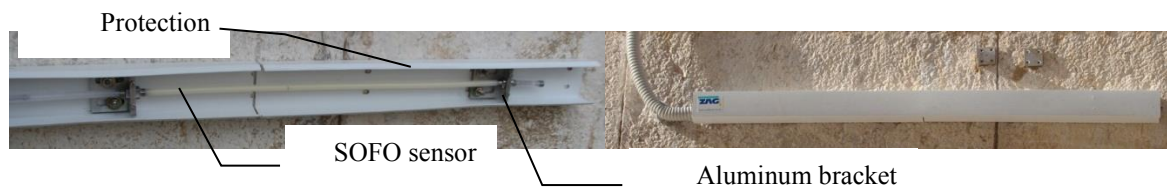
Figure 8: Example of standard SOFO sensor installation

The measurement system consists of SOFO reading unit connected via RS232 to the computer running SOFO SDB software and GPRS router, which enables remote control of the measurement campaign. To avoid power failures the system is equipped with UPS. An example of the installation of the SOFO sensor is shown in Figure 8. The sensor is secured to two standard aluminum L-brackets which are anchored to the stone using metal anchors. Each bracket is anchored with two steel anchors $\phi 8\text{mm}$.

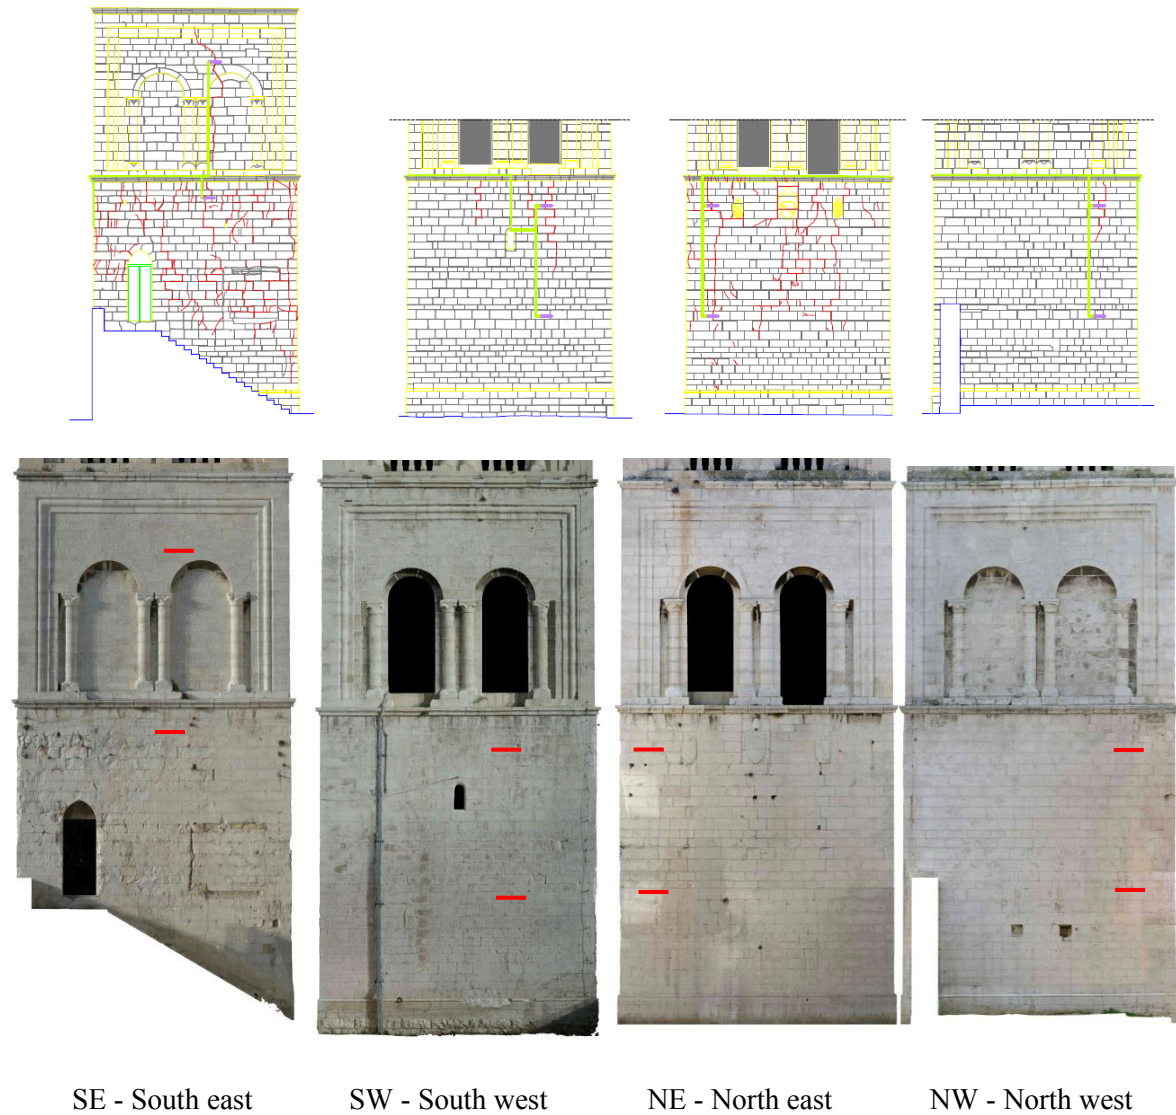
Figure 9: Map of cracks and indicated sensor locations

The crack displacement is measured via optical deformation sensors SOFO standard by SMARTEC SA [2,10]. Eight fiber optic displacement sensors were mounted at locations across the cracks at two elevations on each facade. Base length of all SOFO sensors is 500mm. The sensors measure the displacement between two metal anchors by measuring the elongation of optical fiber spanned between the anchors. The measurements of elongation are absolute and are performed using autonomous reading unit. The reading unit consists of optical multiplexer and the measurement part, which, by physical displacing a small movable mirror which reflects the incident laser light, determines the length difference between active and unstrained optical fiber. The accuracy of measurements is 1µm. The measurements are insensitive to temperature variations due to the temperature compensation achieved through the comparison with the unstrained fiber installed along the active fiber. The measurement principle is highly robust compared to standard measurement principles involving measurement of electrical quantities which are more prone to drift and to outer disturbances like thunderstorms and power failures.

Sensor locations are indicated in Figure 9 and Figure 10.

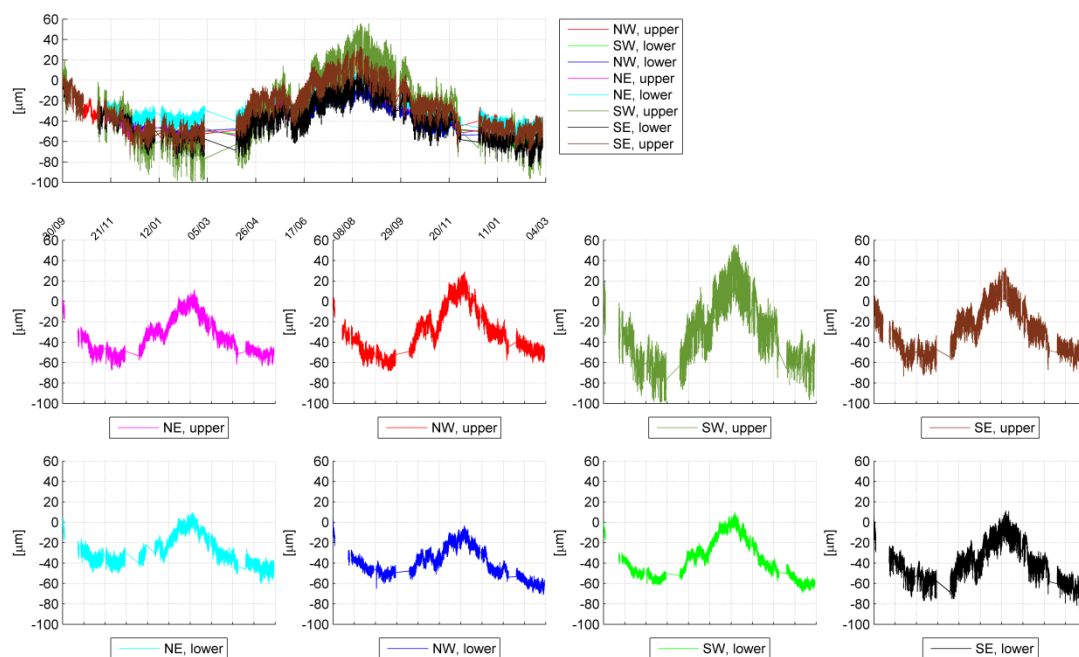
Figure 11: Measurements of crack displacements

The time variation of the displacements of all the sensors is shown in Figure 11 for the period of the monitoring from October 2012 to the end of February 2014. The time history of single sensors is shown in separate diagrams.

Noticeable difference in crack displacement variation can be observed between north facing sides as opposed to the south facing ones. No abrupt changes of crack displacement are noticeable

through the whole period of monitoring indicating there were no major disturbances present which would damage the structure permanently.

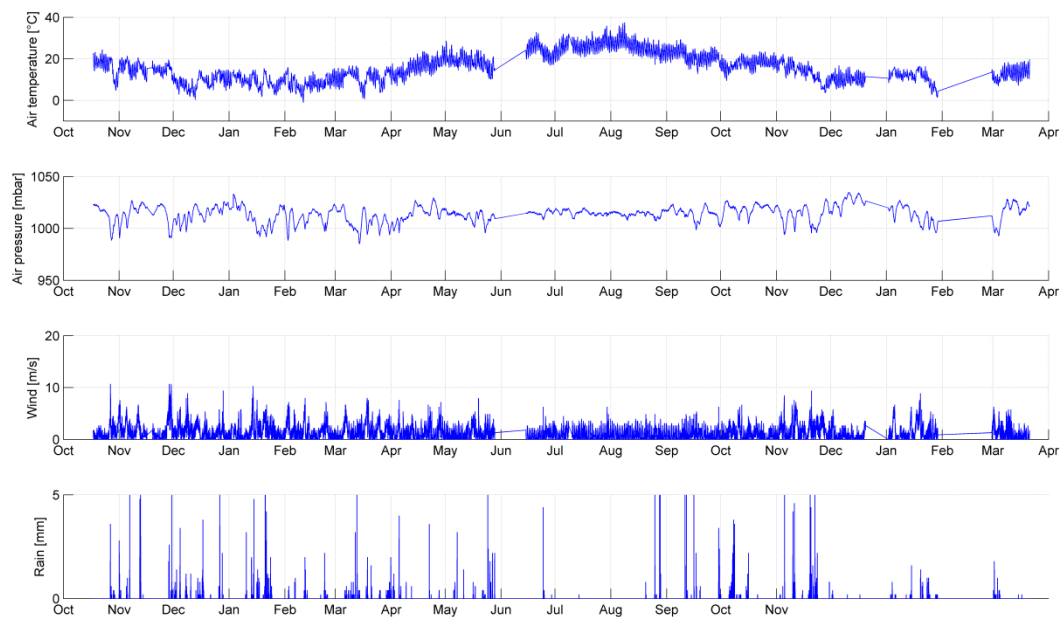
Figure 12: Weather data

In September 2012 thus eight fiber optic displacement sensors were installed, two on characteristic cracks on each façade. At the same time the weather station was installed to monitor changes in weather conditions, temperature, humidity, air pressure, rainfall, wind speed and direction. The weather station is situated 170m northwest of the bell tower.

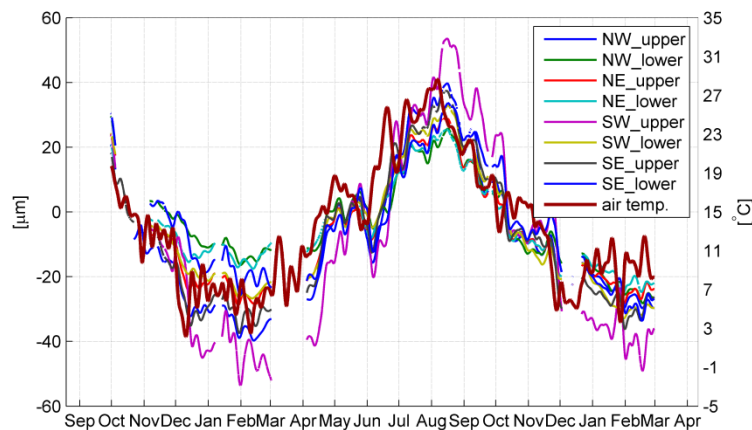
Figure 13: Seasonal variation of crack displacements

The time analysis shows that the seasonal variation of crack displacements d_s are proportional to the temperature and have a lag of 11.6 days relative to the seasonal temperature variation. The amplitude of seasonal variation which is computed as $\Delta d_s = (d_{s,max} - d_{s,min})/2$ and is shown in Table 1. Comparison of d_s for all sensor locations is shown in Figure 13.

NW, upper	NW, lower	NE, upper	NE, lower	SW, upper	SW, lower	SE, upper	SE, lower
Δd_s [μm]	40	29	29	26	54	33	37	34
α_d [$\mu\text{m}/\text{K}$]	1.6	1.6	1.1	1.1	3.7	0.9	3.2	3.0

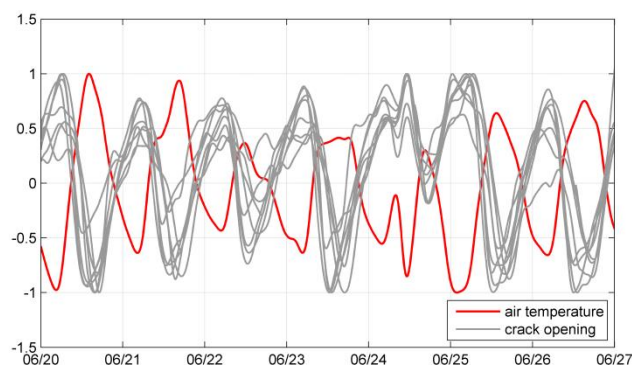
Figure 14: Normalized daily variations of temperature and crack displacements

The daily variation of crack displacements d_d is proportional to daily temperature variation T_d , but with a negative sign, meaning that the cracks are opening with the temperature decrease and vice-versa. Due to the finite dimension of the sensors, the measured crack displacement is a sum of the effect of temperature expansion of the wall as well as the crack opening itself.

The phenomena can be explained by observing the temperature distribution through the depth of the walls. While the part of the material close to the surface of the wall closely follows the temperature variation of the outside air temperature, the temperature of the inner parts responds with a substantial lag, which is a consequence of a large thermal mass of the wall. The temperature increase of the inner part causes the overall expansion of the wall while the temperature increase in the surface layer causes the closing of the crack. The measured crack displacement is thus proportional to the temperature difference between the surface and inner parts of the wall.

The time lag between crack displacements d_d and daily temperature variation T_d is approximately 40-60min, depending on the sensor location. Figure 14 depicts the comparison of normalized daily variations of air temperature to the normalized crack opening on all sensor locations. Since surface temperature of the wall was not measured, an approximation of surface temperature T_{ds} was computed by integrating the differential equation $dT_{ds}/dt = \kappa(T_d - T_{ds})$, where the coefficient $\kappa = 12.3$ was determined to match the mean measured time lag of crack displacement versus the air temperature T . The initial condition was set approximately to the air temperature 40min before the initial time of the integration.
