A New Fire Hazard for MR Imaging Systems: Blankets—Case Report¹

Case Report

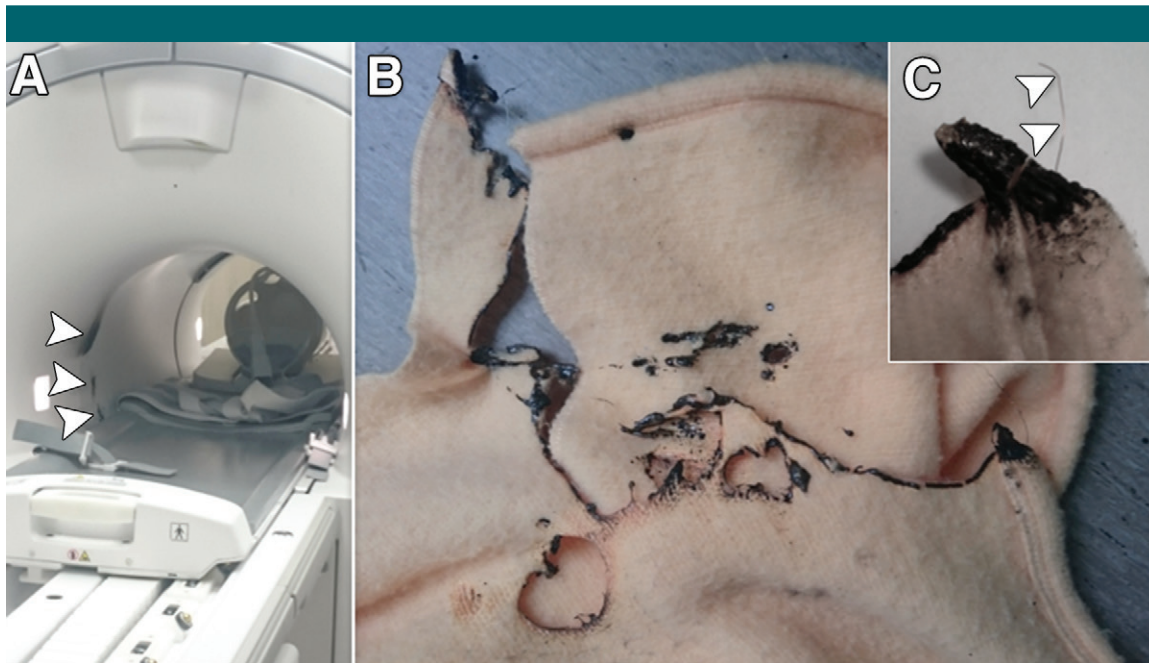
The patient had no skin lesions because she did not have any direct contact with the blanket. The antenna and the inner shell of the PET/MR imaging unit were deformed and covered with soot (Fig, A). Careful inspection of the blanket revealed the presence of a metallic fiber (Fig, B and C). Material safety investigation revealed that these copper fibers were used by the blanket manufacturer during the automatic process of blanket cutting and remained within the blanket hem. Noticeably, this technique does not appear to be specific to our manufacturer and was also used by other companies. Systematic inspection of older blankets at our hospital did not reveal the presence of copper fibers because this technique of production was recently implemented. The manufacturer was informed and modified the production line so that copper fibers were not used anymore. Radiology technicians and radiologists at the hospital were informed of the incident and were asked to stop using blankets inside MR imaging units. An

Images show traces of smoke inside the, *A*, 3.0-T PET/MR imaging unit (arrowheads) related to, *B*, the combustion of a blanket due to the presence of, *C*, a small copper filament (arrowheads).

To conclude, we have shown that the use of a blanket containing copper fibers within an MR imaging unit may present a major fire hazard because of the potential for creating electrical current loops. When isolating the patient from RF coils, disposable linens should be preferred to blankets unless the absence of metallic fiber can be assessed.
