# A New Fire Hazard for MR Imaging Systems: Blankets—Case Report<sup>1</sup>

In this report, a case of fire in a positron emission tomography (PET)/magnetic resonance (MR) imaging system due to blanket combustion is discussed. Manufacturing companies routinely use copper fibers for blanket fabrication, and these fibers may remain within the blanket hem. By folding a blanket with these copper fibers within an MR imaging system, one can create an electrical current loop with a major risk of local excessive heating, burn injury, and fire. This hazard applies to all MR imaging systems. Hybrid PET/MR imaging systems may be particularly vulnerable to this situation, because blankets are commonly used for fluorodeoxyglucose PET to maintain a normal body temperature and to avoid fluorodeoxyglucose uptake in brown adipose tissue.

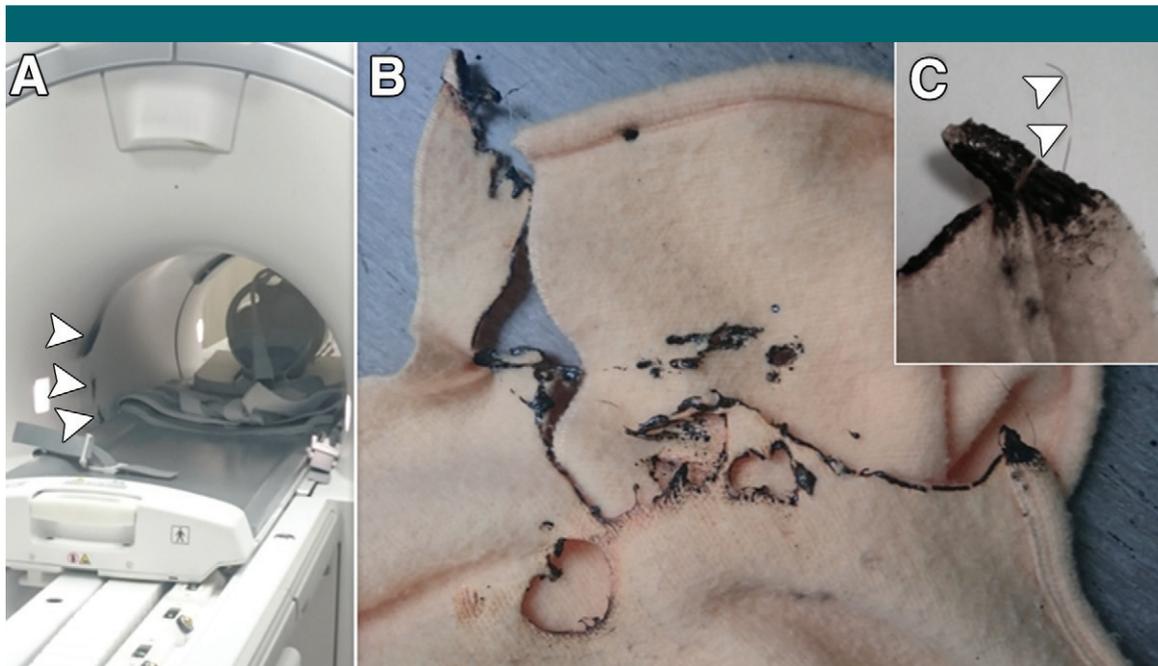
The patient had no skin lesions because she did not have any direct contact with the blanket. The antenna and the inner shell of the PET/MR imaging unit were deformed and covered with soot (Fig, A). Careful inspection of the blanket revealed the presence of a metallic fiber (Fig, B and C). Material safety investigation revealed that these copper fibers were used by the blanket manufacturer during the automatic process of blanket cutting and remained within the blanket hem. Noticeably, this technique does not appear to be specific to our manufacturer and was also used by other companies. Systematic inspection of older blankets at our hospital did not reveal the presence of copper fibers because this technique of production was recently implemented. The manufacturer was informed and modified the production line so that copper fibers were not used anymore. Radiology technicians and radiologists at the hospital were informed of the incident and were asked to stop using blankets inside MR imaging units. An

Images show traces of smoke inside the, *A*, 3.0-T PET/MR imaging unit (arrowheads) related to, *B*, the combustion of a blanket due to the presence of, *C*, a small copper filament (arrowheads).

isolate the patient's body from the RF coils. During fluorodeoxyglucose PET imaging, blankets are routinely used to maintain a normal body temperature, thus avoiding hypothermia-related uptake of fluorodeoxyglucose in brown adipose tissue, which may induce artifactual hypometabolism of the brain (7). Noticeably, this incident occurred in our PET/MR imaging system after 10 months of use and 881 unremarkable examinations with a similar procedure. Hence, the creation of an electrical loop in the blanket requires that the blanket folding has a specific orientation, creating an almost closed loop that likely did not occur during previous examinations. The incident was not noticed until the end of the PET/MR imaging acquisition because the blanket was smoldering without flames, and also because the patient happened to have chronic loss of smell and did not notice a burnt odor in the room. This incident could have had dramatic consequences if the patient had not been protected by the 50-cm-long restraining strap between her and the blanket.

To conclude, we have shown that the use of a blanket containing copper fibers within an MR imaging unit may present a major fire hazard because of the potential for creating electrical current loops. When isolating the patient from RF coils, disposable linens should be preferred to blankets unless the absence of metallic fiber can be assessed.
