A New Fire Hazard for MR Imaging Systems: Blankets—Case Report¹

Anne Bertrand, MD, PhD
Sandrine Brunel, BS
Marie-Odile Habert, MD
Marine Soret, PhD
Simone Jaffre, RN
Nicolas Capeau, BS
Laetitia Bourseul, BS
Isabelle Dufour-Claude, PhD
Aurélie Kas, MD, PhD
Didier Dormont, MD, PhD

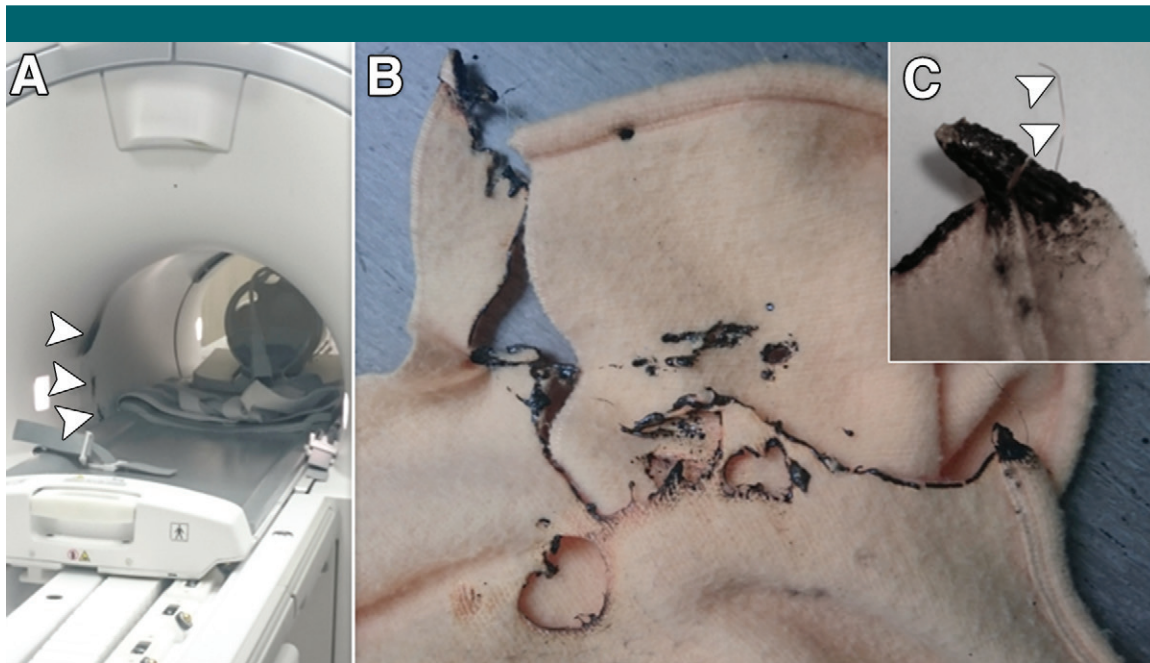
The patient had no skin lesions because she did not have any direct contact with the blanket. The antenna and the inner shell of the PET/MR imaging unit were deformed and covered with soot (Fig, A). Careful inspection of the blanket revealed the presence of a metallic fiber (Fig, B and C). Material safety investigation revealed that these copper fibers were used by the blanket manufacturer during the automatic process of blanket cutting and remained within the blanket hem. Noticeably, this technique does not appear to be specific to our manufacturer and was also used by other companies. Systematic inspection of older blankets at our hospital did not reveal the presence of copper fibers because this technique of production was recently implemented. The manufacturer was informed and modified the production line so that copper fibers were not used anymore. Radiology technicians and radiologists at the hospital were informed of the incident and were asked to stop using blankets inside MR imaging units. An

Images show traces of smoke inside the, *A*, 3.0-T PET/MR imaging unit (arrowheads) related to, *B*, the combustion of a blanket due to the presence of, *C*, a small copper filament (arrowheads).

To conclude, we have shown that the use of a blanket containing copper fibers within an MR imaging unit may present a major fire hazard because of the potential for creating electrical current loops. When isolating the patient from RF coils, disposable linens should be preferred to blankets unless the absence of metallic fiber can be assessed.
