The environment effect on operation of in-vessel mirrors for plasma diagnostics in fusion devices

THE ENVIRONMENT EFFECT ON OPERATION OF IN-VESSEL MIRRORS FOR PLASMA DIAGNOSTICS IN FUSION DEVICES

Introduction

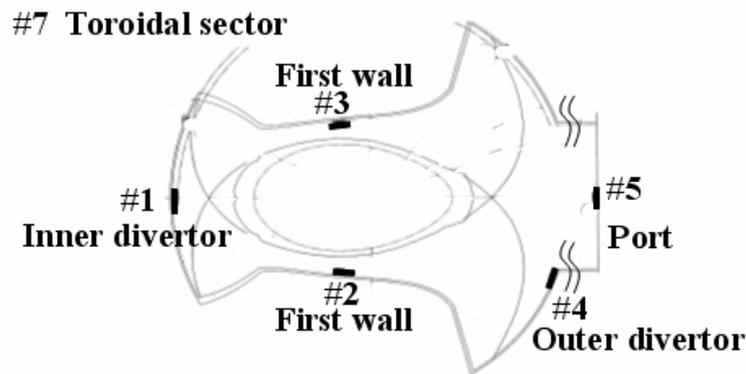
Fig. 1. The scheme of locations of SS mirror samples inside the LHD vessel.

Three SS mirrors with size 20x10x1 mm were mechanically polished, cleansed in an ultrasonic bath filled with acetone, and then the spectral reflectance at normal incidence was measured in the wavelength range 200-700 nm. The samples were installed inside the LHD vacuum vessel in locations indicated in Fig. 1 by numbers 1, 3, and 5: the sample #1 was positioned near the divertor region, #3 – close the plasma edge, and #5 – quite deeply in the diagnostic port in the same poloidal cross section and in the same plane as #1 (central plane). After samples were removed the reflectance was again measured in the same way, and the surface of samples were analyzed by several methods: Auger electron spectroscopy (AES), ion backscattering technique (RBS) using 1.5 MeV He⁺ ion beam, scanning electron microscopy (SEM), profilometry, and ellipsometry at the wavelength 632.8 nm. These data are presented in detail in [4].

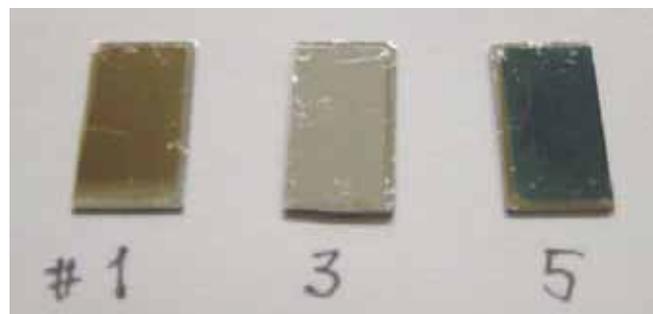
Fig. 2. The photos of samples after they were taken out of the LHD vacuum chamber.

The photos of Fig. 2 show how mirror samples looked just after finishing their exposure in LHD vacuum vessel. As a result of exposure in LHD the reflectance of all samples has changed from the identical initial level, Fig. 3.

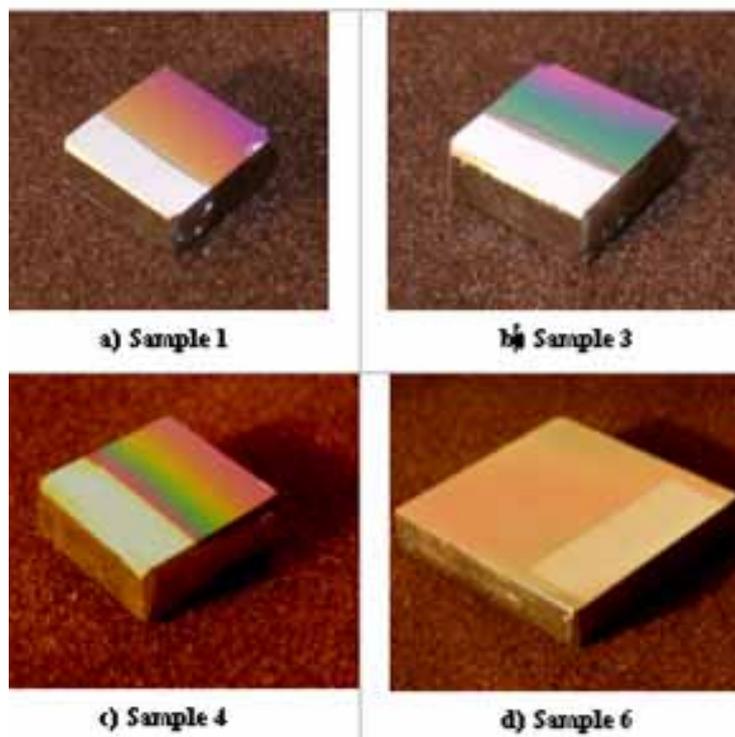
Fig. 6. Photos of samples after finishing the 2002 year campaign. Lighter parts of mirrors were closed during whole exposure time. The deposit has quite homogenous, fine-dispersed structure. On mirrors protected by shutter during conditioning it grew with the rate 0.2 nm/s in 2002 and 4 nm/s in 2003.

looked shining and smooth and the color of deposits varied from golden-crimson to violet-green. The screened parts of mirrors practically did not change by sight, Fig. 6. The deposits not only decrease the reflectance of mirrors but also distort the spectrum of reflected radiation because of interference phenomenon.

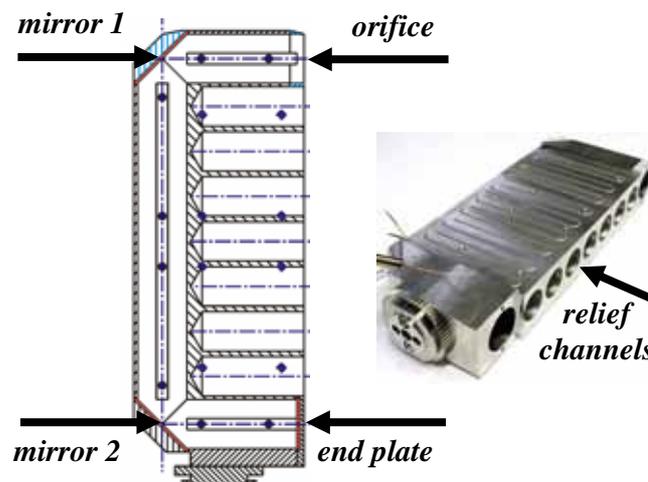
Fig. 10. Periscope system with mirror 1 (closest to the plasma), mirror 2 and the end plate. The tubes (35mm) are wrapped inside with exchangeable steel foils fixed at the wall by bars. The photograph shows the stainless steel body without end plate. Relief channels reduce weight.

The set-up of a periscope-like system on TEXTOR simulates the ITER diagnostic ports transmitting the plasma radiation to further distant sensors. Two plane mirrors were installed in tubes facing each other at a distance of 275 mm. The mirrors are oriented 45° with respect to the line of sight. The orifice (35 mm diameter) is oriented perpendicular to the toroidal direction.

The second end was closed with a polished end plate as is shown in Fig. 10. The SOL fluxes hit the first mirror under 45°. Carbon transport inside and deposition can be investigated after dismantling of the system. The deposition patterns on exchangeable steel foils wrapped inside the tubes complete this information. The stainless steel body can be heated up to about 500°C. Mirrors made from TZM (99% Mo, 0.1% Zr, 0.5% Ti) were used for the pilot experiment. The edge closest to the plasma was kept at 25 mm from the LCFS and the system exposed to 89 (partly neutral beam heated) plasma pulses ($n_e = 1.5$ to $4.5 \times 10^{19} \text{ m}^{-3}$) with a total plasma exposure time of 1047 s. The temperature was 150 °C.

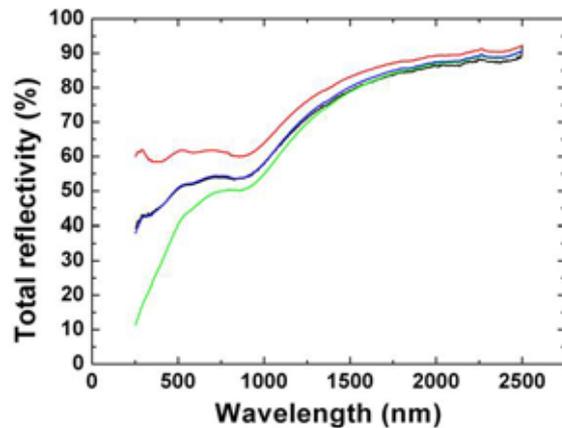
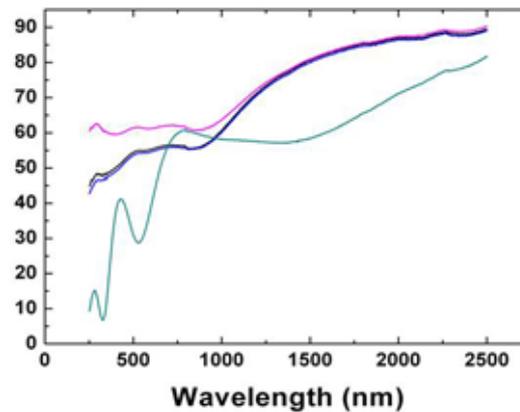
Fig. 11. Total reflectivity R_{tot} depending on wavelength measured on the molybdenum mirrors before and after exposure in a protected area (1) and after exposure in the deposition (2) and erosion (3) area. The mirrors (a) were exposed for 197 s in the erosion dominated zone (edge at LCFS+8mm) and (b) and for 312 s in the deposition dominated zone (edge at LCFS+25mm).

space resolution of ≈ 10 mm. Fig.11 shows examples for the wavelength dependence of the total reflectivity R_{tot} found on the two large mirrors. The central curves (1) represent the total reflectivity measured before and after plasma exposure at a location protected by the aluminum bar. The lines stay below the values given for polycrystalline molybdenum in literature [11]. As soon as deposition begins (curve 2 in Fig.11a) the reflectivity decreases by absorption in the film (thickness ≈ 30 nm). The drop is most pronounced in the UV region and levels off in the IR. In addition to absorption, the reflectivity can be distorted significantly due to destructive and constructive interference in thicker deposits. The example (curve 2, Fig. 11b) was measured on the mirror plate exposed deeper into the SOL (LCFS+25mm) where carbon deposition dominates and a film up to about 220 nm thickness was formed.

Surprisingly, an increase of R_{tot} was measured on surface areas which suffered from net erosion (curves 3). The increases are similar, independent whether the target mirror was exposed near the plasma edge (Fig. 11a) or deeper into the SOL (Fig. 11b). This increase is most pronounced ($\Delta R_{\text{tot}} \approx 10\text{-}20\%$) for short wavelengths and almost vanishes (1-3%) beyond about 1500 nm.

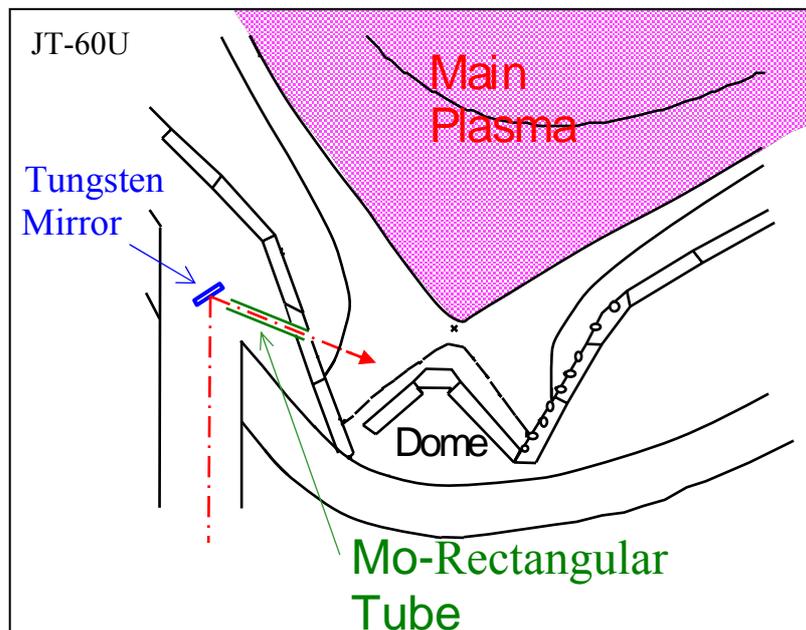
Fig.14. Disposition of W mirror for measurement of VUV and UV radiation emanating by the divertor plasma in JT-60U.
