# The disastrous 17 February 2006 rockslide-debris avalanche on Leyte Island, Philippines: a catastrophic landslide in tropical mountain terrain

S. G. Evans, R. H. Guthrie, N. J. Roberts, and N. F. Bishop

**Abstract.** In February 2006, a disastrous rockslide-debris avalanche occurred in tropical mountain terrain, on Leyte Island, Central Philippines. Over 1100 people perished when the village of Guinsaugon was overwhelmed directly in the path of the landslide. The landslide was initiated by the failure of a 450 m high rock slope within the damage zone of the Philippine Fault where the rock mass consisted of sheared and brecciated volcanic, sedimentary and volcanoclastic rocks. Tectonic weakening of the failed rock mass had resulted from active strike-slip movements along the Philippine Fault which have been estimated by other workers at 2.5 cm/year. The landslide involved a total volume of 15 Mm<sup>3</sup>, including significant entrainment from its path, and ran out a horizontal distance of 3800 m over a vertical distance of 810 m, equivalent to a fahrböschung of 12°. Run-out distance was enhanced by friction reduction due to undrained loading when the debris encountered flood

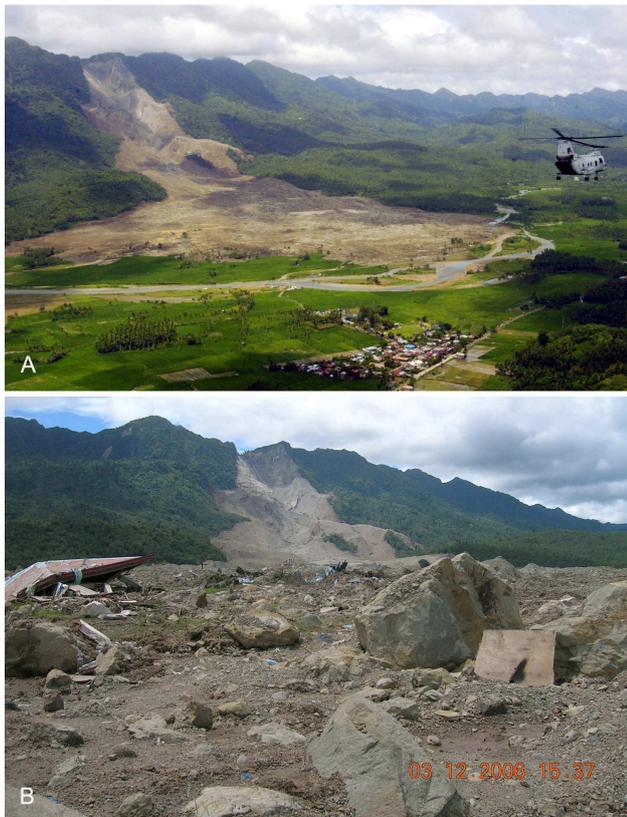
**Fig. 1.** (A) Oblique aerial view (to the northwest) of the Guinsaugon landslide taken on 19 February 2006. (U.S. Navy photograph by M. D. Kennedy). The Himbangao River flows from right to left. (B) View of debris toward the source area of the rockslide-debris avalanche (Photograph taken 12 March 2006).

On 17 February 2006 a disastrous landslide occurred in Southern Leyte Province, Leyte Island, the Philippines (Lagmay et al., 2006; Fig. 1). It originated on a steep 450 m high, heavily-forested rockslope and swept down into the densely-populated Himbangao River valley. The landslide overwhelmed the village of Guinsaugon resulting in the loss of over 1100 people, including 250 schoolchildren who were attending morning classes at the Guinsaugon School.

The landslide (Figs. 1, 5) occurred between 10:30 a.m. and 10:45 a.m. on the morning of 17 February 2006. An eyewitness interviewed during field work said that the landslide started with a shaking of the ground, followed by the sound

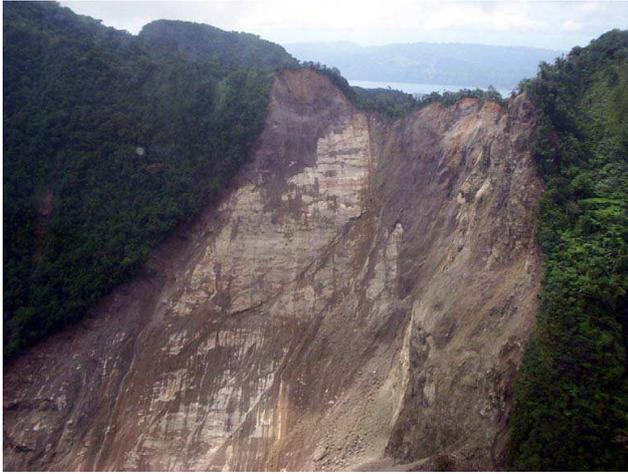
**Fig. 8.** Aerial view of the sliding surface showing horizontal striations consistent with strike-slip fault movement. Note also rock mass characteristics on the right of the source area resulting from movement of Philippine Fault (Photograph courtesy of Mines and Geosciences Bureau, Government of the Philippines).

8) and it appears that a splay of the fault formed the steep sliding surface of the initial rock slope failure (Figs. 5b, 8).

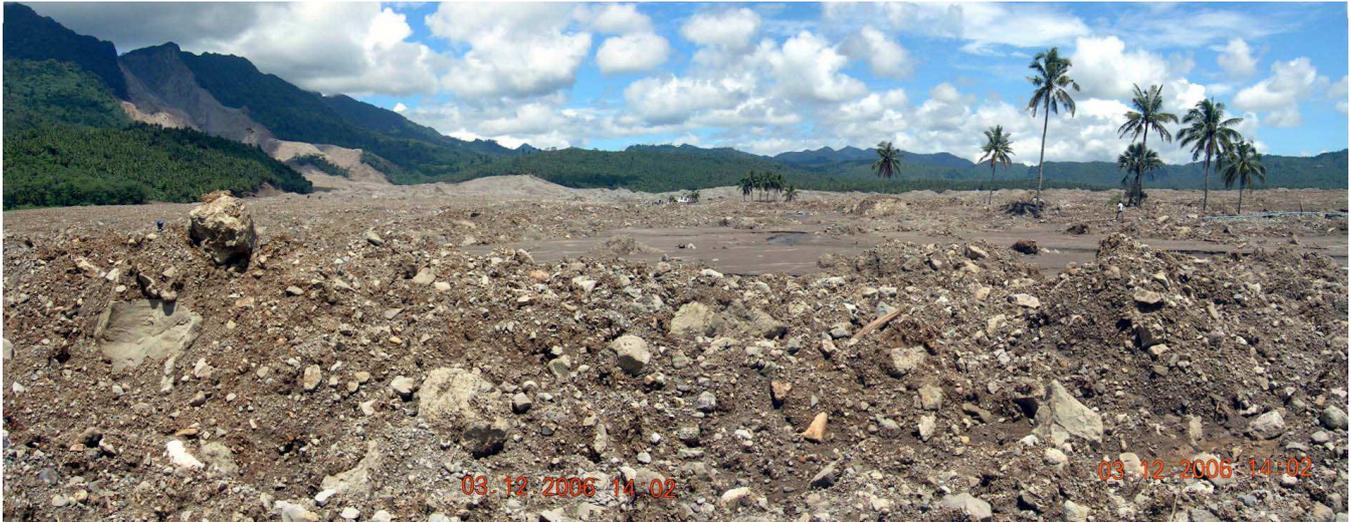
**Fig. 9.** View from near the distal limit of the debris toward the source area. Note matrix supported nature of the debris at this distal location and flat surface, corresponding to rice paddy fields, over which the debris ran in the distal part of its path. Debris thickness here is about 2 m.

Debris deposited on the valley floor is dominated by finer grain sizes which forms a matrix-supported deposit (Figs. 9, 10), despite the fact that large boulders are present (Fig. 11a). This may reflect the entrainment of finer-grained colluvium by the leading edge of the rockslide-debris avalanche from the base of the source slope and/or the mixing of the rockslide-debris avalanche debris with the saturated sediments from paddy fields on the valley floor. The distal limit of the debris consists of series of irregular lobes on the flat valley floor, (Figs. 10a, b) which are rimmed by a zone of dark mud. This represents the fine muds ejected from beneath the moving debris sheet during the final part of its travel over the paddy fields. In some places we noted that trees and buildings were destroyed by the ejected mud beyond the limit of the coarser debris (Fig. 11b).

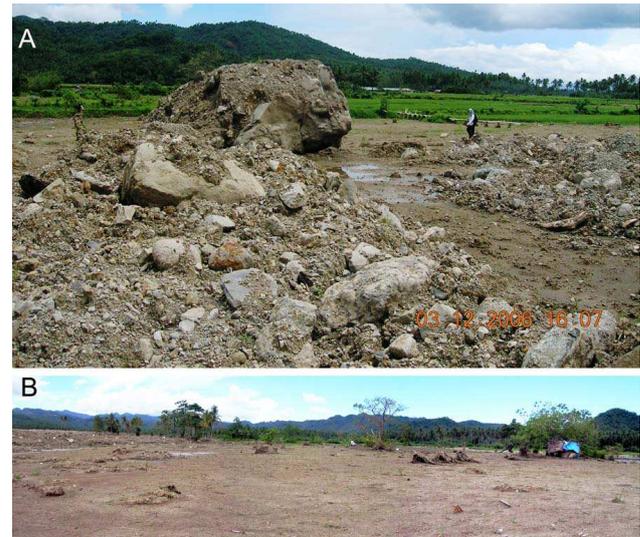
**Fig. 11.** Distal limit of rockslide-debris avalanche. (A) characteristics of debris, including large boulder (B): damage to trees and houses by fine mud ejected from base of debris sheet, the limit of which is seen at left.

The debris contains large boulders up to 5 m in diameter, transported in some cases to the distal limit of the debris (Figs. 1b, 11a). As noted above, a significant part of the debris is made up of a fine-grained matrix including significant amounts of silty sand, sandy silt, and low plasticity clay (Liquid Limit = 48 and Plasticity Index = 22), reflecting the composition of the sheared source rock mass and the colluvium entrained from the base of the rock slope.
