Shock machine for the mechanical behaviour of hip prostheses: a description of performance capabilities

Juliana Uribe, Jean G eringer, Bernard Forest

Juliana Uribe, Jean G eringer, Bernard Forest. Shock machine for the mechanical behaviour of hip prostheses: a description of performance capabilities. *Lubrication Science*, 2012, 24 (2), pp.45-60. 10.1002/lis.167 . hal-00682226

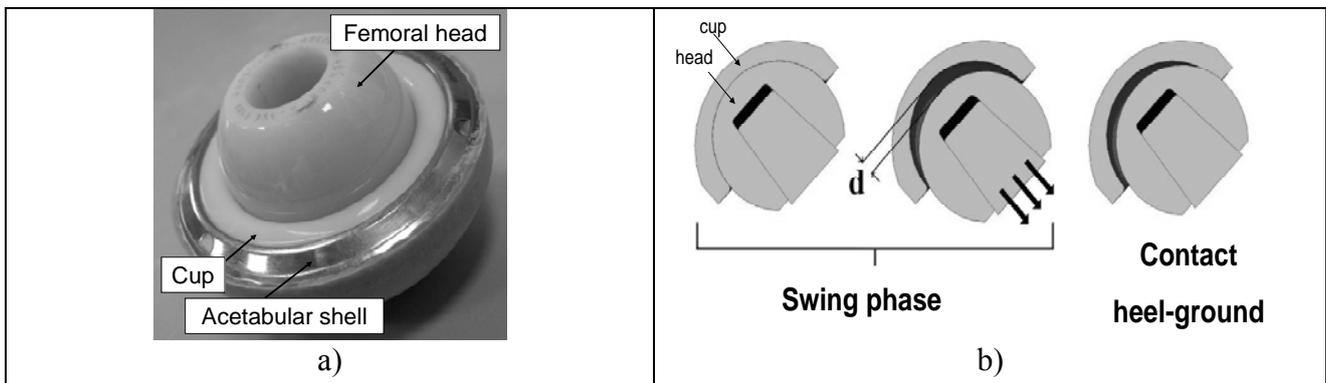
Figure 1. a) Hip prosthesis and b) Microseparation phenomena, d represents the distance of microseparation^{3,4}.

Total hip arthroplasty consists of replacing hip joint with an artificial femoral head, cup and acetabular shell, Figure 1a. Because of the increasing life expectancy, there is a need of prostheses with a longer lifetime. Ceramics are submitted to lower friction and more reduced wear than the ones of metal or polymer (Ultra High Molecular Weight PolyEthylene) bearing surfaces.^{1,2} Aseptic loosening with accompanying osteolysis is less frequent for ceramics cups compared to polymer ones, therefore better long term results are obtained. However, ceramics could be worn and, in some cases fractured, when subjected to shocks.

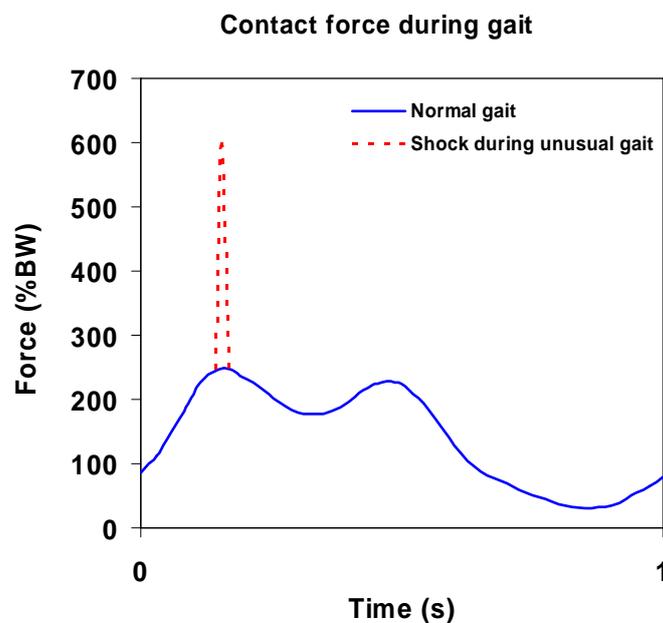
Figure 2. Hip contact force in %BW. Gait cycle showing the maximum of force when the heel hits the ground, BW: Body Weight⁵.

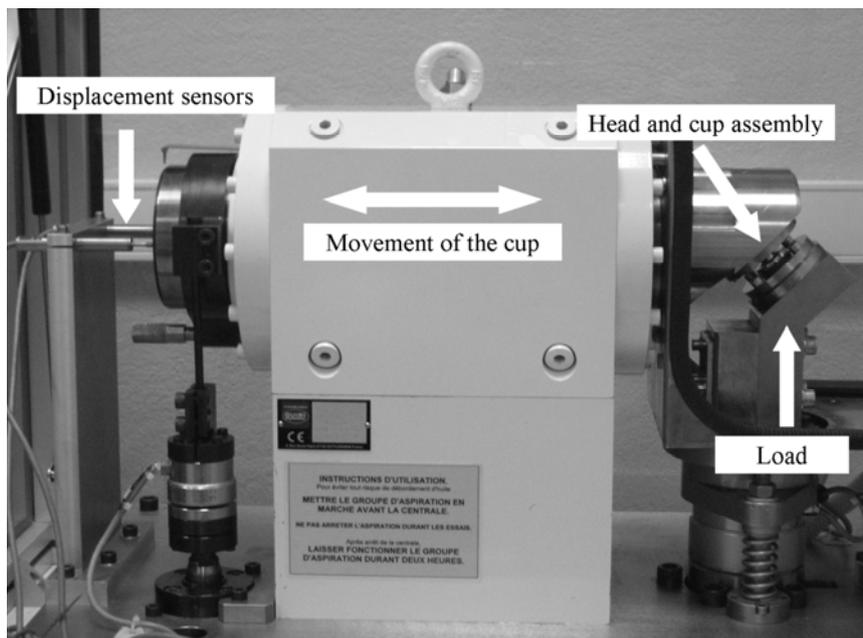
The shock machine (QUIRI Hydromecanique) is shown in Figure 3. This device was designed specially for testing hip prostheses, head and cup assembly, subjected to shocks.

Figure 3. Shock machine

Force varies between from 0 to 10kN with an adjustable duration from 20 to 100ms and a frequency between 0.1 and 5Hz. Tests in both dry and wet conditions are possible. The main feature that makes this machine different from usual hip simulators is the opportunity to impose a microseparation. A control by displacement is possible. Microseparation between cup and head was controlled.

Displacements signals from LVDT, see Figure 3, were recorded and analysed in order to determine the mechanical behaviour of the cup after the impact. The cup response was described as a damped spring-mass system. The cup oscillates during 0.2s which is about seven times the duration of the peak of force. Positive sign means the cup moves in the positive x direction.

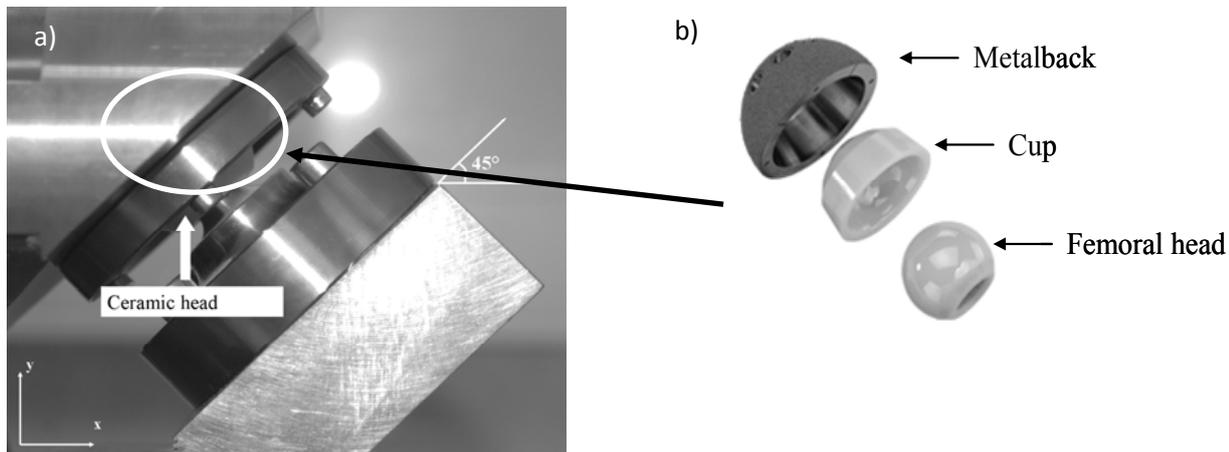
Figure 4. a) Head and cup assembly inclined at 45°; b) head/cup/metal back assembly

Cups and heads were manufactured from alumina of diameter 32mm. The radial clearance between the head and the cup is ranging between 50 and 100 μ m. The actual value of radial clearance will not be exposed due to confidential agreement with the manufacturer (SERF company). Grain size, density and Young's modulus were in agreement with the ISO 6474-1 standard requirements, Table I. The ceramic cups were sheathed in an acetabular shell. In order to accelerate degradations, the tests were carried out in severe conditions; no lubrication and a 30ms load of 9kN at 2Hz⁴. Assembly was inclined at 45° to respect standard anatomic position, Figure 4. The cup was fixed and the head was maintained into a cone.

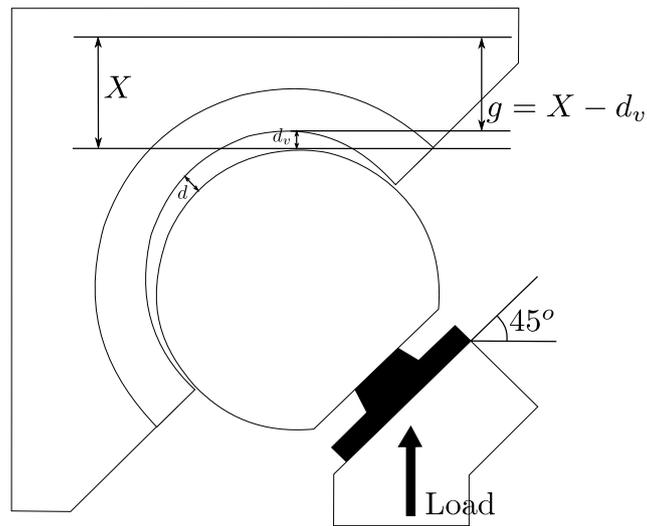
Figure 5. Virtual distance $g=X-d_v$. d : microseparation, d_v : vertical distance to obtain the value d . X is the displacement imposed to the head

Several values of microseparations (d), Figure 5, were tested: 0, 0.7, 1, 1.3, 1.6 and 1.9mm. They are related to the *in vivo* behaviour. To each microseparation corresponded a vertical distance, (dv). For each microseparation, a displacement of X was imposed to the head. Since the distance between the head and the cup was dv , a force is applied when $X > dv$ and increased with X . The distance $g = X - dv$ was defined as "relative distance", Figure 5.

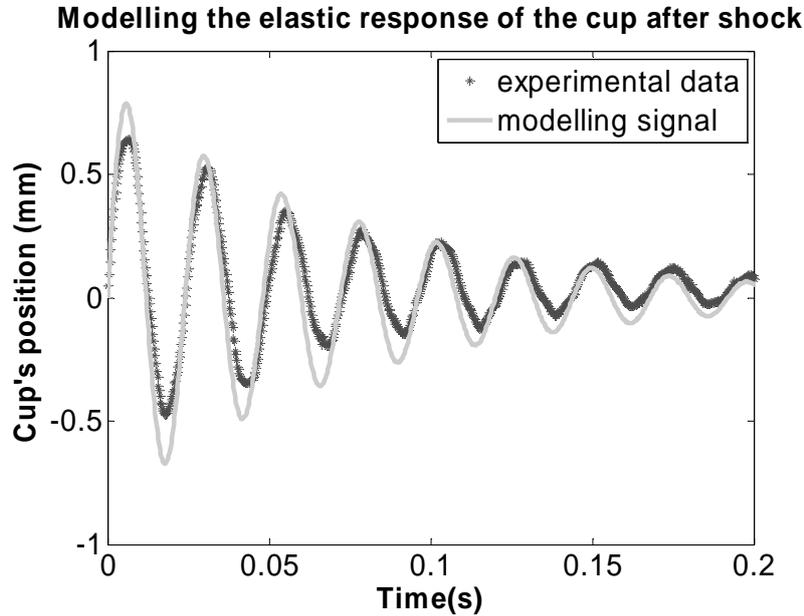
Figure 6. Results for a square signal, with a microseparation of 1.3mm and a force of 9kN, black dotted line: the elastic response of the cup after the shock, gray continued line: the modelling signal.

Since the response of the cup was similar regardless the signal studied, we decided calculating the parameters k and c using only one type of signal. As an example, the parameters were calculated using Matlab[®] for a square signal, with a load of 9kN and a microseparation of 1.3mm.

As can be seen in Figure 6, the underdamped oscillator model fits experimental data well. The k and c values will be adopted in a finite element modelling, further investigations not mentioned in this work, for reproducing the movement of the cup after a shock and studying stresses distribution on the assembly cup-head.

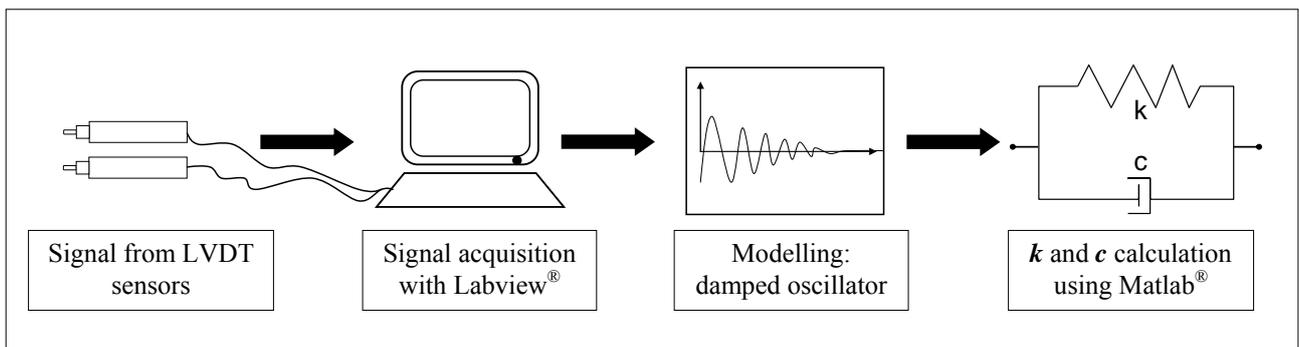
Figure 7. Diagram of data acquisition and postprocessing

The process of data acquisition, processing and modelling is summarized in Figure 7. Spring constant, k , and damping coefficient, c , were determined by fitting using Matlab®.

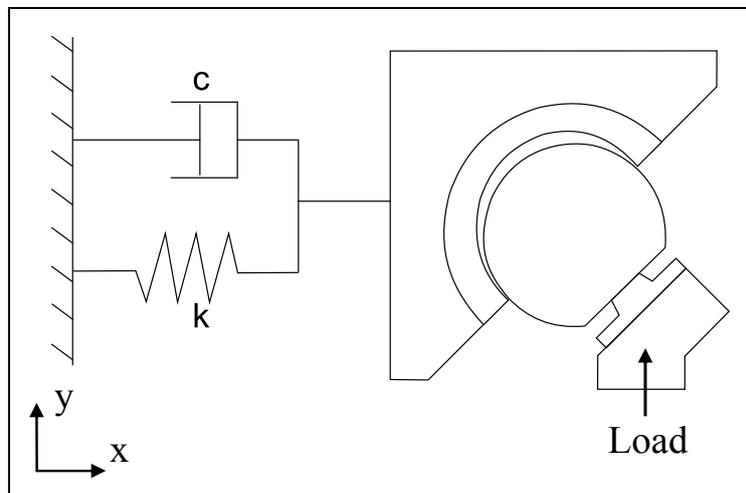
Figure 8. Scheme of shocks machine. The movements of the cup and the device are represented by a damped spring system.

Finally, the shocks device could be described in a more simplified manner as shown in Figure 8.

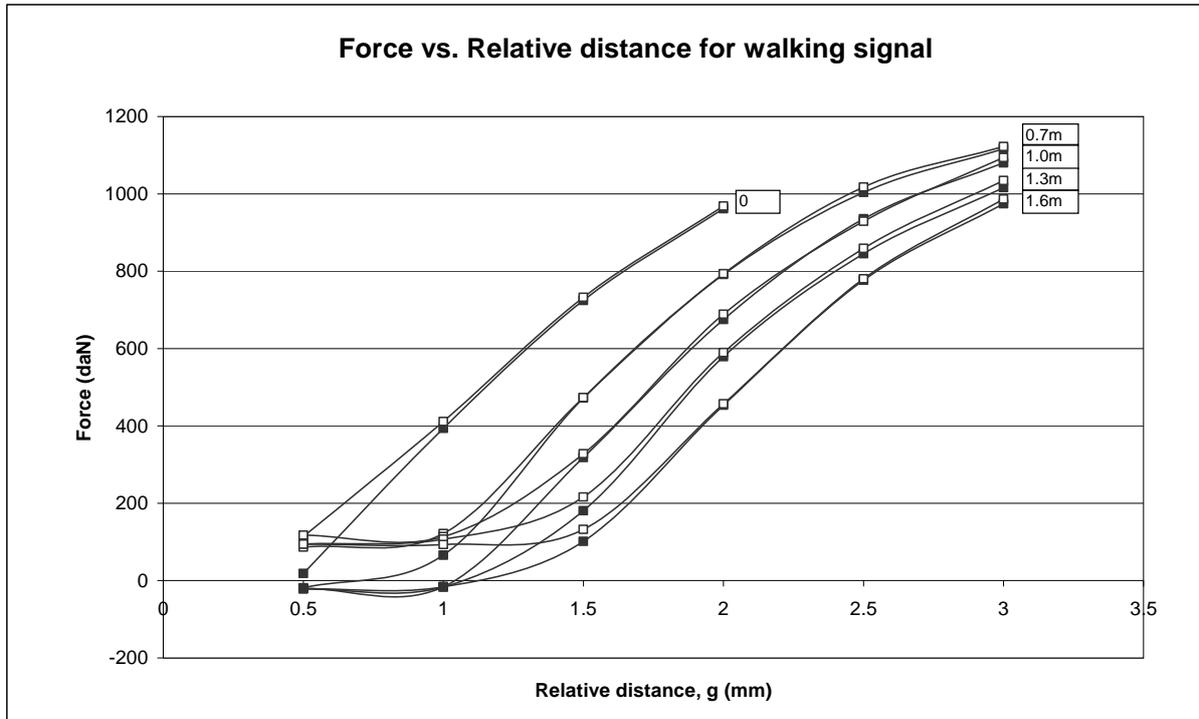
Figure 9. Force on the assembly cup-head as a function of relative distance of the head, for different values of microseparation; □: Ni-DAQ, ■: machine software

The validation tests were made to determine the range of operating conditions to reach a force of 9kN, and 3 signals were studied: sinus, triangle and walking. The signals from Ni-DAQ™ and machine software, Quiri™ did not show significant difference for sinus and triangle. On the other hand, for walking signal, recorded signals were considerably different for forces under 2kN. Above 2kN, signals are similar and may be modelled by a linear curve which slope is calculated for each microseparation value (Figure 9 and Table III).

Tests had duration of 20s and were stopped when force was greater than 11kN to avoid fracture of ceramic components and to be consistent with device capabilities. The results in Figure 9 show that a relative distance of 1.8mm has to be imposed to the head for reaching 9kN, without

microseparation. Hence, from Figure 9, an equation was established for microseparation of 1.3mm, the typical microseparation for *in vivo* tests:

$$F = (549.6 \pm 6.8) * g - (571.3 \pm 29.0) \quad (10)$$

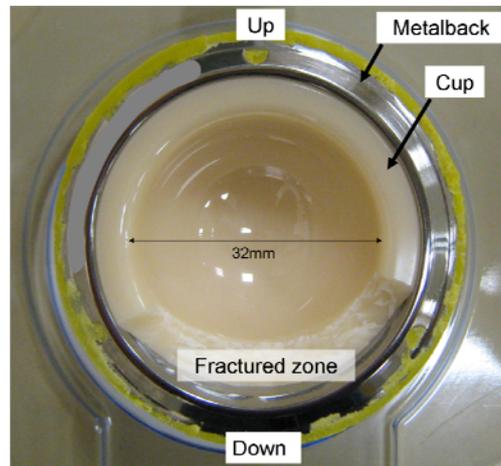
Figure 10. Alumina cup tested in dry conditions. Fracture at the lower rim.

Tests and cycles at fracture are summarized in Table IV. The three cups from dry tests fractured at the lower rim of the cup, Figure 10. Cup fracture occurred at $254,000 \pm 43,000$ cycles. Fractured bearing surfaces observed by Scanning Electron Microscopy, SEM, revealed intergranular and transgranular fractures, Figure 11. The size of debris from fractured cups was less than 1mm to several mm. There was no fracture for wet tests.

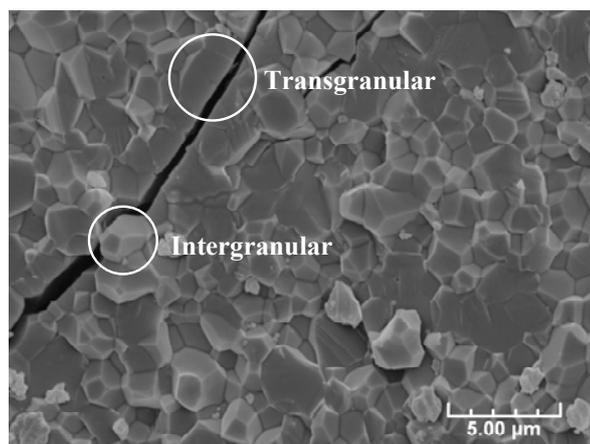
Figure 11. SEM image from alumina debris. Intergranular and transgranular fracture.

Figure 11 shows that debris could be mostly about 1µm of diameter. Shocks induce these typical debris. This experimental result involves some expectations about the reactions of cells. Studies on the biological tolerance of alumina and zirconia nanosized powder on rats suggested that the inflammatory response is similar to those reported for polyethylene or metal particles²³. Nevertheless, testing composites under shocks could lead to intergranular and transgranular fracture and smaller nanometric debris could be found, which might induce an inflammatory response.

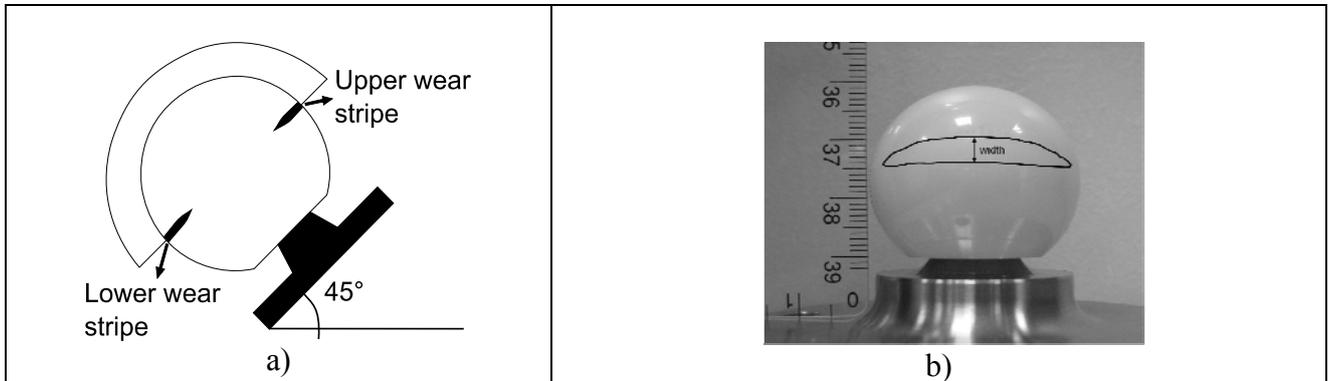
Figure 12. a) Location of wear stripes and b) Wear stripe on a head tested in dry conditions.

Wear stripes were observed for all heads in the contact zone of the head with the rim of the cup, Figure 12a. There were no visible macroscopic cracks.

For dry tests, a wear stripe appears in first 50,000 cycles, while it appears only after 100,000 cycles in wet conditions. The location and general shape of the stripes were similar for shock machine and retrieved femoral heads¹¹. Figure 12b shows wear stripes location. The width of the wear stripes was measured every 50,000 cycles for dry conditions and every 100,000 cycles for wet conditions, Figure 13. Since shape of the wear stripe exhibited on the head was not well defined at first cycles, first measurement of width was taken after 100,000 cycles for dry tests and after 250,000 cycles for wet tests.

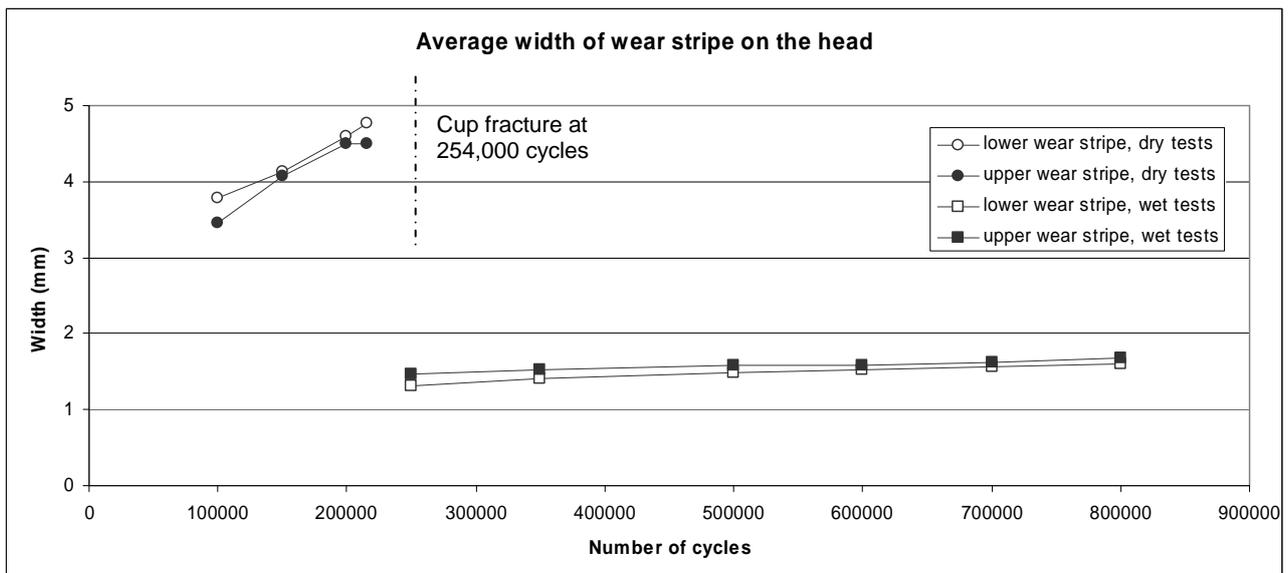
Figure 13. Width of wear stripes on the head for dry and wet tests.
Enlever lignes horizontales

Average width of wear stripe was strongly different for heads tested in dry and wet conditions; wear stripes were wider than 4mm in dry conditions while it was less than 2mm for wet conditions, Figure 13. However, at a macroscopic scale, the worn surfaces from the dry tests and wet tests were morphologically indistinguishable. Since wear stripes did not reached 4mm and had a small growth rate, tests were stopped at 800,000 cycles in wet conditions.

In both dry and wet conditions there was an accelerate growth in the first 150,000 cycles; the slope is bigger for dry than the one for wet. After 200,000 cycles the width of the wear stripe of heads increased slowly. Figure 14 shows the average width of the wear stripes at the end of the tests.

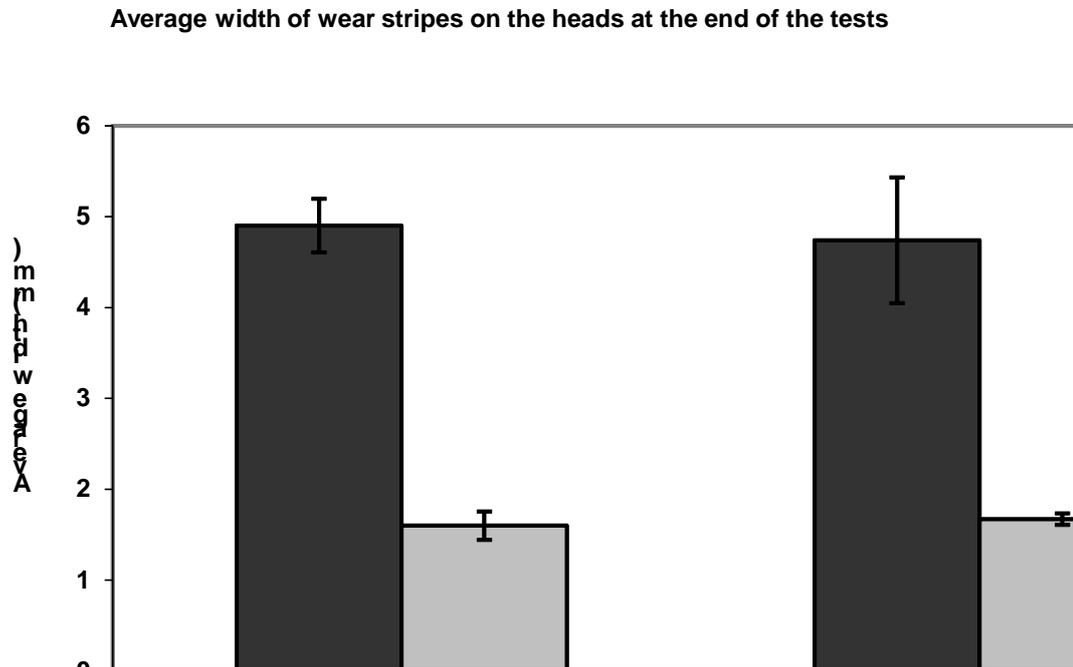
Figure 14. Width of wear stripes for heads in dry and wet conditions.

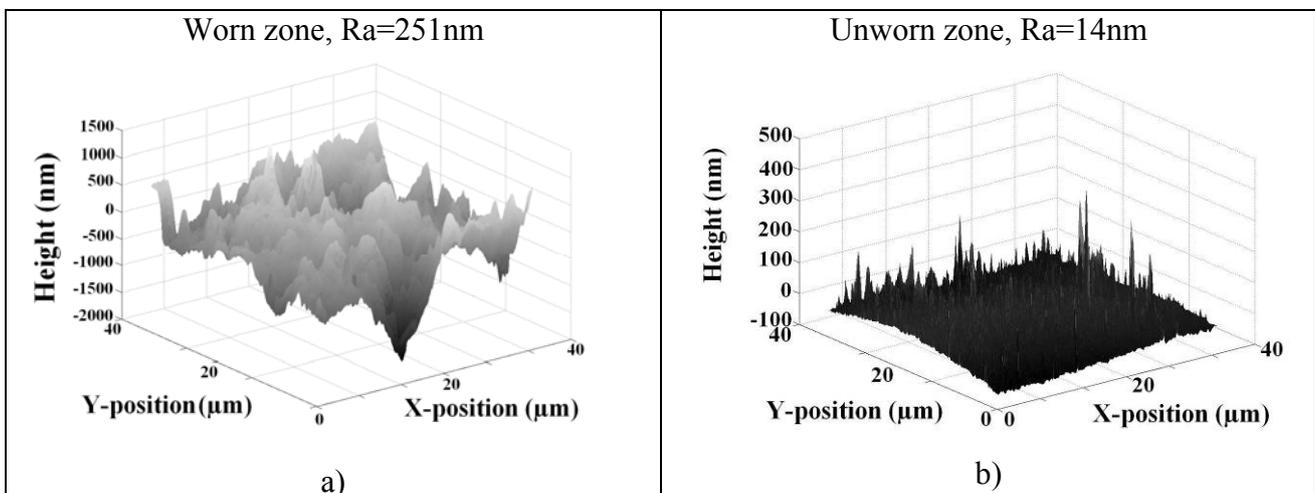
Figure 15. Three- dimensional reconstruction of a roughness profile for both a) worn and b) unworn zones studied by AFM.

After the shock tests, heads were cut carefully and analysed by Atomic Force Microscopy (AFM, Software 6.13) to determine surface roughness evolution. A first order flatten filter was applied to suppress the effect of the spherical shape. 3D-roughness was of 9.1 ± 5.1 nm in unworn zones whereas it was measured to be 277.9 ± 29.4 nm in worn zones. Roughness in worn zones is 20 to 30-fold higher than in unworn zones. These values are comparable with retrieved heads¹². A three dimensional reconstruction of the surface was made using Matlab[®]. Figure 15 shows surface for a worn and unworn zone from the same head.

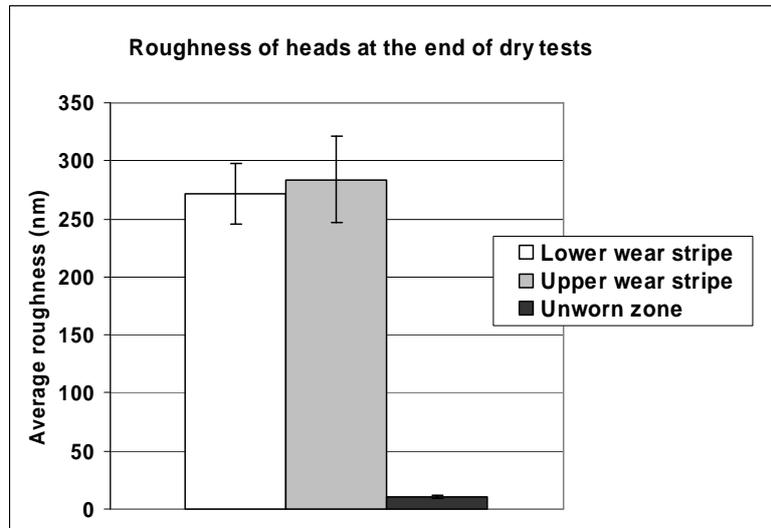
Figure 16. Wear stripe roughness from heads tested in dry conditions.

Analyses by AFM showed a similar roughness for the upper and lower wear stripe, showed in Figure 16.
