# Experimental analysis of CFRP laminates subjected to compression after impact: The role of impact-induced cracks in failure

This paper presents an experimental analysis of composite laminates subjected to low velocity impact and compression after impact (CAI). Two types of CFRP specimens are studied: a highly oriented laminate and a quasi-isotropic laminate. Impact energy is chosen to obtain a dent depth less than or around the BVID level. 3D digital image correlation is used to make detailed analyses of plates behaviour during CAI. Even if the damage morphologies are very different, the study shows that, in both cases, classical global buckling of the plate and local buckling of the delaminated sublaminates are accompanied by a crack on the impact face of the laminate. This crack appears in the highly damaged zone, under the impactor, and propagates in the direction transverse to the loading direction in a stable way. It is shown to play an essential role in the final failure of the laminate under compression.

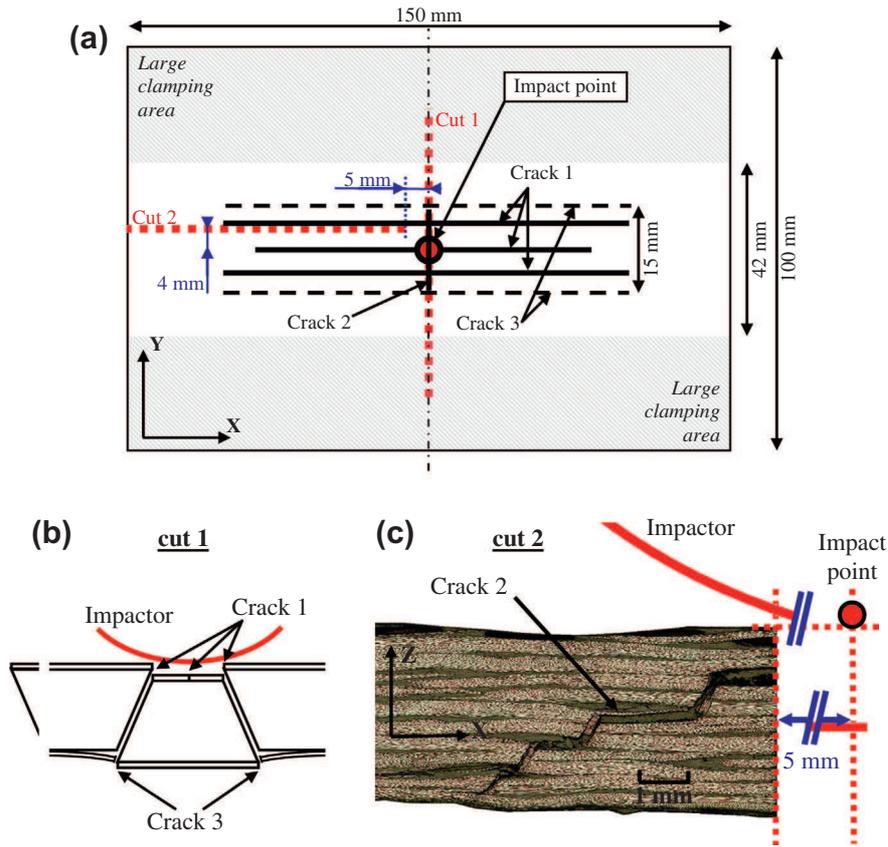
Fig. 1. Main damage after impact in HO plates: (a) localisation of main cracks, (b) trapezoidal shaped damage, and (c) crack 2.

Due to its specific stacking sequence, damage inside HO plates is very particular (Fig. 1). Chronologically, 45° microcracks appear in the quasi-UD on the back face of the laminates under the impactor, and propagate in the thickness till the impact face, and then

along the lower fabric, to induce delamination. Next step is the rupture of the upper fabric (cracks 1), and afterward, rupture of the lower fabric (cracks 3), that both propagate then in the longitudinal direction ( $x$ ). At this moment, the damage consists mostly in a partially detached stripe with a trapezoidal section. In parallel, a crack (crack 2) appears and propagates in the transverse direction ( $y$ ). This crack is of first importance, as it plays a major role in the final rupture of the laminate in CAI (see Section 4). The comparison between static and dynamic tests shows similarities in quantity and form in the damage except for the permanent indentation, which is higher in the static cases.

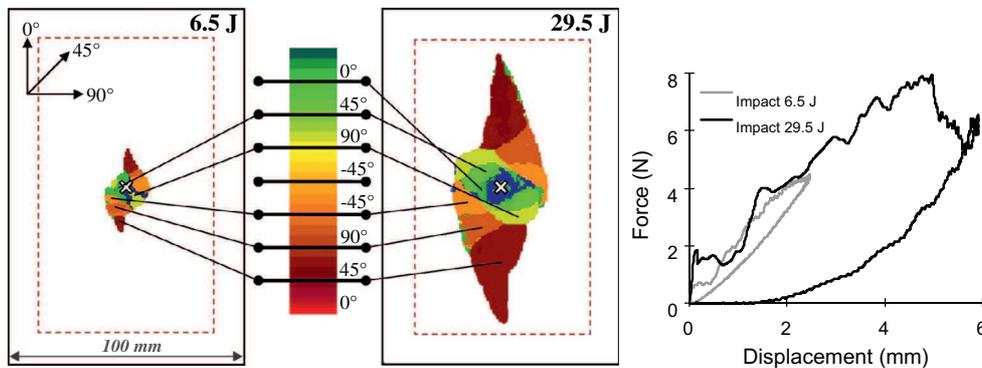
Fig. 2. QI plate C-Scan and force/displacement curve: 6.5 J and 29.5 J impact.

The damage in QI specimen is more classical, with the well-known helix-shape delamination increasing in the depth of the plate. This damage is also increasing with the impact energy level. Fig. 2 shows C-Scans of 6.5 J and 29.5 J impact tests, which reveal delamination areas inside the plate.

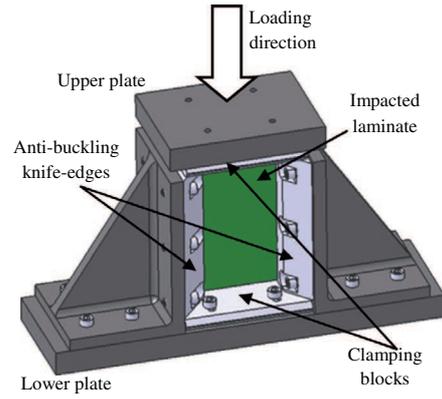
Fig. 3. CAI setup.

CAI tests were also performed according to the AITM 1-0010 standards [35] (Fig. 3), with an adaptation for HO specimen: due to their high flexibility, the distance between stabilizing knife-edges was decreased to 75 mm instead of the 90 mm used for the QI plates (Fig. 4), which was enough to obtain a stable propagation of cracks due to fibres failure in compression.

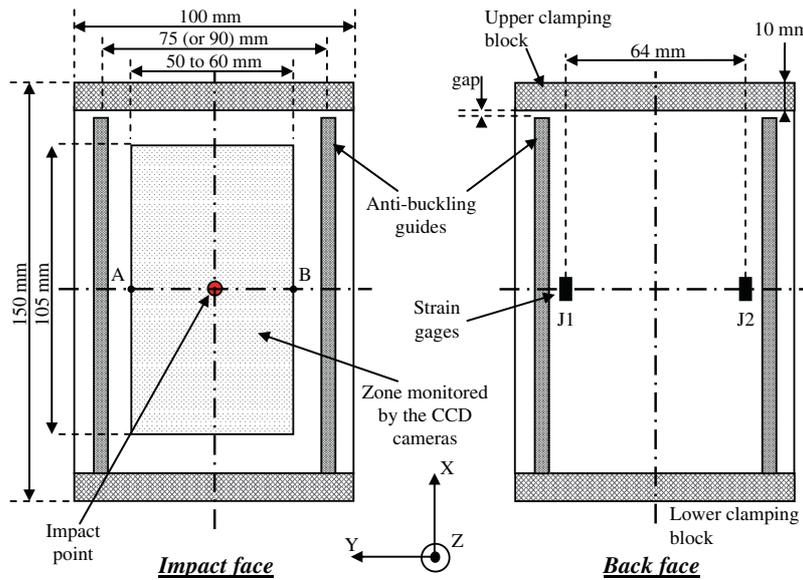
Fig. 4. Instrumented laminate for CAI test.

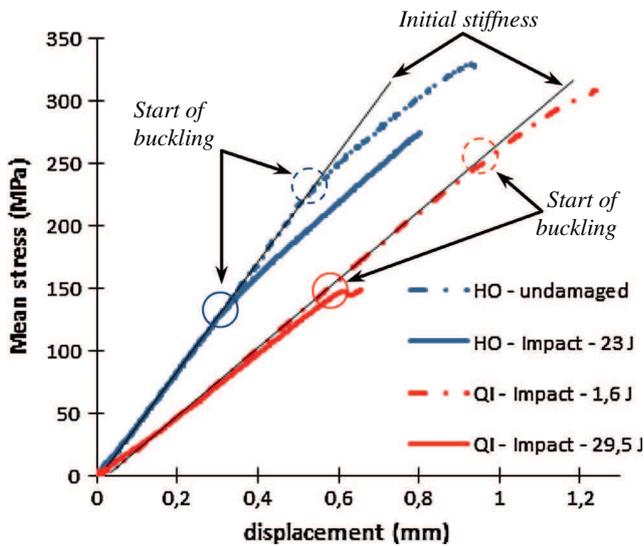
Fig. 5. Example of mean stress/In-plane displacement curves during CAI for HO and QI plates.

Fig. 5 shows the mean stress curve in the specimen as a function of the imposed displacement for two HO plate cases: the non-impacted test and the 23 J impact test. All the tests give similar curves. We note on these curves the presence of two phases. The first one, linear, corresponds to the increase of stress when the plate is subjected to compression loading. The slope of this curve is the same for healthy and damaged samples: the presence of initial damage has little influence on the plate membrane stiffness. The second part corresponds to the appearance of an overall buckling of the plate, and the damage propagation in the plate. So the knee-point refers to the beginning of buckling.

CAI tests were carried out on the impact configurations presented in Table 3. Fig. 5 shows the mean stress curve in the specimens as a function of the imposed displacement for two of those configurations (1.6 J and 29.5 J). All tests result in similar curves. The nonlinearities just before rupture are not as pronounced as in the HO plates because buckling occurs at loads closer to failure.

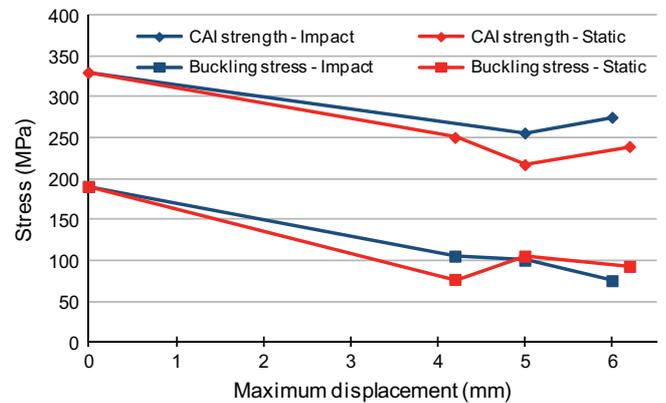
Fig. 6. Evolution of CAI strength and buckling stress in function of the maximum displacement reached during impact or static tests for HO plates.

Fig. 6 shows the evolution of the failure stress and the buckling stress (see following section for details on the calculation of buckling stress). There is a significant decrease in failure stress, up to 30%, with increasing impact energy. There are few differences between dynamic tests and quasi-static tests. In any case, the small number of tests does not give a significant trend in this respect.

Despite the modifications in CAI test set-up, global buckling appears early in the test, and Fig. 6 shows that the buckling stress decreases significantly with increasing initial damage. For all tests, the out-of-plane displacement due to global buckling is in the same direction, and keeps increasing till failure. However, CAI strength remains significantly higher than buckling stress (Fig. 6).

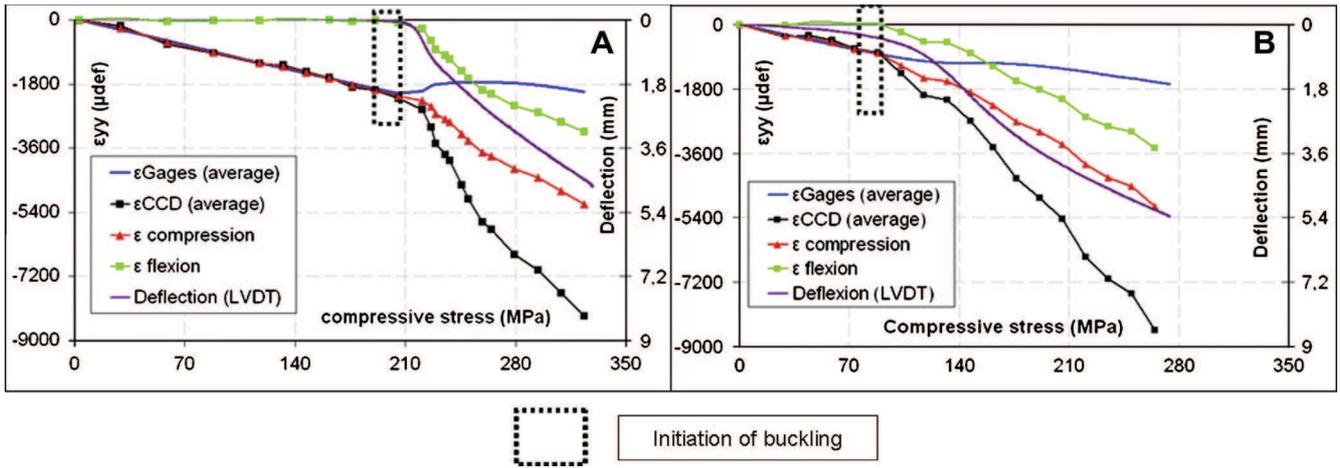
Fig. 7. Gages and DIC results of CAI tests: (A) non-impacted HO plate and (B) HO plate impacted at 23 J.

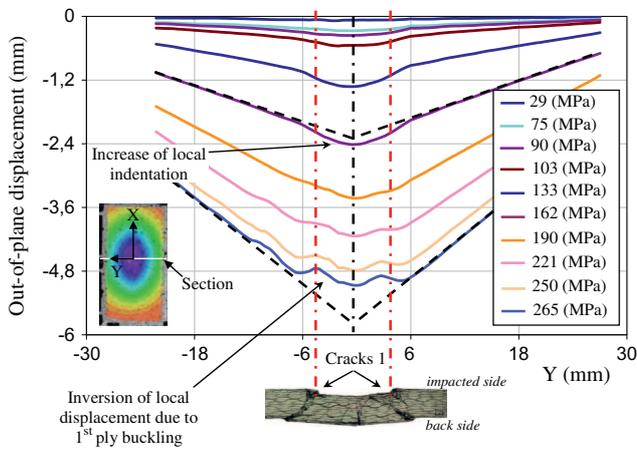
Fig. 8. Out-of-plane displacement during CAI for the 23 J impacted HO plate (impact face).

The buckling is also analysed thanks to the CCD cameras and the associated cartographies of the out-of-plane displacement around the impact point. Cuts parallel to Y axis and passing by the centre of the plate at different compressive loadings lead to the out-of-plane curves in Fig. 8 for the 23 J impacted plate case.

These curves show the evolution of the global shape of the plate during CAI, and especially the global buckling of the plate, and the local buckling of the partially detached central part.

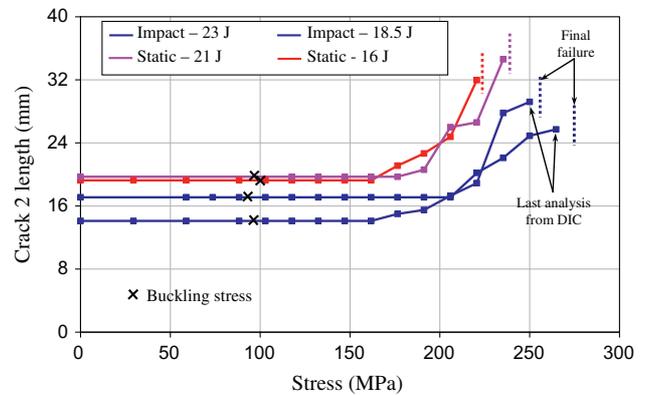
Fig. 10. Evolution of crack 2 length in function of stress during CAI for HO plates.

Fig. 10 shows the evolution of crack 2 length as a function of the applied stress until the total failure of the specimen during four CAI tests. It can be remarked that the length of this crack remains constant (no propagation) until a certain stress which is far greater than the buckling stress. Afterwards the crack starts to propagate smoothly while out-of-plane displacement increases, before leading to the total failure of the specimen. The domain of stable growth of the crack can be significant, as the length before instability can be more than twice the initial length. The evolution of the crack can be explained by looking at the stress and strain fields around the crack tip. Indeed, the propagation of the crack 2 as a function of the strain through  $x$  axis is plotted in Fig. 11. The strain is determined at the crack tip from the CCD cameras by computing the partial derivatives of the displacement field. It must be noted that when the crack 2 propagates, the location  $y$  where the strain is calculated also changes. It can be seen that the length of this

crack remains constant until a strain varying between 7000 and 11,000  $\mu\text{def}$ , and starts to propagate and reaches its maximal length at a strain of about 12,000 and 13,000  $\mu\text{def}$  coming along with the total failure of the specimen. These strain values are close to the failure strains of the materials (woven fabric and quasi-UD). It means that the crack propagates only if the failure strain is reached in the fibres at the tip of the crack.

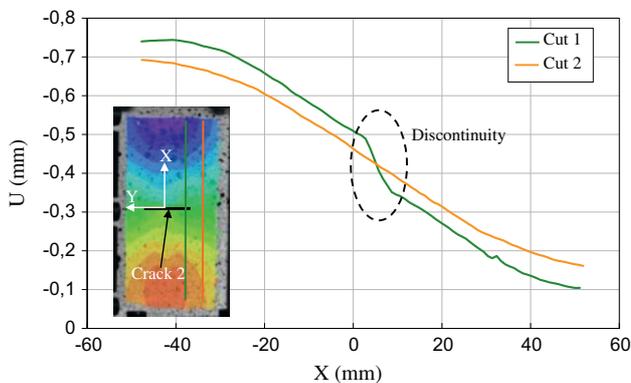
Fig. 9. Method for determination of crack 2 tip.

Another thing to be monitored during the compression after impact test is the evolution of crack 2. The detection of this crack and its evolution are done with the CCD cameras. Different cuts parallel to the X-axis are done and the displacement  $u$  (in X direction) is measured (Fig. 9). When there is no failure along that cut, the  $u$  curve is approximately smooth. However, the existence of a discontinuity means that the upper part moves down more than the lower part which gives an indication of a discontinuity between the two parts. This phenomenon can be explained by the presence of crack 2. Fig. 9 presents an example of two  $u$  curves with different cut locations  $y$ . A discontinuity can clearly be seen in the curve of cut 2. By minimising the distance between the different cuts, the

tips of crack 2 can be localized and the length of this crack can be calculated. The same method was tested on out-of-plane displacement curves but discontinuities are less obvious.

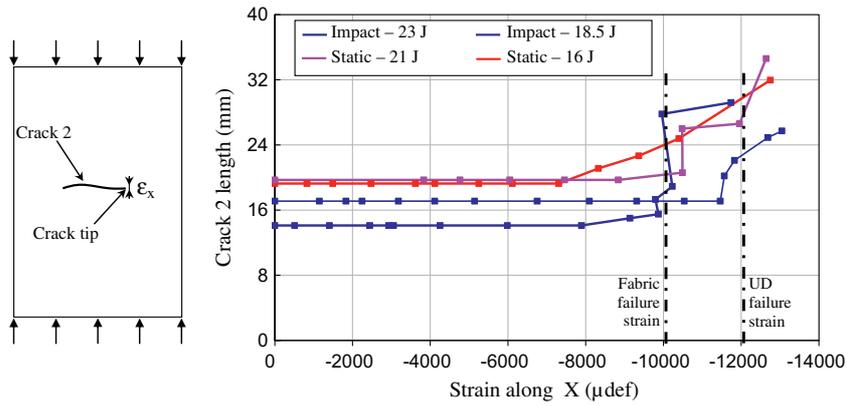
Fig. 11. Evolution of crack 2 length in function of the compressive strain in X direction at crack tip for HO plates.

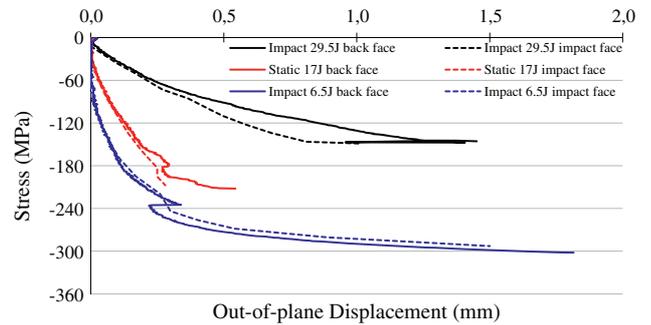
Fig. 13. Stress/out-of-plane displacement curve during CAI for three QI plates.

Fig. 13 shows the out-of-plane displacement at the centre of the plate versus the stress during three different CAI tests. The more damaged is the plate after impact (or static indentation) the faster is the increase of out-of-plane displacement during CAI. To see if this displacement is due to local or global buckling, a more precise analysis of the 29.5 J impact case was done using gages, DIC from CCD cameras and LVDT sensors. Fig. 14 shows the three classical steps: first, a quite homogeneous compression of the overall plate, till point A. Then, a slight increase of the plate thickness (difference between displacement at back face and impact face) can be observed between points A and B. It is due to the local buckling of sublaminates around the impact point. Finally, the plate suddenly

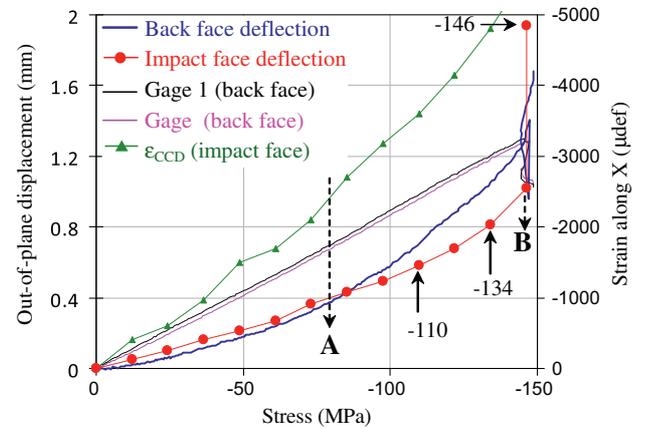
Fig. 14. (a) Out-of-plane displacement and strain gages curves during CAI -29.5 J impact QI plate.

fails. No global buckling of the plate occurs, as proved by the linearity of gages curves till the failure.

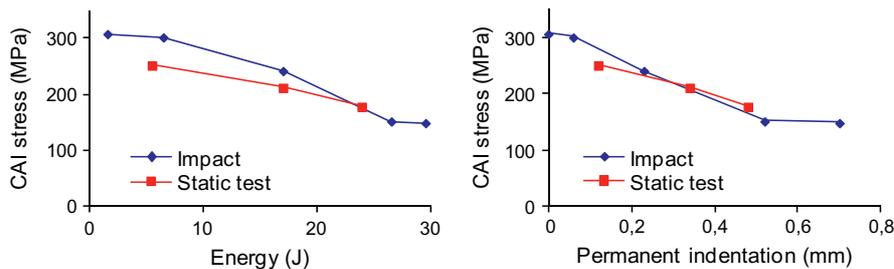
Fig. 12. CAI strength versus impact energy (a) and permanent indentation (b) for QI plates.

Fig. 12 presents the evolution of CAI stress with the impact (or static indentation) energy and permanent indentation (measured 48 h after the impact tests). The decrease in strength due to impact is also greater than 30% for impact at more than 25 J. All the damaged plates break at the centre except the 1.6 J impact test, for which rupture occurs at one extremity of the plate, and the 6.5 J impact test, for which failure occurs at the third of the plate. The case of 17 J impact is specific, as buckling appeared in the opposite direction compared to what is commonly obtained.

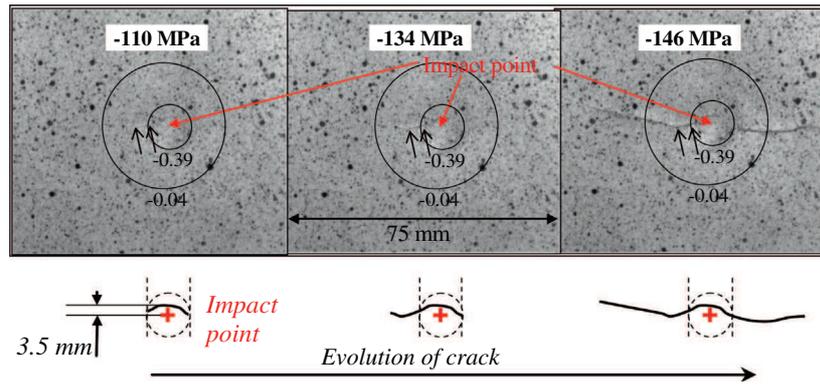
Fig. 15. Pictures of cracks during CAI: 29.5 J impact QI plate.

Fig. 15 shows pictures of the impact face taken during the CAI test made after a 29.5 J impact. Until  $-110$  MPa, the crack is not clearly visible, as it is confined in the vicinity of the impact mark, and remains hidden by the paint. When the crack propagates in the upper ply, it also propagates in the paint, and then is clearly visible. Fig. 16 presents the photo of the cracks induced by a 27.3 J static indentation before painting, which proves the presence of these post-impact cracks in some of the impacted (or indented) laminates before any CAI loading. However, they are not so obvious on all the specimen tested.

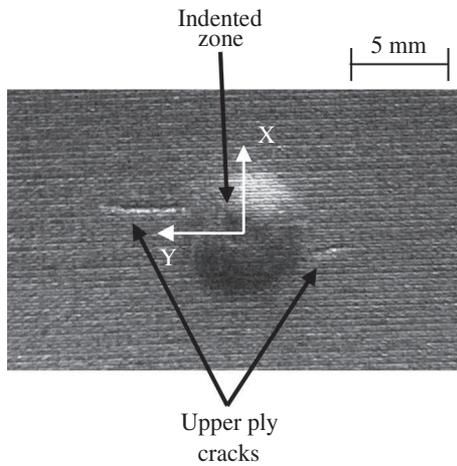
Fig. 16. Post-impact cracks: 27.3 J static indentation test on QI plate.

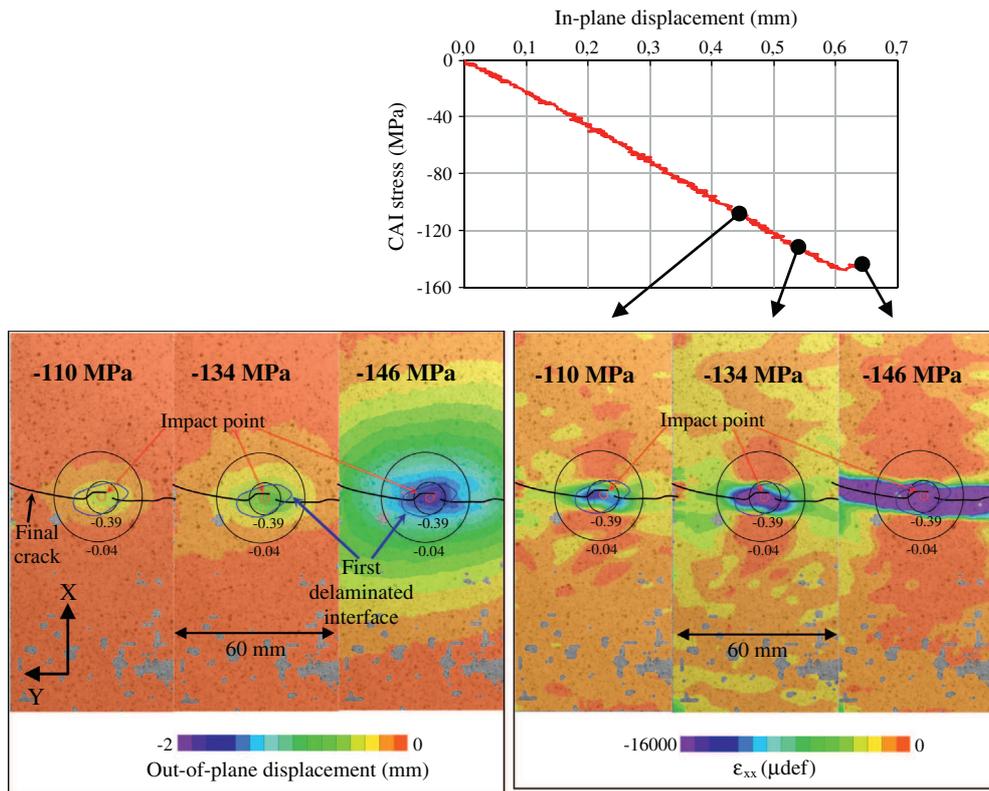
Fig. 17. CAI at 29.5 J: stress–displacement curve, out-of-plane displacement field, and longitudinal strain field.

In Fig. 17, out-of-plane displacement and longitudinal strain fields obtained from DIC are represented. Iso-lines for  $-0.04$  and  $-0.39$  mm of initial out-of-plane displacement (measured after impact) are also drawn to give an idea of the post-impact indentation. The first delaminated interface and the crack obtained at final CAI failure are also presented. It is seen in these photos that when the CAI stress reaches about  $-110$  MPa, a crack start to propagate from the strongly damaged zone, and especially from the middle of the

area highly indented by the impact. This crack is easily observable through the deformation field  $\epsilon_{xx}$  determined by DIC, and only takes place in the upper plies (no crack on the back face). It should be noted that the value of minimum deformation chosen for scale is the compressive deformation of the material and thus a higher deformation in absolute value would inevitably lead to material failure. The same comments as for HO plates can be made regarding the limitations in strain calculation from DIC in this kind of test.

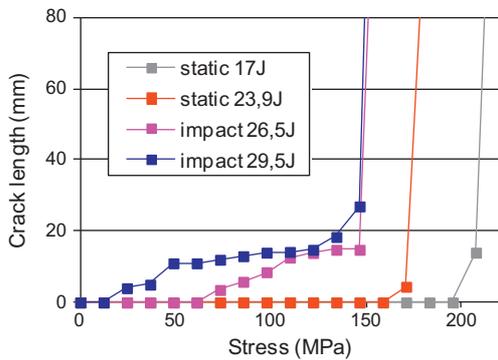
Fig. 18. Evolution of crack length during CAI test.

To complete this analysis, a more specific study of the crack was led on all CAI tests where a crack appeared: impact at 26.5 J and 29.5 J, and static tests at 17 J and 23.9 J. Fig. 18 shows the evolution of crack length with the applied stress. The definition of crack length is the distance between the two extremities of the crack. More precisely, Fig. 19 presents the position of the crack tips (left and right). These curves clearly show that for these four different test cases, a crack appears during CAI and propagates during the test. For the 26.5 J and 29.5 J impact, the crack appears early in the test and has a stable propagation. In the cases of 17 J and 23.9 J static tests, the crack appears lately. Fig. 19 clearly shows that the crack initiates inside the highly indented area around the impact (or indentation) point, i.e. within an 8 mm radius area approximately, and more precisely, at 3.5–4 mm from the centre of the impact zone (see Fig. 15). Only the crack in the 29.5 J impact case propagates outside this zone in a stable way. It must be noted that the location of the cracks tips and thus the value of crack length when the compressive load is low must be treated with caution. Indeed, with the method used to detect the crack (Fig. 9), it is necessary to have a differential displacement in  $x$  direction between the two sides of the crack, and unfortunately, for low loads, this displacement is very small. This is the reason why these values are hidden in Fig. 19 (hatched area).

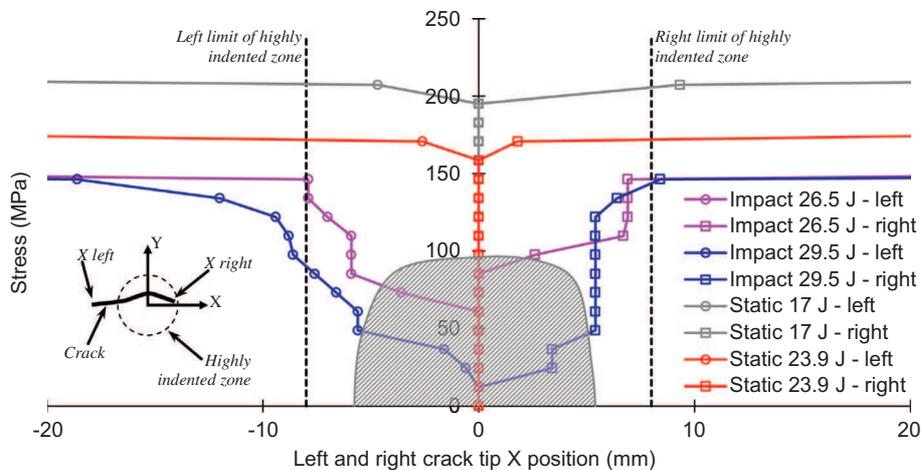
Fig. 19. Evolution of left and right crack tips.

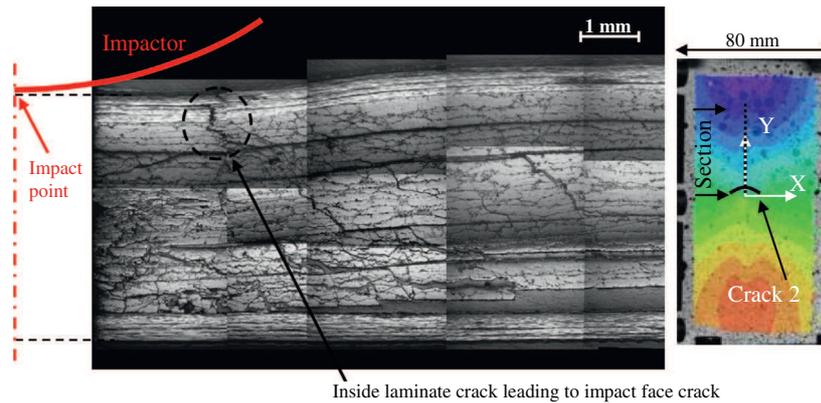
Inside laminate crack leading to impact face crack

**Fig. 20.** Inside laminate cracks after static indentation.

To understand the presence of this crack and the reason for its initiation at that location (i.e. inside the highly indented area), microscopic observations were made on a specific specimen. Fig. 20 shows a microscope image of a section of the 24.8 J statically indented plate (5.4 mm of maximum displacement). The cut was made in the  $y$  direction. A crack can clearly be seen in the upper  $45^\circ$  double-ply and in the external  $0^\circ$  ply. Its location appears to correspond to the location found for the initiation of crack studied in the CAI tests. This proves that, even if not easily detectable from a single observation, a post-impact crack exists in the upper plies of the laminate, under the impactor.
