OPERATIONAL MODAL ANALYSIS AND WAVELET TRANSFORMATION FOR DAMAGE IDENTIFICATION IN WIND TURBINE BLADES

Martin D. Ulriksen¹, Dmitri Tcherniak², Poul H. Kirkegaard¹, Lars Damkilde¹

¹ Dept. of Civil Engineering, Aalborg University, Sohngaardsholmsvej 57, Aalborg, Denmark

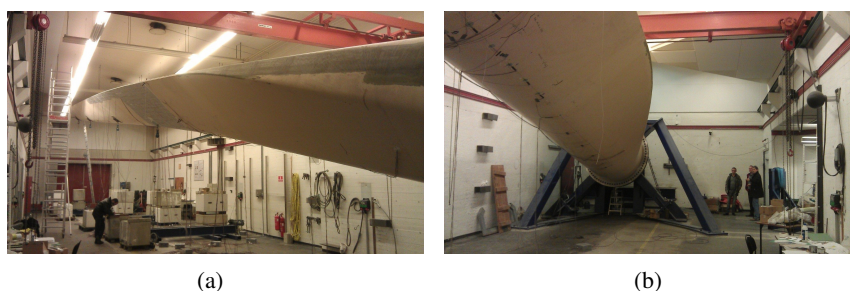
Figure 1 : SSP 34 m blade mounted on the test rig. (a) Root-to-tip view. (b) Tip-to-root view.

A 34 m long wind turbine blade, designed and manufactured by SSP, was mounted on an indoor test rig as shown in Figure 1. The SSP 34 m blade is made from epoxy fiberglass and has a mass of 4,600 kg [10].
