Three Experimental Applications of Health Algorithms to Improve Infrastructure Inspection

Elizabeth K. Ervin. Three Experimental Applications of Health Algorithms to Improve Infrastructure Inspection. Le Cam, Vincent and Mevel, Laurent and Schoefs, Franck. EWSHM - 7th European Workshop on Structural Health Monitoring, Jul 2014, Nantes, France. 2014. <hal-01020331>

THREE EXPERIMENTAL APPLICATIONS OF HEALTH ALGORITHMS TO IMPROVE INFRASTRUCTURE INSPECTION

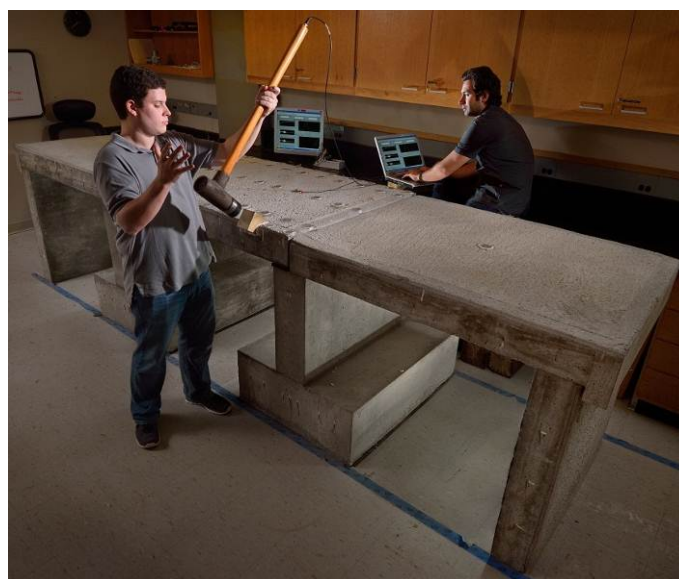
Figure 3: Graduate students performing impact hammer testing on the scale model bridge

Based upon the general dimensions of an on-campus bridge, a 1:12 scale model reinforced concrete bridge was built by students for expanded testing. The scaled bridge consisted of two inverted T-shaped piers, two end slabs with shear keys, two end walls, and one center slab. Note that the slab thicknesses were not to scale: since a two-inch slab is impractical, a six-inch minimum slab thickness was used for enough rebar cover. The scale model bridge pieces were precast in a single concrete pour. After 35 days, the pieces were unformed and assembled inside of the lab using a forklift. One surprise was that the three cubic yards of concrete tested at an unusually high average strength of 7,110 psi (ASTM C 172 and 143). The completed product is shown in Figure 3.

Weighing approximately 1270 pounds, the 60"x42"x6" center slab was the target of the vibration testing. A twelve-pound PCB sledge hammer (Figure 3) impacted a wood block on the bridge, inducing multi-dimensional vibrations. A Dytran tri-axial accelerometer on a level epoxy pad measured nearly imperceptible motions, and this was repeated for 57 spatially diverse locations for each damage case. Note that two measurements were on each approach slab, which proved very helpful in separating dissimilar modes. The other 55 measurements provided a grid that will allow for mode visualization in all three directions. A National Instruments CompactDAQ recorded the accelerometer signals via NI LabVIEW, and the csv time histories were loaded into the MATLAB structural health algorithm for post-processing.
