CASE STUDIES ILLUSTRATING THE EFFECT OF WEAKENED LOAD TRANSFER ON NEUTRAL AXIS MEASUREMENTS

Michael V. Gangone

*Department of Civil Engineering, University of Texas at Tyler, 3900 University Blvd., Tyler, TX
75799*

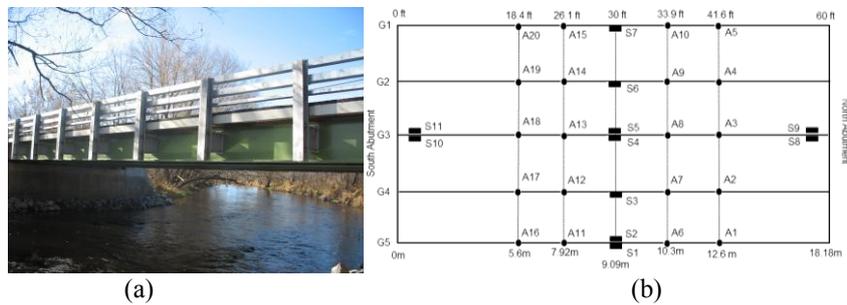
The bridge instrumented is located in Brasher Falls, New York crossing the Deer River (figure 1a). The bridge was reconstructed in the summer of 2009 to replace a deteriorated open steel grating deck on steel girders. The replacement design incorporates 8- 19.96cm (7.75 in) thick glass FRP (GFRP) panels 2.4m (7.9 ft) in length by 7.27m (24 ft) wide which rest on 5 – W30x235 steel

Eleven reusable strain transducers measured the quasi-static and dynamic response of the bridge. Sensor locations are shown in figure 1b. The strain transducers were distributed to measure the girder load distributions, neutral axis locations, and end fixity. The majority of the strain transducers were mounted along the centerline of the bottom flange in the longitudinal direction of the bridge. At the locations where the neutral axis is determined (girders 3 and 5), an additional gauge was placed on the top flange. All strain transducers were mounted with removable threaded tabs affixed to the girders with the manufacturer recommended adhesive. For additional information regarding this test see Gangone et al. [12].

Figure 1: (a) CR55 Bridge Test Structure; (b) Instrumentation Setup (A : Accelerometer, S : Strain)

girders spaced at 1.67m (5.5ft) on center. Steel girders are supported by elastomeric bearings and cast into the gravity abutments in an integral abutment design. Seven equally spaced MC 18x42.7 sections served as intermediate diaphragms between each girder. The bridge has a non-composite inventory rating of 75.1 metric ton (82.8 tons) for the HS46.0 truck and an operating rating of 124.9 metric ton (137.7 tons) for the HS76.5.

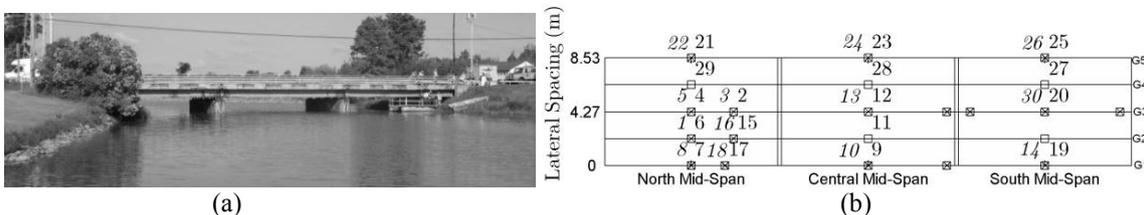
The highway bridge investigated, located on RT345 in upstate New York consists of a 19.1 cm (7.5 in) thick reinforced concrete slab supported by three interior W33x152 and two W33x141 exterior steel girders (figure 2a). The bridge is a 3-span simply supported two-lane structure consisting of a 13.7 m (45 ft) simply supported span at an elevation of approximately 1.2 m (4 ft) from the waterline. The girders have a center-to-center spacing of 2.1 m (7 ft) and are supported by pin and rocker steel bearings. End and midspan intermediate diaphragms are constructed of C15x33.9 sections that are bolted to transverse plates welded to the girders. Prior to the scheduled closure for replacement, the structure serviced New York State Route 345 over Big Sucker Brook in the town of Waddington. Constructed in 1957, the bridge maintained a sufficiency rating of 61.2%, an operational rating of 44.5 metric tons, and an average daily traffic estimate of 1169 vehicles.

Figure 2: (a) RT345 Bridge over Big Sucker Brook Test Structure; (b) Instrumentation Layout

Wireless Bridge Diagnostic Incorporated (BDI) strain transducers were deployed for completion of a full scale load test on all three spans. BDI sensors were deployed primarily at the midspan of the steel girders for measuring NA, DF, and impact factor response for a flexural ASD load rating. The instrumentation layouts for both tests showing the strain gauges placed at the bottom and in some cases top flanges as well are presented in figure 2b. Locations which show two

numbers side by side (e.g. 4 and 5 of figure 2b) indicate that both the top and bottom flanges were instrumented at that location. It should be noted that while some sensors were placed at locations other than just the midspan, only the midspan measurements are used in the discussion of this paper. Additional information from this test can be found in Gangone et al. [13].

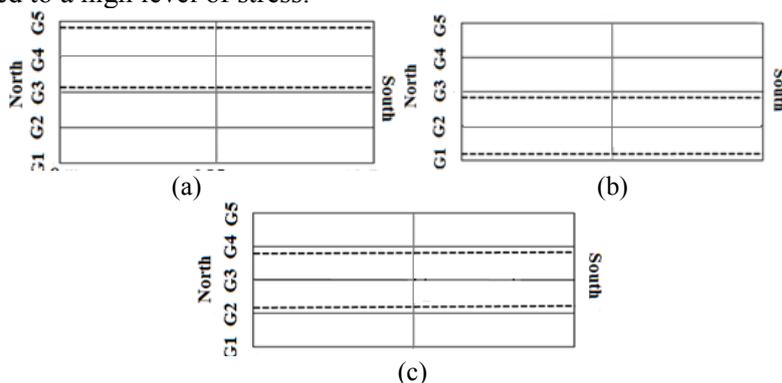
Both bridges were sectioned into three different lanes, east, west and center (figure 3). Calibrated testing vehicles were provided by the New York Department of Transportation (NYSDOT). Axle weights were known and their position on the bridge within each of the three lanes was pre-determined. The rear axle, the heavier of the two axles, was positioned at the midspan to excite the maximum strain response at each sensor location. From testing in each of the three lanes, each girder was excited to a high level of stress.

Figure 3: Testing lanes (a) east, (b) west, (c) center

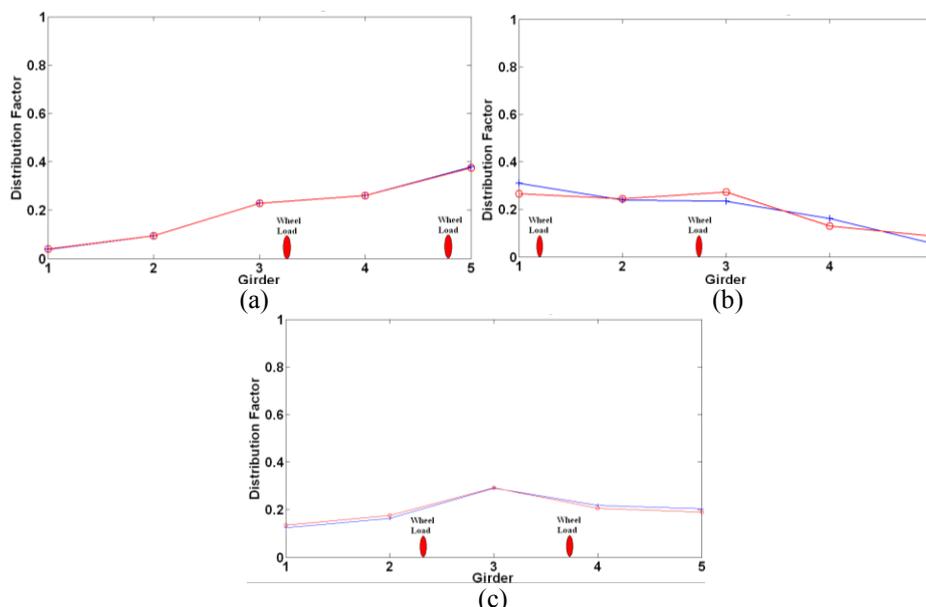
This bridge was monitored within one year of construction. There were no visible signs of deterioration that would normally hinder the load shedding capabilities. Figure 5 illustrates the load shedding characteristics based on the test vehicle positioned in each of the three lanes. The results in figure 5a are as expected with girders 4 and 5 receiving a majority of the load demand then shedding to the remaining girders. West and center lane load cases (figures 5 b,c respectively) seem to show similar findings. The findings also suggest good repeatability in the data as the distribution factors appear to be nearly identical for both load tests particularly for loading in the east and center lanes.

Figure 5: Distribution factors at the midspan of CR55 Bridge based on; (a) loading in the east lane; (b) loading in the west lane; (c) load in the center lane

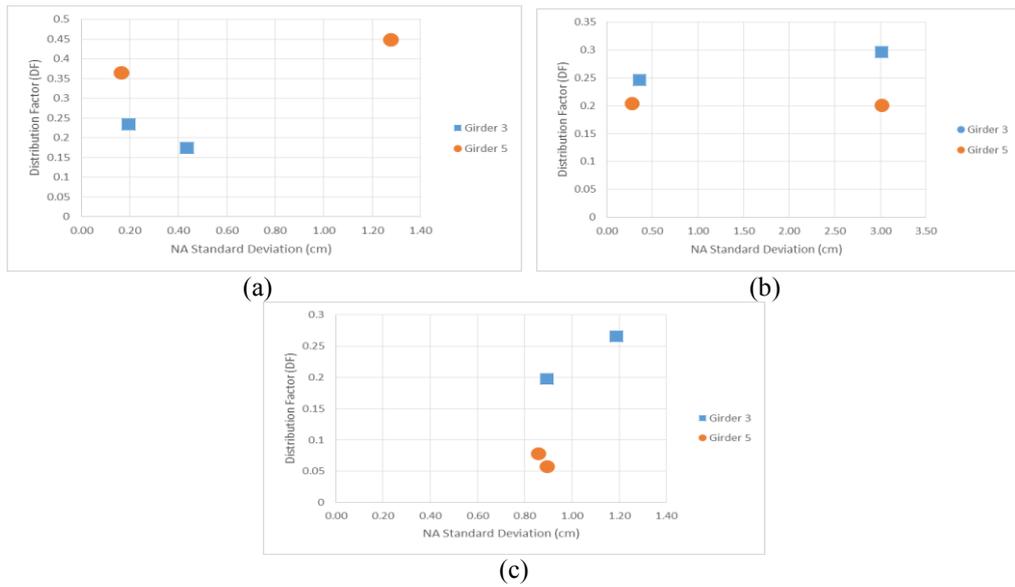
Four load tests were performed in each of the three testing lanes. Figure 6 compares the average distribution factor for the girder with the standard deviation of the neutral axis (NA) measurements. Girder 3 represents the center girder and girder 5 is the eastern most girders. The data for this bridge indicates that there are very small standard deviations among the neutral axis measurements. In addition, the distribution factors were large enough that the strains were able to be acquired with high enough resolution to get greater precision for each case. For this bridge, the load shed thoroughly from girder-to-girder no matter the position of the vehicle. Part of the precision of this measurement is due to the bridge deck material. Glass FRP deck panels do not produce the composite action that is seen between a reinforced concrete deck and steel girder. Therefore, the neutral axis lies near mid-depth of the girder providing high strains at both flanges. These high strains give greater resolution of the strain measurements.

Figure 6: Standard deviation in of the neutral axis measurements based on the load distribution factor of the beam of the CR55 Bridge; (a) East lane load test; (b) Center lane load test; (c) West lane load test

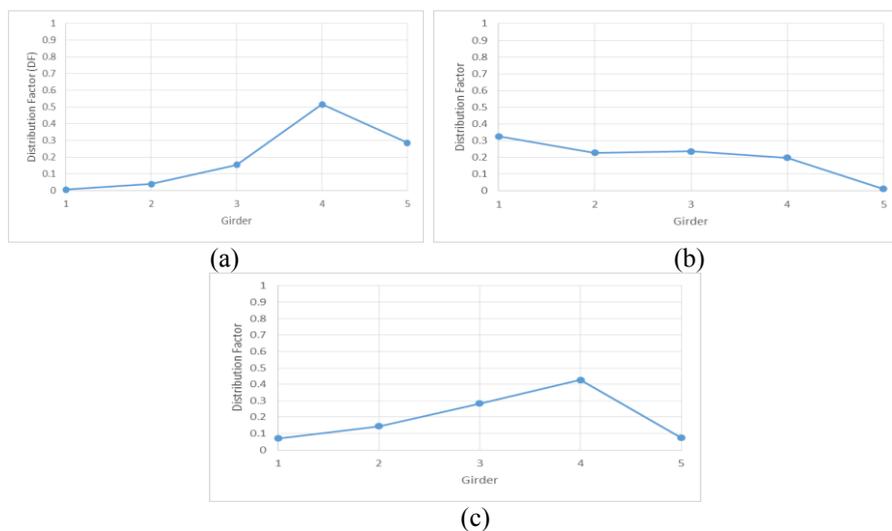
This bridge was monitored at the end of its service life. Significant deterioration relating to corrosion in the steel girders and bearings and concrete bridge deck cracking were noticed. As a result, it was expected that the load shedding capabilities would be reduced. Figure 7 illustrates the load shedding characteristics of the north span based on the test vehicle positioned in each of the three lanes. Only results from the north span are shown due to paper length restrictions. The results in figure 7a are as expected with girders 4 and 5 receiving a majority of the load demand then shedding to the remaining girders. In figure 7b girder 2 does not have the spike that girder 4 had in the east lane case (figure 7a). This could suggest that girder 2 has lost some load stiffness due to the deterioration and as a result the neighboring girders are carrying higher loads. In both cases the girder farthest from the loading experiences very low stress levels. For the center lane case, the load has shed to girder 4 more so than girder 3. This could suggest that girder 4 is less deteriorated than the remaining members.

Figure 7: Distribution factors at the midspan of RT345 Bridge based on; (a) loading in the east lane; (b) loading in the west lane; (c) load in the center lane

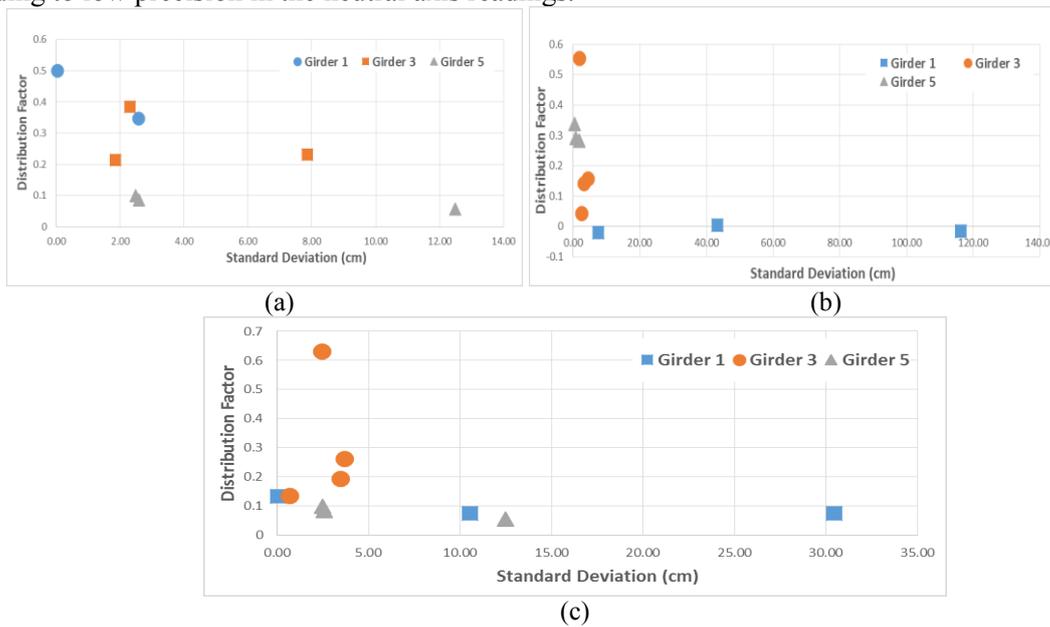
Two load tests were repeated on each of the three lanes during testing. The neutral axis was computed for each case. The standard deviation is noticed to be very high for girder 1 (which is on the far west side of the bridge) when the vehicle is in the east lane (figure 8b). Similarly, when the test vehicle is in the west lane, girder 5 shows a large standard deviation in the neutral axis (figure 8a). In the case of center lane loading, the neutral axis in girder 1 also was shown to have a high standard deviation. Much of this can be seen from the distribution factors in figure 7. When the distribution factor is low, less strain is recorded by the sensor and the system noise levels become dominate. This bridge differs from the previous structure in that it uses a reinforced concrete bridge deck. This typically results in much greater composite action between the deck and girder. As a result, the neutral axis is typically near the top flange and therefore produces very low top flange strain readings. With a low strain level recorded at the bottom flange it is expected that the top flange would be even lower. The result is a heavy influence of system noise in the measurement leading to low precision in the neutral axis readings.

Figure 8: Standard deviation in of the neutral axis measurements based on the load distribution factor of the beam for the RT 345 Bridge (a) West lane load test; (b) East lane load test; (c) Center lane load test

The load shedding abilities of the bridge were noticed to be weaker for the bridge with the greatest deterioration. This deterioration prevented most of the load from transferring to the farthest girder resulting in lower resolution in the measurement. The reinforced concrete deck also

generated a composite action that put the neutral axis near or in the top flange. As a result, a much smaller strain was recorded in the top flange in comparison to the bottom. This created an even lower resolution of the measurement with the high amount of system noise in the reading. The result was low precision in the neutral axis location. The newer structure with a glass FRP panel deck had much lower standard deviation in the neutral axis measurements for each instrumented girder. This is the result of the strong load transfer mechanisms within the superstructure combined with the less significant composite action between the steel girder and panel. This allowed for higher strain readings in both the bottom and top flanges creating greater resolution in the measurement and therefore greater precision in the neutral axis location.
