CASE STUDIES ILLUSTRATING THE EFFECT OF WEAKENED LOAD TRANSFER ON NEUTRAL AXIS MEASUREMENTS

Michael V. Gangone

Department of Civil Engineering, University of Texas at Tyler, 3900 University Blvd., Tyler, TX
75799

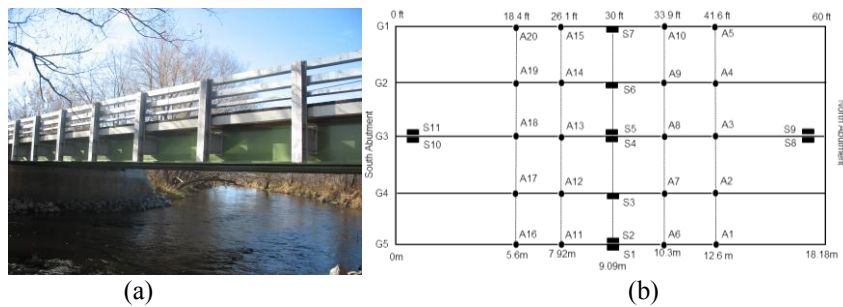
Figure 1: (a) CR55 Bridge Test Structure; (b) Instrumentation Setup (A : Accelerometer, S : Strain)

The bridge instrumented is located in Brasher Falls, New York crossing the Deer River (figure 1a). The bridge was reconstructed in the summer of 2009 to replace a deteriorated open steel grating deck on steel girders. The replacement design incorporates 8- 19.96cm (7.75 in) thick glass FRP (GFRP) panels 2.4m (7.9 ft) in length by 7.27m (24 ft) wide which rest on 5 – W30x235 steel

Eleven reusable strain transducers measured the quasi-static and dynamic response of the bridge. Sensor locations are shown in figure 1b. The strain transducers were distributed to measure the girder load distributions, neutral axis locations, and end fixity. The majority of the strain transducers were mounted along the centerline of the bottom flange in the longitudinal direction of the bridge. At the locations where the neutral axis is determined (girders 3 and 5), an additional gauge was placed on the top flange. All strain transducers were mounted with removable threaded tabs affixed to the girders with the manufacturer recommended adhesive. For additional information regarding this test see Gangone et al. [12].

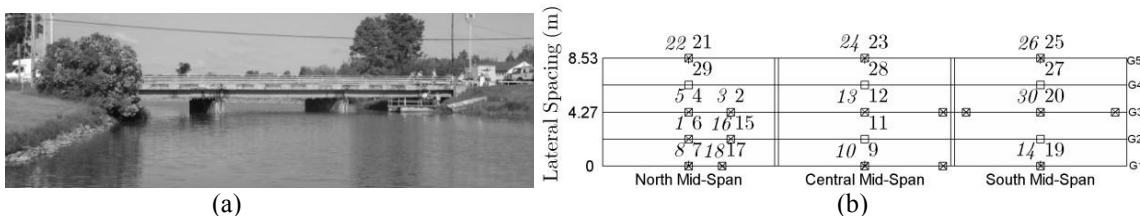
Figure 2: (a) RT345 Bridge over Big Sucker Brook Test Structure; (b) Instrumentation Layout

The highway bridge investigated, located on RT345 in upstate New York consists of a 19.1 cm (7.5 in) thick reinforced concrete slab supported by three interior W33x152 and two W33x141 exterior steel girders (figure 2a). The bridge is a 3-span simply supported two-lane structure consisting of a 13.7 m (45 ft) simply supported span at an elevation of approximately 1.2 m (4 ft) from the waterline. The girders have a center-to-center spacing of 2.1 m (7 ft) and are supported by pin and rocker steel bearings. End and midspan intermediate diaphragms are constructed of C15x33.9 sections that are bolted to transverse plates welded to the girders. Prior to the scheduled closure for replacement, the structure serviced New York State Route 345 over Big Sucker Brook in the town of Waddington. Constructed in 1957, the bridge maintained a sufficiency rating of 61.2%, an operational rating of 44.5 metric tons, and an average daily traffic estimate of 1169 vehicles.

Wireless Bridge Diagnostic Incorporated (BDI) strain transducers were deployed for completion of a full scale load test on all three spans. BDI sensors were deployed primarily at the midspan of the steel girders for measuring NA, DF, and impact factor response for a flexural ASD load rating. The instrumentation layouts for both tests showing the strain gauges placed at the bottom and in some cases top flanges as well are presented in figure 2b. Locations which show two

numbers side by side (e.g. 4 and 5 of figure 2b) indicate that both the top and bottom flanges were instrumented at that location. It should be noted that while some sensors were placed at locations other than just the midspan, only the midspan measurements are used in the discussion of this paper. Additional information from this test can be found in Gangone et al. [13].

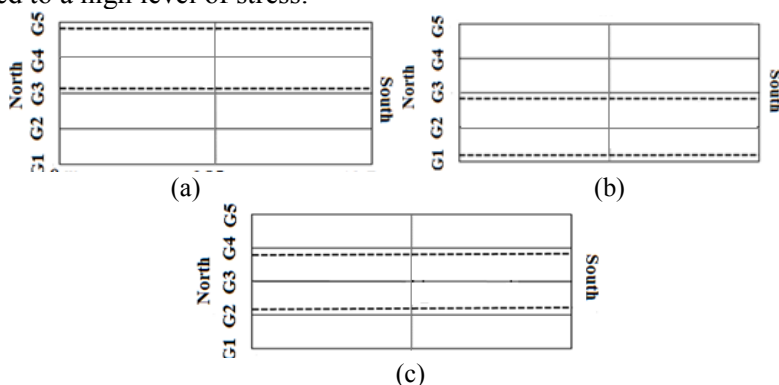
Figure 3: Testing lanes (a) east, (b) west, (c) center

Both bridges were sectioned into three different lanes, east, west and center (figure 3). Calibrated testing vehicles were provided by the New York Department of Transportation (NYSDOT). Axle weights were known and their position on the bridge within each of the three lanes was pre-determined. The rear axle, the heavier of the two axles, was positioned at the midspan to excite the maximum strain response at each sensor location. From testing in each of the three lanes, each girder was excited to a high level of stress.

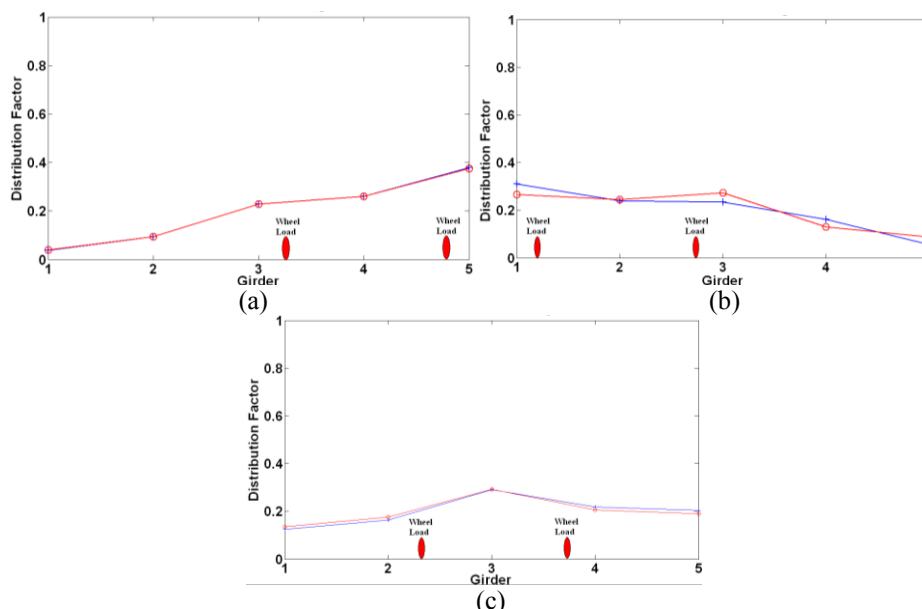
Figure 5: Distribution factors at the midspan of CR55 Bridge based on; (a) loading in the east lane; (b) loading in the west lane; (c) load in the center lane

This bridge was monitored within one year of construction. There were no visible signs of deterioration that would normally hinder the load shedding capabilities. Figure 5 illustrates the load shedding characteristics based on the test vehicle positioned in each of the three lanes. The results in figure 5a are as expected with girders 4 and 5 receiving a majority of the load demand then shedding to the remaining girders. West and center lane load cases (figures 5 b,c respectively) seem to show similar findings. The findings also suggest good repeatability in the data as the distribution factors appear to be nearly identical for both load tests particularly for loading in the east and center lanes.

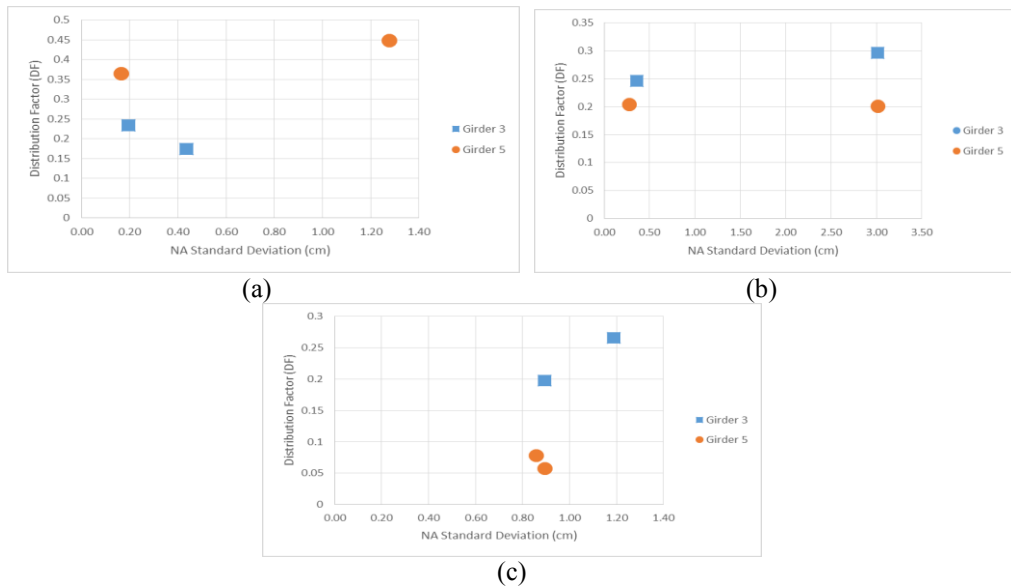
Figure 6: Standard deviation in of the neutral axis measurements based on the load distribution factor of the beam of the CR55 Bridge; (a) East lane load test; (b) Center lane load test; (c) West lane load test

Four load tests were performed in each of the three testing lanes. Figure 6 compares the average distribution factor for the girder with the standard deviation of the neutral axis (NA) measurements. Girder 3 represents the center girder and girder 5 is the eastern most girders. The data for this bridge indicates that there are very small standard deviations among the neutral axis measurements. In addition, the distribution factors were large enough that the strains were able to be acquired with high enough resolution to get greater precision for each case. For this bridge, the load shed thoroughly from girder-to-girder no matter the position of the vehicle. Part of the precision of this measurement is due to the bridge deck material. Glass FRP deck panels do not produce the composite action that is seen between a reinforced concrete deck and steel girder. Therefore, the neutral axis lies near mid-depth of the girder providing high strains at both flanges. These high strains give greater resolution of the strain measurements.

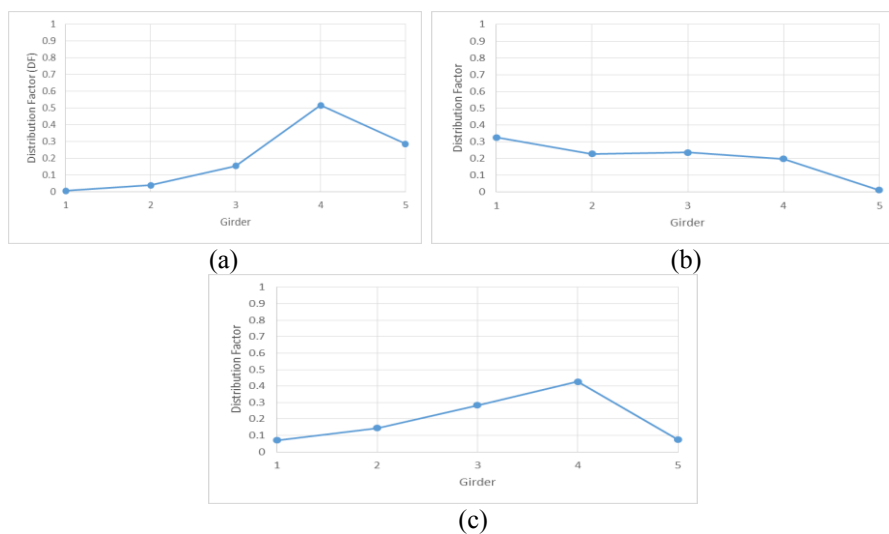
Figure 7: Distribution factors at the midspan of RT345 Bridge based on; (a) loading in the east lane; (b) loading in the west lane; (c) load in the center lane

This bridge was monitored at the end of its service life. Significant deterioration relating to corrosion in the steel girders and bearings and concrete bridge deck cracking were noticed. As a result, it was expected that the load shedding capabilities would be reduced. Figure 7 illustrates the load shedding characteristics of the north span based on the test vehicle positioned in each of the three lanes. Only results from the north span are shown due to paper length restrictions. The results in figure 7a are as expected with girders 4 and 5 receiving a majority of the load demand then shedding to the remaining girders. In figure 7b girder 2 does not have the spike that girder 4 had in the east lane case (figure 7a). This could suggest that girder 2 has lost some load stiffness due to the deterioration and as a result the neighboring girders are carrying higher loads. In both cases the girder farthest from the loading experiences very low stress levels. For the center lane case, the load has shed to girder 4 more so than girder 3. This could suggest that girder 4 is less deteriorated than the remaining members.

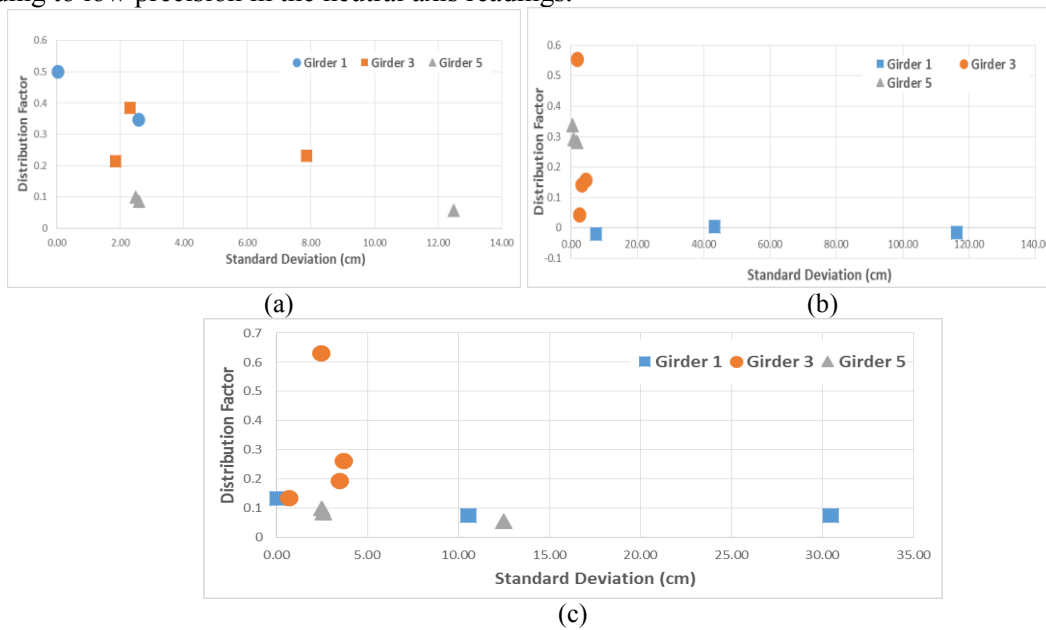
Figure 8: Standard deviation in of the neutral axis measurements based on the load distribution factor of the beam for the RT 345 Bridge (a) West lane load test; (b) East lane load test; (c) Center lane load test

Two load tests were repeated on each of the three lanes during testing. The neutral axis was computed for each case. The standard deviation is noticed to be very high for girder 1 (which is on the far west side of the bridge) when the vehicle is in the east lane (figure 8b). Similarly, when the test vehicle is in the west lane, girder 5 shows a large standard deviation in the neutral axis (figure 8a). In the case of center lane loading, the neutral axis in girder 1 also was shown to have a high standard deviation. Much of this can be seen from the distribution factors in figure 7. When the distribution factor is low, less strain is recorded by the sensor and the system noise levels become dominate. This bridge differs from the previous structure in that it uses a reinforced concrete bridge deck. This typically results in much greater composite action between the deck and girder. As a result, the neutral axis is typically near the top flange and therefore produces very low top flange strain readings. With a low strain level recorded at the bottom flange it is expected that the top flange would be even lower. The result is a heavy influence of system noise in the measurement leading to low precision in the neutral axis readings.
