VIBRATION AMPLITUDE - DEPENDENT NATURAL FREQUENCY AND DAMPING RATIO OF REPAIRED PIER MODEL

Reem Al Sehnawi¹, Akinori Nakajima¹, Ryuji Takeshima², Hafez Al Sadeq³

KEYWORDS : *Dynamic characteristics, Amplitude dependency, RC Pier model, Shaking table test, Free vibration test.*

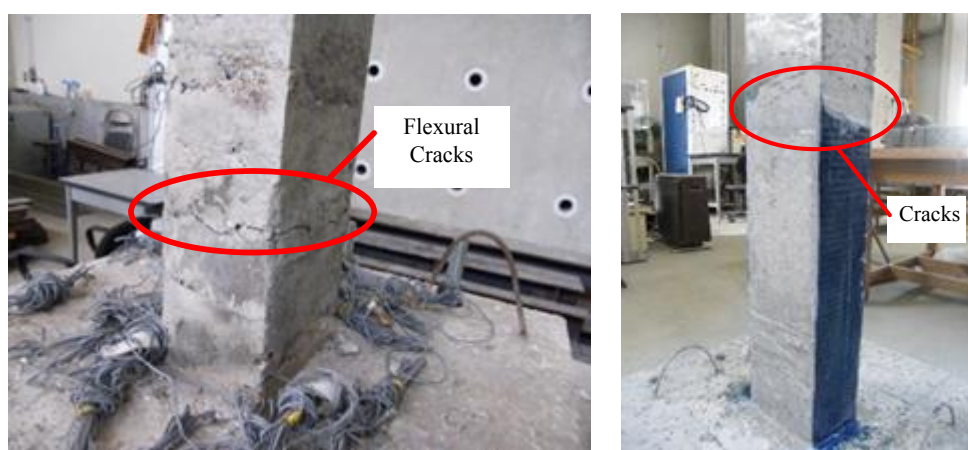
(a) Cracks in original specimen

(b) Cracks in repaired specimen

Figure 4: Cracks in plastic hinge zone of original pier model and at top of CFS of repaired pier model

In order to elucidate the damage effect on the dynamic characteristics, the original and repaired specimen was tested to failure by applying shaking table test. The seismic behaviour of the repaired specimen was also evaluated and compared to the seismic behaviour of the original specimen. Cracks in original specimen is depicted in Figure 4(a). It was observed that the cracks size increased by increasing the excitation amplitude gradually until the cracks width exceeded about 2.0mm around the pier perimeter. Hairline vertical cracks were also observed at the plastic hinge zone within 300mm from the bottom of the pier cross-section, whereas, the concrete cover didn't spall off. On the other hand, the concrete flexural cracks of the repaired specimen, as shown in Figure 4(b), were observed within a distance of about 150mm from the top of CFS jacketing. Meanwhile, no cracks appeared on the surface of CFS jacketing. Thus, the repaired specimen performed well under the seismic excitations since the repairing technique delay the concrete damage in the repaired region. Fourier spectrum of the acceleration time-history responses under shaking table test was derived by applying FFT analysis.
