# Operational Modal Analysis and Wavelet Transformation for Damage Identification in Wind Turbine Blades

Martin Dalgaard Ulriksen, Dmitri Tcherniak, Poul Henning Kirkegaard, Lars Damkilde

Martin Dalgaard Ulriksen, Dmitri Tcherniak, Poul Henning Kirkegaard, Lars Damkilde. Operational Modal Analysis and Wavelet Transformation for Damage Identification in Wind Turbine Blades. EW-SHM - 7th European Workshop on Structural Health Monitoring, IFFSTTAR, Inria, Université de Nantes, Jul 2014, Nantes, France. hal-01021191

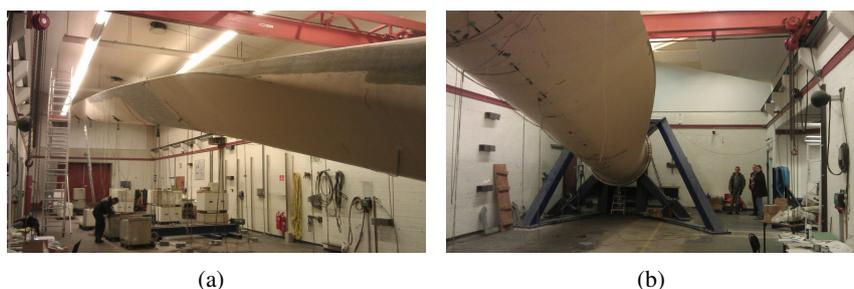
Figure 1 : SSP 34 m blade mounted on the test rig. (a) Root-to-tip view. (b) Tip-to-root view.

A 34 m long wind turbine blade, designed and manufactured by SSP, was mounted on an indoor test rig as shown in Figure 1. The SSP 34 m blade is made from epoxy fiberglass and has a mass of 4,600 kg [10].

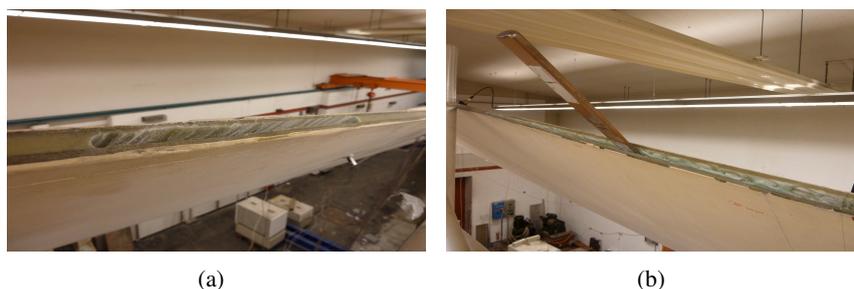
Figure 3 : Debonding introduced in the trailing edge of an SSP 34 m blade. (a) Original drilled debonding. (b) Extended debonding.

The debonding was first introduced by drilling a series of holes perpendicular to the trailing edge, such that the glue connecting the shells was removed to yield the damage depicted in Figure 3(a). Subsequently, the debonding was gradually extended using a hammer and a chisel, resulting in the 1,200 mm long debonding shown in Figure 3(b). The extended debonding was located between 18,800 mm and 20,000 mm from the blade root.
