# Examples of Damage Detection in Real-Life Settings Based on the Position of the Neutral Axis

## EXAMPLES OF DAMAGE DETECTION IN REAL-LIFE SETTINGS BASED ON THE POSITION OF THE NEUTRAL AXIS

Dorotea H Sigurdardottir<sup>1</sup> and Branko Glisic<sup>1</sup>

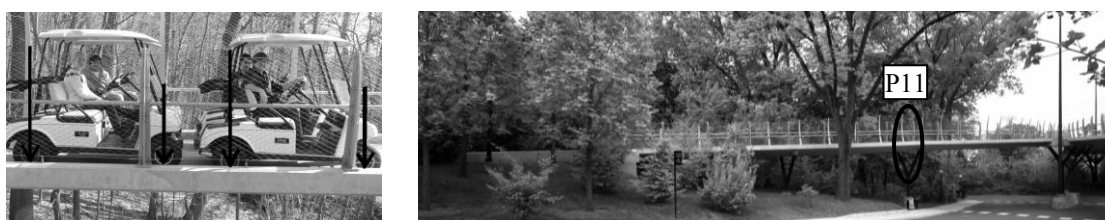
Figure 2: Left: Load test, the bridge was loaded with four golf carts. Right: Location P11 is above a support.

Streicker Bridge is a pedestrian bridge on the Princeton University Campus. It has four approach ramps, called legs, and a main span which crosses the Washington Road. Streicker Bridge has been transformed into an on-site laboratory. Approximately 100 long-gauge (60cm) Fiber Bragg-Grating (FBG) sensors were installed in the concrete deck during construction. The monitoring system has been logging data every 5 minutes since construction, with intermissions. The southeast leg is used as an example in this paper; it is shown in Figure 2. It is a post-tensioned, curved continuous concrete girder supported by slender steel columns. Nine cross-sections along the length of the southeast leg are instrumented with parallel sensors. That is, with two sensors in each monitored cross-section, one at the top and one at the bottom, close to the vertical axis of symmetry. In this paper the focus is on location P11, see Figure 2.

A load test of the southeast leg was performed in March 2011, see Figure 2. Four golf-carts with passengers were placed sequentially at midspan of the longest span in the southeast leg, i.e. the load was gradually increased and then gradually decreased by driving the carts onto and off the structure one by one. The results for location P11 are shown in Figure 3. In the first two load steps the strain magnitude is low and therefore the uncertainty is high. The same is true for the last two load steps. A stable value of  $\sim 300$  mm is achieved when all the golf carts are on the midspan simultaneously (load steps 3-6). Thus, the neutral axis was found to be approximately 50 mm below the expected position.

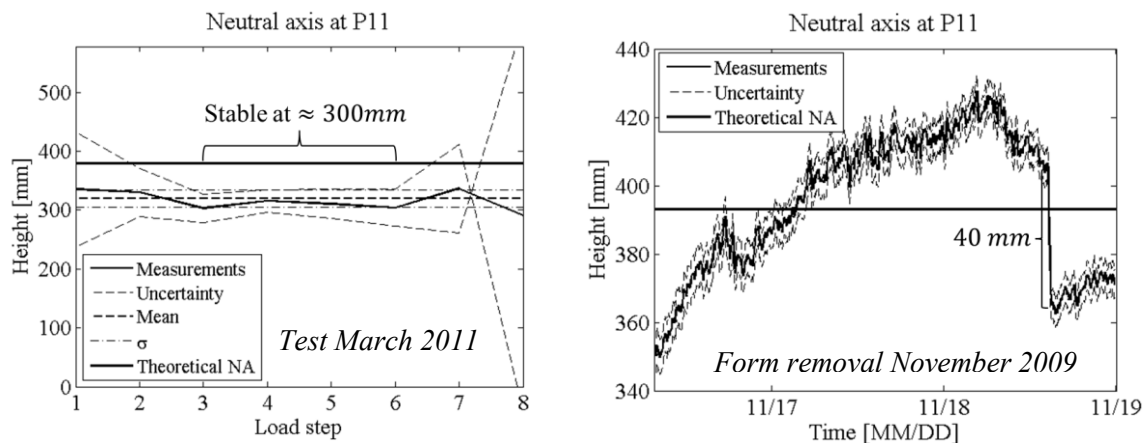
Figure 3: Left: Neutral axis location during static testing with golf carts. Right: Neutral axis location after form removal. Both figures are modified from [1].

The reason for the lower neutral axis location can be found three days after the form removal, see Figure 3. The figure shows the neutral axis as a function of time right after the form removal. The variation in the neutral axis location is caused by nonlinear thermal gradients through the cross-section (more discussion provided in [1]). However, at first the neutral axis is at 350 mm, which is the expected healthy location. Approximately three days later a crack forms at location P11 and therefore causes the neutral axis to move down.

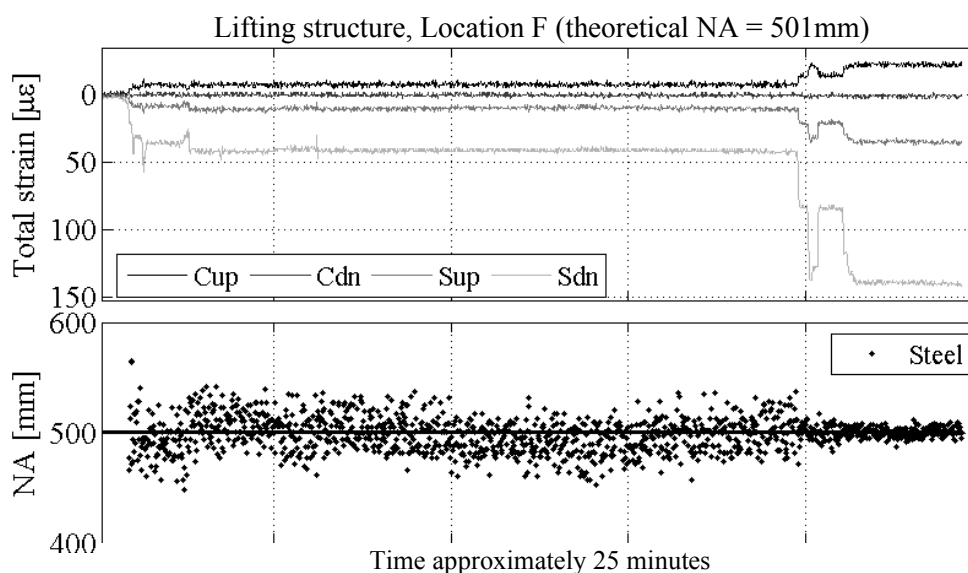
Figure 5. Strain at location F during the lifting from the floor onto supports. Cup is sensor at concrete up, Cdn is sensor at concrete down, Sup is sensor on the upper steel flange, and Sdn is sensor on the lower steel flange. The neutral axis location measured from the bottom of the cross-section as measured by the steel sensors.

The location of the neutral axis was calculated from the lifting data using three different sensor combinations; first using the steel sensors (Figure 5), then the concrete sensors, and lastly all four sensors. The results are presented in Table 1. At the healthy location F all combinations of sensors
