## Smart Textile Reinforced Concrete Sensory Structures

## SMART TEXTILE REINFORCED CONCRETE SENSORY STRUCTURES

### ABSTRACT

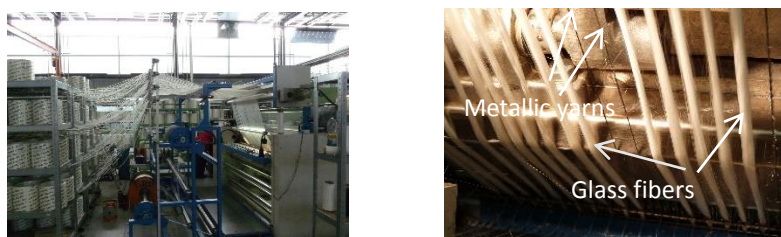
Figure1: Conductive thread insertion into warp knit.

The production of the multi-material textile is illustrated in Figure 1. The production process was not involved with any modifications in terms of tribology or tension control of the fibers. This demonstrates that the embedment of the sensory agents by their implementation as an additional component of the textile does not introduce significant complexity to the textile manufacturing procedure. The layout of the textile was designed to assure its suitability for application as reinforcement for TRC elements. These two aspects demonstrate that the conversion of the textile into a sensory one does not necessitate significant changes to the conventional procedures, either for the textile itself or for the textile reinforced concrete (TRC) member element. Correspondingly, the cost associated with the conversion into a sensory system is not expected to be a significant factor.

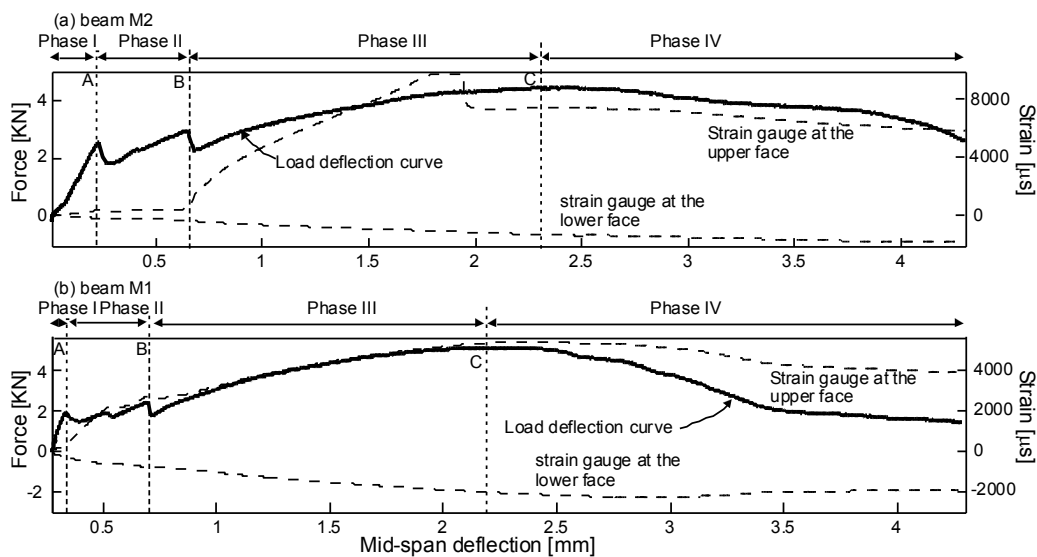
Figure 4: Load-deflection curves and readings of the strain gauges: (a) beam M2, (b) beam M1.

The load-deflection curves and the strain response curves (Figure 4) reveal three main phases in the structural response of the TRC beams. The first one includes the initial response of the un-cracked beam. After the initial settlement of the test setup, this phase reveals a linear response. This phase extends up to a load level of about 2.5 kN (point A) for beam M2 and 1.9 kN for beam M1, where the first flexural cracks are detected. The cracking from this point and on is well reflected by the changes of the slopes of the load-deflection and strain evolution curves.

The second phase starts after the first cracking at Point A. The formation of flexural hairline cracks yields a reduction in the stiffness of the beam manifested by the slope of the load deflection curve and the increased rate of strain evolution. The flexural cracking and the resistance of the global bending moment through compression in the concrete and tension in the reinforcing textile also shifts the height of the natural axis upwards. Consequently, the tensile strains at the lower face grow much faster than the compressive ones at the upper face, see Figure 4.

The third phase of the structural response starts at a load level of about 2.9 kN for beam M2 and 2.37 kN for beam M1 (point B in Figure 4). Here, the load slightly drops down with the opening of one major shear-flexure crack that develops under the right loading point (see Figure 5). The phase involves a gradual reduction in the slope of the load-deflection curve up to the peak load (Point C) and then a monotonic reduction in load up to the point where the test has been terminated. The tensile strains at the lower face of the beam (Figure 4) reveal a similar pattern. These observations are typical to beams of such aspect ratios at the ultimate state.

In order to examine the quantitative capabilities of the sensory system, the electrical readings detected by the metallic yarns are calibrated using the interpolated strains (Equation 1) in phase I. The calibrated results appear in Figure 8 for beam M2 and in Figure 9 for beam M1. In both cases, the levels of strain detected near the middle of the beam are very low and therefore they are not shown. In both cases, the calibrated results reveal a good level of correlation, particularly in terms of the ability to quantitatively detect the strains near the tensed face of the beam. It is also revealed that in each beam, the same calibration factors (which are listed in the figure) hold for the tensed and the compressed fibers. On the other hand, the calibration factors differ from one beam to another. This effect is mainly attributed to the different levels of strains detected by the external strain gauges mounted on the two beams (Figure 4). Comparing Figure 4a with Figure 4b reveals that the strain

values detected in beam M2 are about two times larger than the ones in beam M1. Correspondingly, the calibration factor for beam M2 ( $45 \text{ } \epsilon/\mu\text{V}$ ) is about twice as large as the factor for beam M1 ( $25 \text{ } \epsilon/\mu\text{V}$ ). In that sense, the discrepancy is not necessarily attributed to the sensory system but to other factors affecting the readings of the external strain gauges. Bearing that in mind, it appears that the sensory TRC system that is based on the metallic yarns can indeed monitor quantitative and relevant information about the structural state of the element.

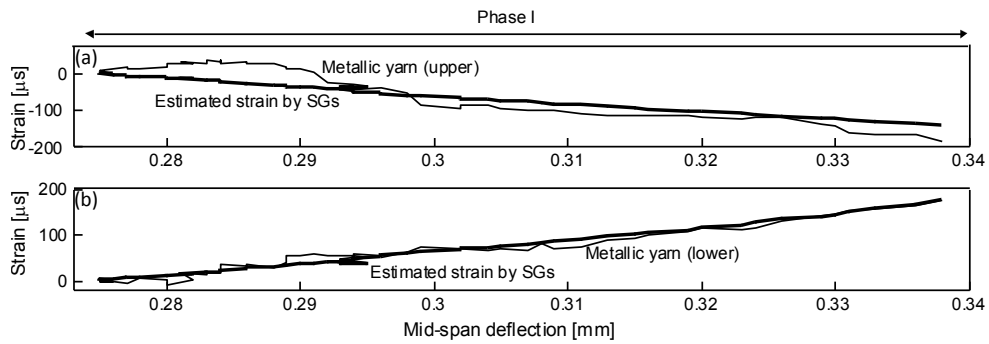
Figure 9: Strain reading of the metallic yarns in beam M1 compared with strains interpolated using the readings of the strain gauges (calibration factor=25  $\epsilon/\mu V$ ): (a) upper yarns; (b) lower yarns.
