# Damage Detection on a Cable Stayed Bridge Using Wave Propagation Analysis

Juan Quintana, Francisco Carrión, Saúl Crespo. Damage Detection on a Cable Stayed Bridge Using Wave Propagation Analysis. Le Cam, Vincent and Mevel, Laurent and Schoefs, Franck. EWSHM - 7th European Workshop on Structural Health Monitoring, Jul 2014, Nantes, France. 2014. <hal-01022065>

## DAMAGE DETECTION ON A CABLE STAYED BRIDGE USING WAVE PROPAGATION ANALYSIS

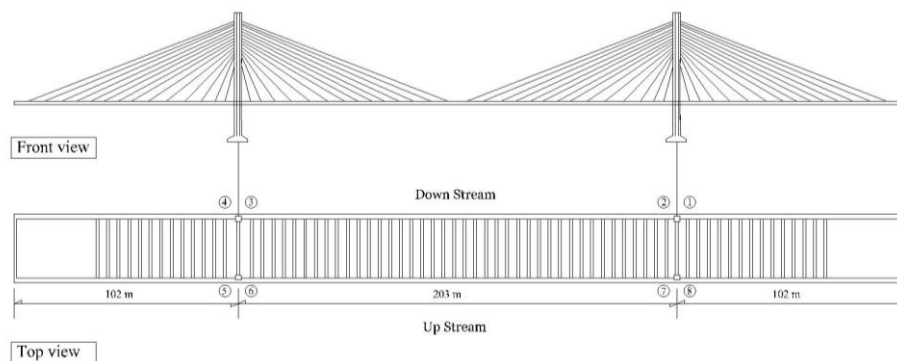
Figure 1: Rio Papaloapan Bridge layout.

The Rio Papaloapan Bridge is located in the La Tinaja-Acayucan highway, in the state of Veracruz, Mexico. It was commissioned in 1995, and it is a stayed bridge with a span of 203 meters and an overall length of 407 meters. The bridge has 112 cables in 8 semi-harps with 14 cables each; semi-harps are numbered from 1 to 8 (figure 1), and cables are also identified from 1 to 14, starting with the shortest [1]. After 5 years of service, the upper anchorage element of cable 11, semi-harp 7, failed in 2000. In this case, a full fracture took place under normal operational conditions near the weld joint of the anchorage and the A-50 structural steel plate (embedded in the concrete tower).

Figure 4a shows variations on the dynamic responses for sensor 11; the Y axis represents the difference between the experimental and simulated responses, while the X axis is the position of the cable with respect to the bridge deck from left to right (figure 1) so that, for example, cable 1 of semi-harp 6 is number 15. Here 3 curves are observed: the first (squares) represents the upstream cables; the second (diamonds), denotes the downstream cables; and the third (line) symbolizes the actual position of the removed cable.

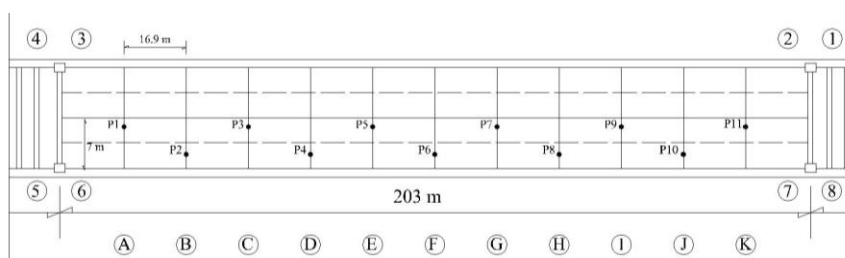
Figure 2: Experimental arrangement for dynamic testing.

The second test consisted on dynamic tests where a controlled impact forces was applied at different points on the bridge deck. In this second case, 11 accelerometers on the deck were located on one side of the bridge between the two towers as indicated in figure 2. The impact forces were applied without traffic with a Dynatest falling weight deflectometer at different points on the deck. For this set of dynamic tests, a 2000 Hz sampling rate during 2 seconds was used for all sensors simultaneously; the experimental procedure was as follows:

A set of dynamic tests was done at 10 different impact points on the deck before freeing the cable, and a similar set of 10 impacts was also done after release. At each point, the test was done 3 times for statistical analysis. The previous set of tests was used for calibration, while the second was used to evaluate the GSM.

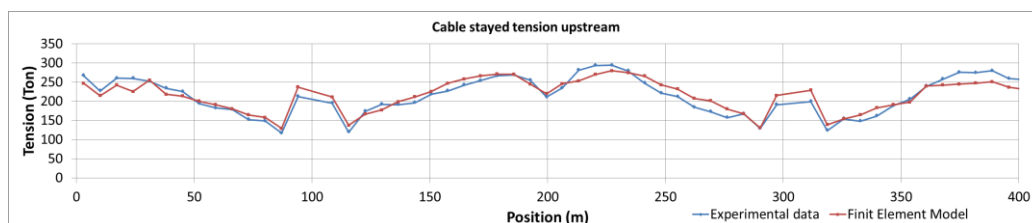
Figure 3: Experimental and FEM Tensions.

The unknown structural parameters were calculated using the dynamic responses or the initial condition, the pre-calibrated model and the software StrIdent [7,10], which is a StaDyn complementary software that solves inverse problems [11]. The model was considered as calibrated when tensions were within 10% from the experimental values with dead loads only. Figure 3 shows the comparison of the experimental tensions to those from the calibrated model.

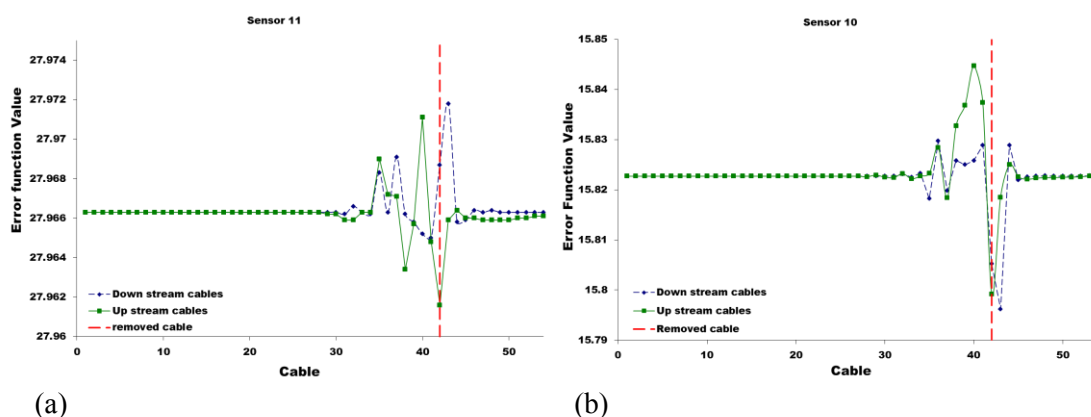
Figure 4: Objective function Values generated by the GSM. (a) Using sensor 11 data. (b) Using sensor 10 data.

Dynamic response of sensor 11 is minimized at position 42 of the upstream cable figure 4a, which corresponds to the actual damage scenario. Figure 4b shows the same for sensor 10, where the minimum does not correspond to the real damage position and indicates the cable 1 of semi-harp 1 (position 43 of downstream cable), and the second minimum effectively corresponds to the actual damage position. It is important to note that, although the sensor 10 is not precise, it locates damage close to the actual position. When comparing sensor 10 with 11, clearly sensor 11 has higher sensitivity as it is closer to the damage location (4 meters of sensor 11 to 17 meters of sensor 10).

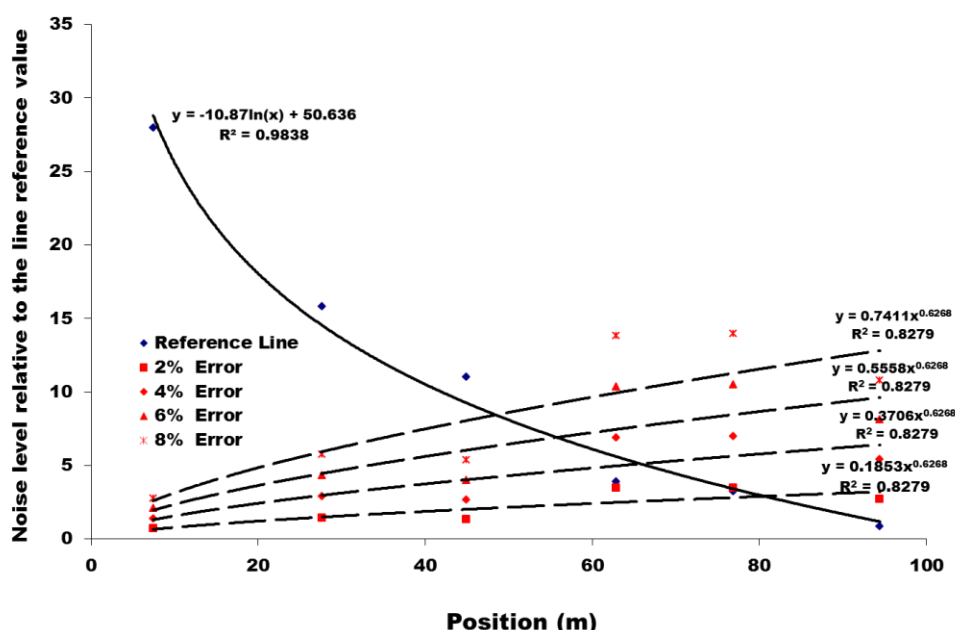
Figure 5: GSM sensitivity with respect to the sensors position.

To analyze the GSM sensitivity with respect to the sensors position, the model calibration and the electronic noise, an overall noise was calculated with respect to the actual responses magnitude and normalized to the highest value of the reference line from the optimization process of the error function; which is the average of the optimized error of all positions. Then, the reference value is plotted to the distance and compared to different 2%, 4%, 6% and 8% noise levels, which are typical values obtained experimentally (figure 5). Clearly, from figure 5 it can be noticed that sensors 45 meters farther (like sensor 9), have little sensitivity with respect to noise and are not well suited for damage analysis of the particular simulated damage of cable 1. At the same time, if noise is reduced, including a better calibration and model response, the sensitivity increases in terms of amplitude and distance.
