Decomposition Analysis Resolution Process (DAR) of Systems Engineering Applied to Development of Countermeasure on Leakage of Engine Head-Gasket

Satoshi Ohkawa, Hidekazu Nishimura, Yoshiaki Ohkami

Satoshi Ohkawa, Hidekazu Nishimura, Yoshiaki Ohkami. Decomposition Analysis Resolution Process (DAR) of Systems Engineering Applied to Development of Countermeasure on Leakage of Engine Head-Gasket. 11th IFIP International Conference on Product Lifecycle Management (PLM), Jul 2014, Yokohama, Japan. pp.181-192, 10.1007/978-3-662-45937-9_19 . hal-01386495

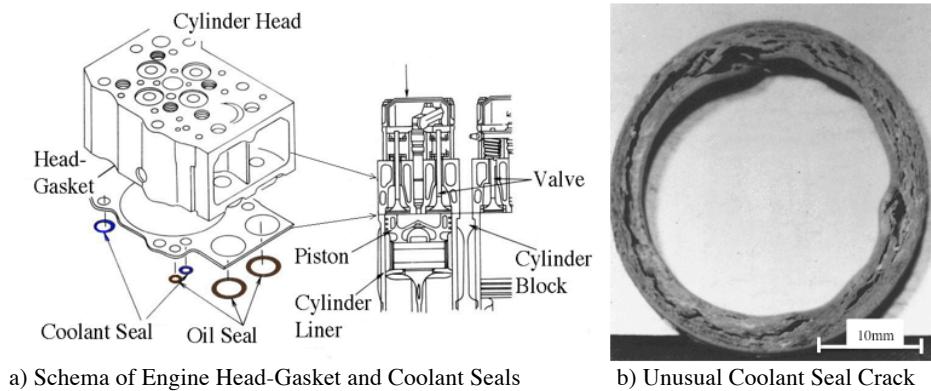
Fig. 1. Schema of Engine Head-gasket and Unusual Crack of Coolant Seal (Ohkawa S. et al. 1994 [4])

Although a coolant seal is only a simple square-ring part, the leakage process has complexity. Fig. 1a) shows the configuration of the engine head-gasket and coolant seals. Coolant and oil galleries both in a cylinder block and cylinder heads are connected with each seal of the head-gasket. The head-gasket is a steel plane plate. The previous coolant seals adopted the same silicone rubber: Rubber-P, as those of oil seals. Within a year from its production, newly developed high-output diesel engines caused the coolant leakage from the head-gasket in the field. After dismantling all cylinder heads, unusual seal cracks were found as shown in Fig. 1b). Although the oil seals adapt the same Rubber-P, and have similar dimensions as those

of coolant seals, the oil seals never caused oil leakage or a crack in the field. The cause of coolant leakage seemed to have complexity. Therefore, we have conducted thorough DAR for analyzing the complexity and for confirming appropriateness of the countermeasure.

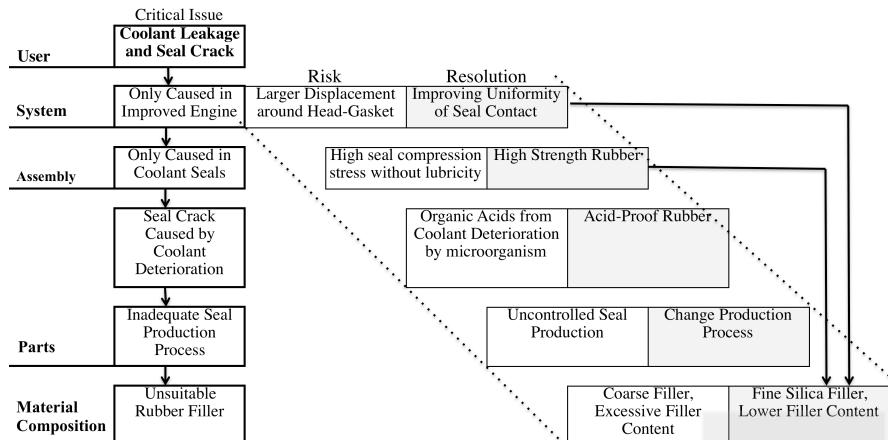
Fig. 2. Critical Issues of Coolant Seal Leakage

Fig. 2 summarizes all the critical issues of the coolant leakage as the DAR [5]. Every critical issue is discussed in the following sections from the top of the system to the bottom of material composition.

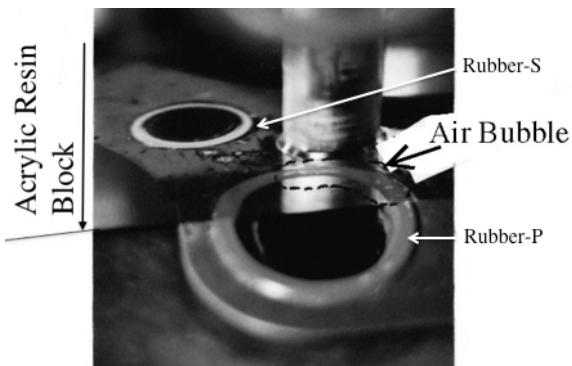
Fig. 3. Visual Observation of Silicone Rubber Seals Contact with Acrylic Resin Block: Simulated Cylinder Head (Ohkawa S. et al. 1993[4])

Therefore, we investigated uniformity of seal contact at a higher compression condition. Fig. 3 shows a visual observation of seal contact condition on the engine cylinder block. A front square-ring seal: previous Rubber-P, generates air-bubbles on the square-ring surface because of seal distortion. Contrarily, a rear square-ring seal; candidate Rubber-S, does not cause air-bubble.

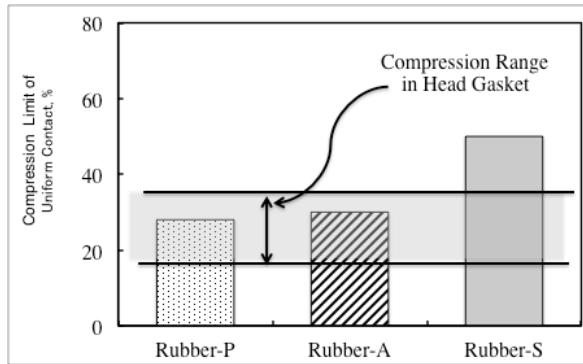
Fig. 4. Upper Limit of Compression Ratio for Keeping Uniform Contact

Fig. 4 shows upper limits of compression ratio up to the generation of unequal pressure distribution. The beginning of seal distortion was measured using a pressure measurement film. The Rubber-P has the lowest property on contact uniformity and causes distortion only at 28% compression. Since the seal compression range in the head-gasket is 20-40%, the Rubber-P and a Rubber-A (COTS) seals cause unequal contact in the head-gasket.

The candidate Rubber-S can keep uniformity of seal contact in the head-gasket.

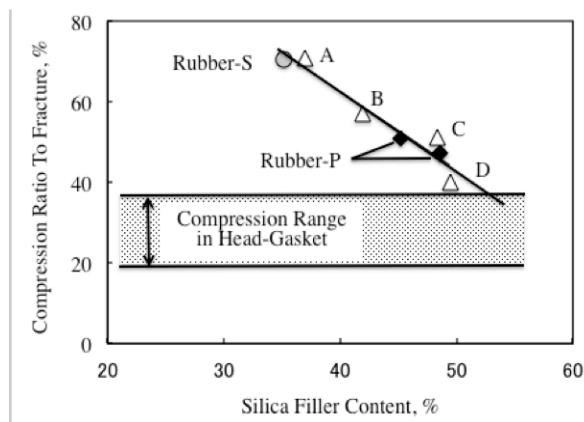
Fig. 5. Compression Fracture Test Results (ts: Seal thickness, tg: Head-gasket thickness) (Ohkawa S. et al. 1993[3])

From our seal fracture observation, we clarified that the unusual seal crack is fatigue damage. Fig. 5 shows the results of seal compression fracture test on the Rubber-P, candidate Rubber-S and COTS's silicone rubbers (A to D). It is clear that the silica filler content has a relationship with the fracture strength. Although the Rubber-Ps show lower fracture compression ratios, the values are higher than the maximum compression ratio in the head-gasket. Therefore a seal fatigue test was planned as a verification test to reproduce the unusual crack. The Rubber-S and COTS Rubber-A show the highest fracture strength.

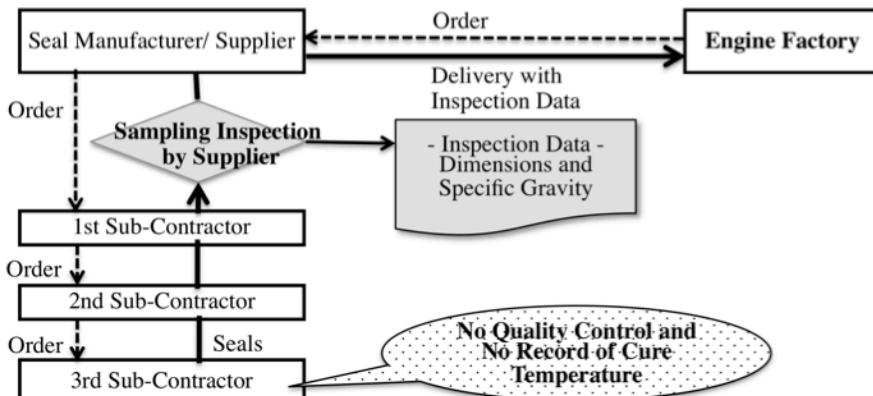
Fig. 6. Previous Seal Production Process

Since a manufacturing failure of seals was also considered as a cause of unusual seal cracks, we conducted process check to the seal manufacturer. We found that the seals were manufactured in the 3rd sub-contractor and they did not conduct any quality control on rubber cure conditions (Fig. 6). Therefore, an engine quality assurance division soon changed this situation and ordered the seal supplier to conduct strict quality control of the seal production.

Despite the serious potential risk on previous seal quality, we could not find any seal quality problem in all the stock seals. The estimated potential risk is to cause the crack by lowering the rubber fatigue strength. We came to the conclusion that the process is not the cause of the unusual crack.

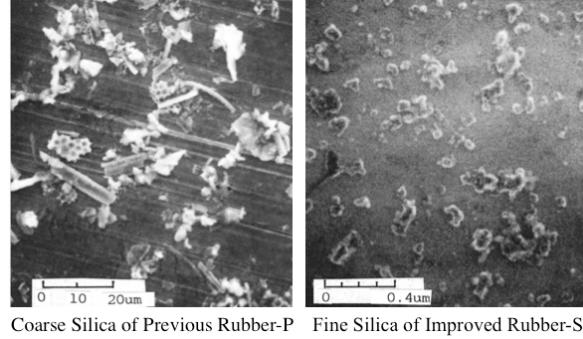
Fig. 7. SEM Photos of Fillers in Rubber-P and Rubber-S (Ohkawa S. et al. 1993 [3])

Fig. 7 shows filler photos of scanning electron microscope (SEM) in the silicone rubbers. The non-uniform contact property of the Rubber-P can be generated by a

coarse filler. On the contrary, a fine silica filler of the Rubber-S can keep uniform contact as mentioned above. In addition, the Rubber-A, which contains 30% coarse filler has the highest fracture strength but causes distortion at a low compression. This indicates that the coarse filler mainly causes seal distortion and a high filler content causes strength reduction.

Therefore, it became clear that a quality control on both the filler size and the filler content are important for preventing coolant leakage.

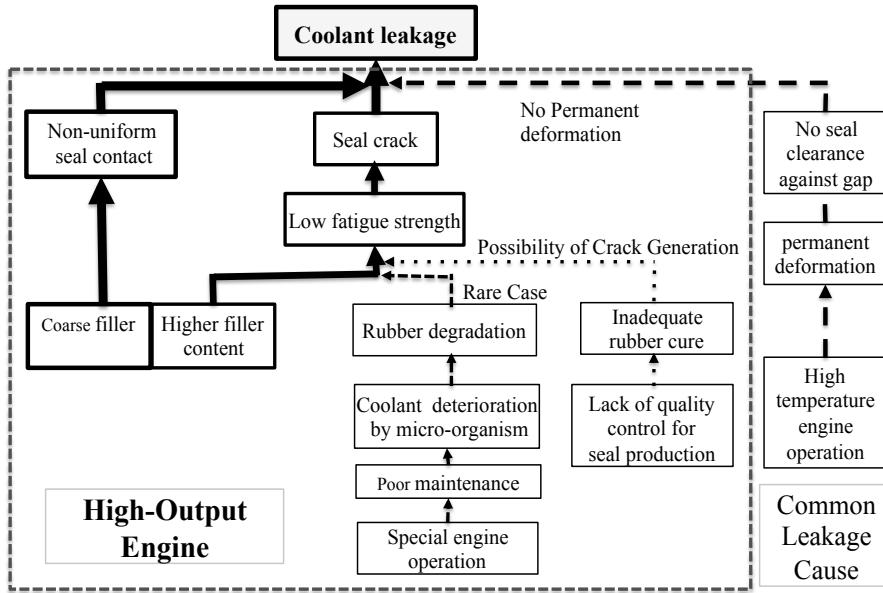
Fig. 8. Estimated Mechanism of Coolant Leakage

Through the DAR, we can estimate the coolant leakage mechanism as shown in Fig. 8. The leakage initially occurs the seal distortion, which is caused by coarse filler, and then the seal crack generates by rubber compression fatigue from excessive filler content. Since the type and the content of silicone filler in the silicone rubbers mainly affect the coolant leakage, adoption of the candidate Rubber-S, which contains

smaller volume of fine silica filler, becomes the best suitable resolution for improvement. The rubber degradation by the microorganism is a rare case. Other possible crack cause is by the lack of quality control of the seal production. Although a common leakage cause is seal permanent deformation, there is no permanent deformation problem of the coolant seal in the field.

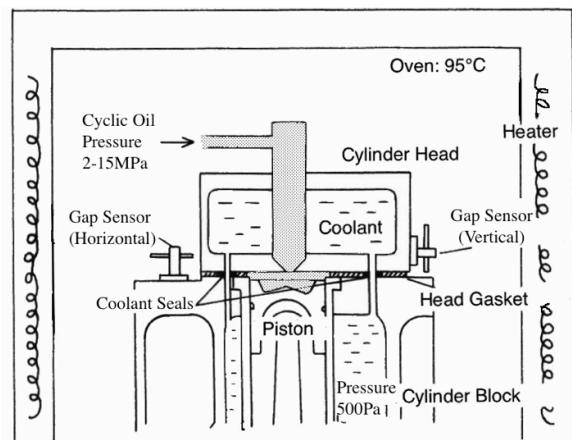
Fig. 9. Head-Gasket Seal Tester (S. Ohkawa et al. 1993 [3])

Table 2 shows verification and validation (hatched parts) of the improved Rubber-S. The test methodologies are head-gasket unit tests by a newly developed tester, engine bench tests and field survey of modified engines, which adopted improved Rubber-S seals. Since agile countermeasure was requested, thorough validation: field survey, was conducted as soon as the verification was completed. To simulate the actual engine coolant seal conditions, seal verification tests were conducted by the head-gasket seal tester, which used the high-output engine assembly. Fig. 9 shows the tester schema. A cyclic hydraulic pressure is applied to a piston cavity. The cyclic pressure, which simulates engine firing, re-produces the largest displacement

around the head-gasket in the engine tests. To adjust seal compression ratios, some head-gaskets having different thickness are used in every test.

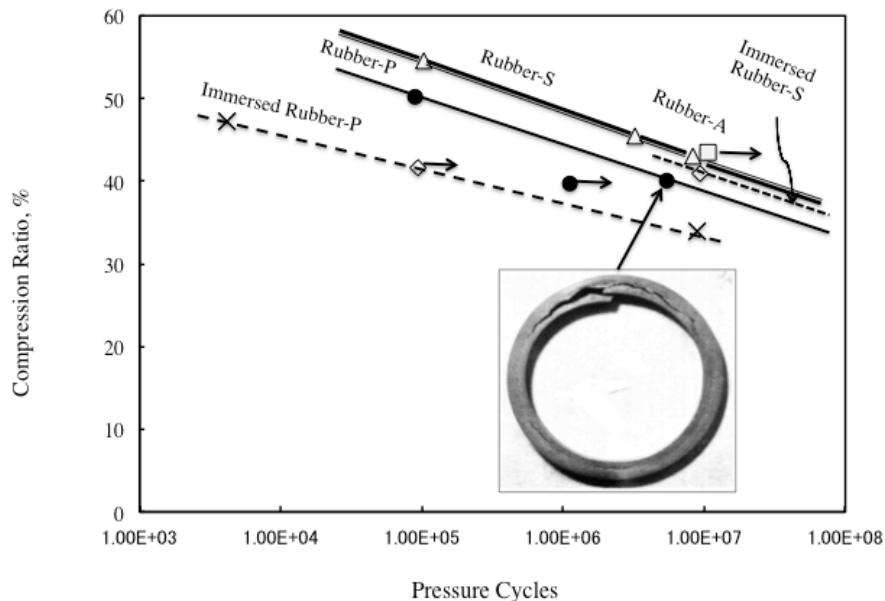
Fig. 10. Seal Fatigue Curves Obtained by Head-Gasket Seal Tester

Fatigue test of seals to verify seal strength of improved Rubber-S. The unusual seal crack could be reproduced by this tester as shown in Fig. 10. The fatigue curves, drawn by the crack generation, were also obtained. The previous Rubber-P and the improved Rubber-S clearly shows different fatigue lives. The fatigue life of the Rubber-S is 10 times longer than that of the Rubber-P at the same compression.

Fatigue test of acid immersed seals to verify effectiveness of acid-resistant polymer. After both Rubber-P and Rubber-S were immersed in an organic acid solution, the fatigue tests were conducted (Fig.10). The Rubber-P shows a large drop of decrease of the fatigue life. The fatigue life reduction of the immersed Rubber-S is small due to adoption of the acid-proof polymer. Therefore the fatigue life of the Rubber-S is about 100 times longer than that of the Rubber-P.

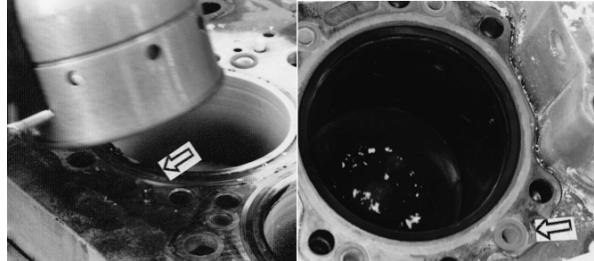
Fig. 11. Detected Coolant Leakage on Engine Bench Test
Right: Detected Coolant (arrow mark)
Left: Leaked Seal (arrow mark)
(S. Ohkawa et al. 1993 [3])

Verification of coolant leakage mechanism on seal distortion. On the bench engine test of the Rubber-P, we found that the coolant often leaks without seal

cracking. To verify the leakage mechanism, the engine head was frozen with dry ice as soon as the leakage was detected. The cylinder head was removed and the leak was inspected using an ultraviolet rays as shown in Fig. 11. The leakage is detected clearly by the ultraviolet rays. The leaked seal did not generate any crack. Therefore it was proved that a leakage factor of the Rubber-P is unequal pressure distribution.

The coolant seals of all kinds of engine were exchanged to the improved Rubber-S seal. All the engines, which caused coolant leakage in the field, were dismantled and were exchanged to the improved seals. As the results, the field coolant leakage problem is not reported in the field.

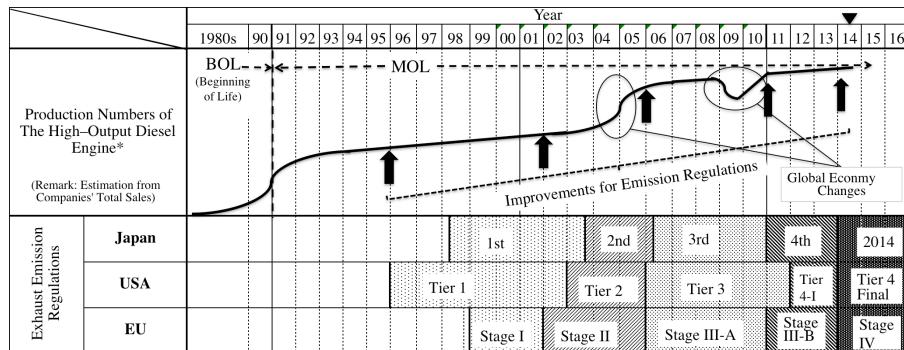
Fig. 12. MOL of the high output diesel engine and world off-road exhaust emission regulations [8]

All the high-output engines should be used for a longer period of time than U.S. final off-road emission regulation of 2014 [8] as shown in Fig.12. In order to obtain the longer MOL of the high-output engine production, the engine should withstand 5 times improvements/modifications for the emission regulations. Therefore a high-output engine, which attached exhaust emission reduction devices, was tested. As the result, the improved Rubber-S reduced the compression ratio down to 0%, and we have developed a further improved hydrogenated nitrile rubber [9, 10]: Rubber-T seal according to the DAR and the VAR as a permanent measure. Although a hydrogenated nitrile rubber shows shorter life than that of a silicone rubber in the air, we have found that a Rubber-T in the coolant extends its life 10 times longer than that of the Rubber-S. The timing of the permanent measure adoption is in the beginning
