Monitoring of the Cracks on Bell Tower of ST. Anastasia Cathedral in Zadar Croatia

Davor Uglešić, Uroš Bohinc. Monitoring of the Cracks on Bell Tower of ST. Anastasia Cathedral in Zadar Croatia. EWSHM - 7th European Workshop on Structural Health Monitoring, IFFSTTAR, Inria, Université de Nantes, Jul 2014, Nantes, France. hal-01022060

MONITORING OF CRACKS ON THE BELL TOWER OF ST. ANASTASIA CATHEDRAL IN ZADAR CROATIA

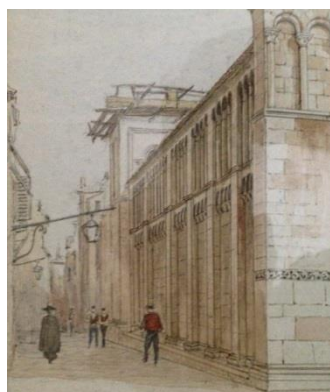
Figure 1 : Aquarelle

The bell tower of the cathedral in Zadar was built in two phases. The ground floor and first floor (height of 16.6 m) were built in the 15th century (Figure 1); while the rest (height 38.3 m - in total 54.9 m) was upgraded in 1885 and was designed by the English architect Thomas Graham Jackson (Figure 7). The bell tower was built with carved stones of limestone, the older part from the local quarries, while the newer part mainly from the quarry Vrnik near island of Korčula.
