Repair Patch Monitoring with Embedded Optical Sensors by the Residual Strain Release

REPAIR PATCH MONITORING WITH EMBEDDED OPTICAL SENSORS BY A RESIDUAL STRAIN RELEASE TECHNIQUE

KEYWORDS : *Bonded composite patch repair, metallic aircraft structures, SHM, FBGS, strain release*

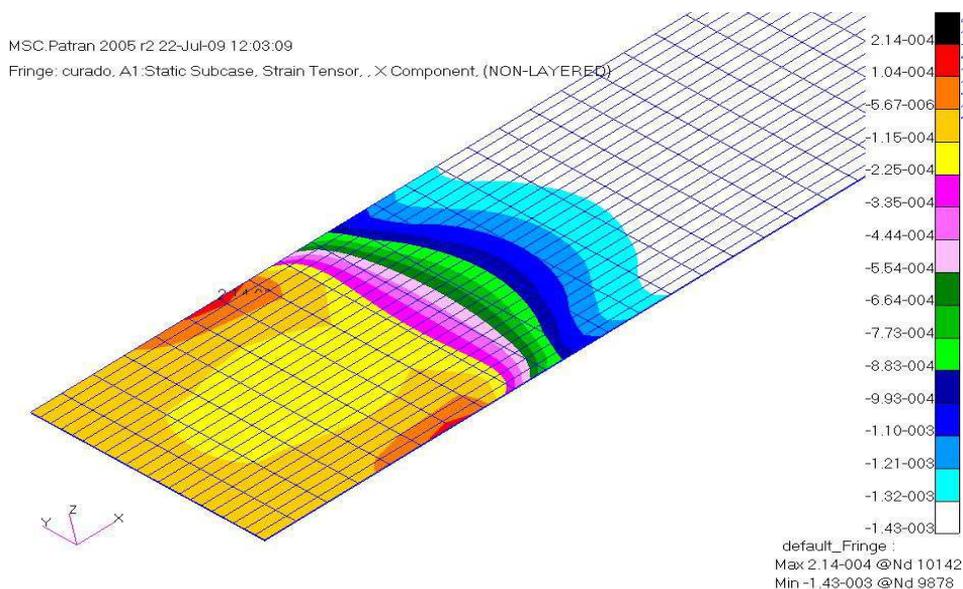
Figure 2: Residual strain in sensor layer for a debonding length of 25 mm.

The objective is to prove that when the debonding grows, the residual strain is progressively released, therefore FBGSs can be used to monitor the health of the repair, or in other words FBGS can be used to detect debonding growth before it gets critical. In figure 2 the FE residual strain at sensor layer is shown for a debonding length of 25 mm. The residual strain well inside the CFRP patch is around $-1430 \mu\epsilon$, this level decreases when approaching the debonding edge (becomes almost zero). At the FBG sensor position the residual strain change or drop is measurable. This FE analysis is useful to correlate mechanical tests performed on samples with different debonding lengths, and measuring residual strain with no load applied. The 2nd FEM is quite similar to the 1st
