DETECTABILITY ASSESSMENT OF OPTICAL FIBER SENSOR BASED IMPACT DAMAGE DETECTION FOR COMPOSITE AIRFRAME STRUCTURE

Noriyoshi Hirano¹, Hiroshi Mamizu¹, Akira Kuraishi¹, Toru Itoh¹,
Nobuo Takeda², Kiyoshi Enomoto³

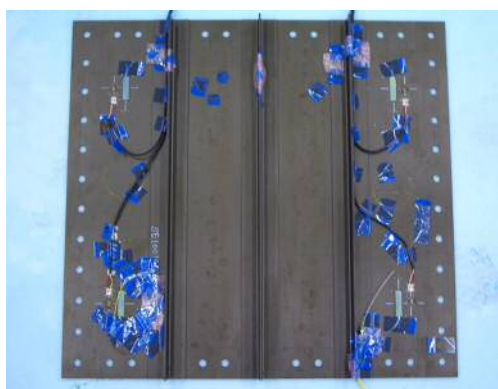
Figure 2: CFRP stiffened panel for simulated vibration test (Looking from stringer side)

The impact tests under vibration were performed to assess the impact detectability of IDDS under simulated vibration condition. In this test, a quasi-isotropic Carbon Fiber Reinforced Plastics (CFRP) stiffened panel shown in Figure 2 was used. The panel has three T-shape stringers. The size of the skin is 600x630x3mm. One optical fiber with 4 FBG sensors was bonded on the stringer side surface of the specimen. The sensor directions were aligned parallel with the stringers. The diameter of bonded optical fiber is 125 micro meter. The applied vibration condition was vertical random vibration of 5.83 Grms with the frequency range of 10Hz to 2000Hz. This condition is based on RTCA DO-160, Section 8, Category R, which is applicable to the fuselage of fixed wing turbojet airplane. The stiffened panel was set to the shaker by the test fixture as shown in Figure 3. Impacts were applied using an impact hammer under the random vibration. The impact load was approximately 1.5kN, which did not cause any impact damage.

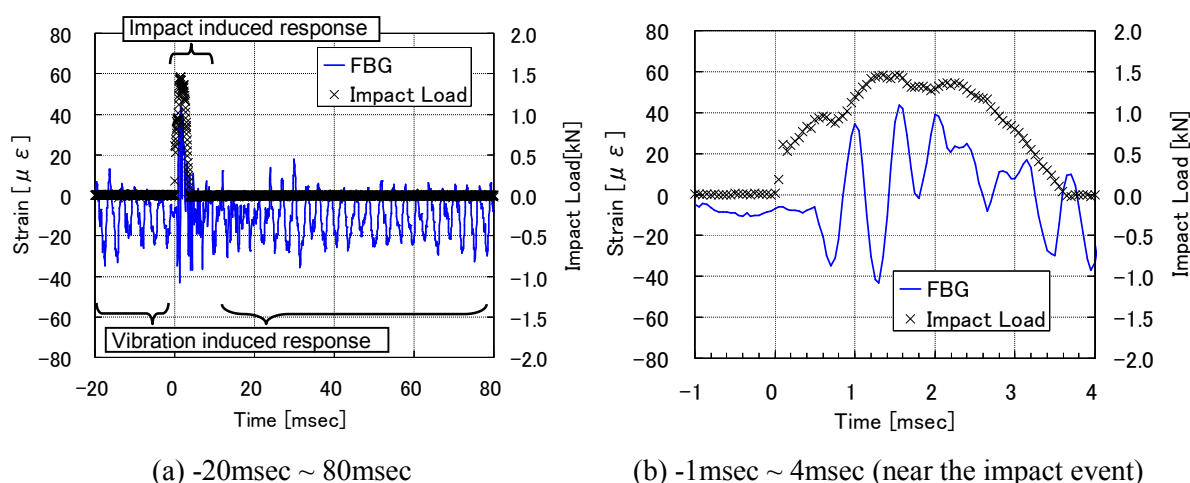
Figure 4: History of strain response and impact load under random vibration

Typical strain response is shown in Figure 4. Also shown is the impact load signal measured by the load cell built in the impact hammer. This strain history involved the responses due to both impact and simulated random vibration. The strain history before impact was obtained by pre-trigger for 20msec before impact occurrence. The impact induced response can be readily separated. This indicates that strain arrival time can be extracted from the strain response using a properly designed filter.

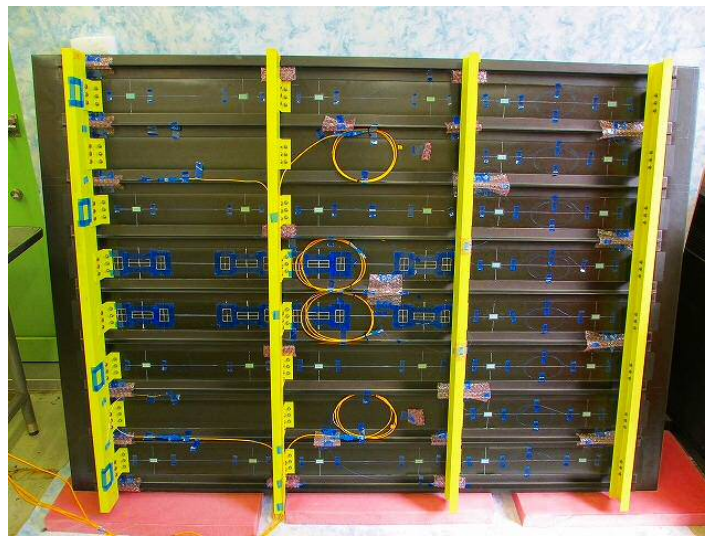
Figure 6: CFRP stiffened panel (Looking from stringer side)

In the study on the optimal FBG sensor direction, impact tests were performed for three types of FBG sensor alignment patterns using a CFRP stiffened panel imitating an actual aircraft structure as shown in Figure 6. This stiffened panel consists of quasi-isotropic CFRP skin, 9 CFRP T shaped stringers, 4 aluminium frames and 32 aluminium shear ties. The frames were fastened to the skin via shear ties. The size of the skin is 1800x1300x3mm. 12 FBG sensors were bonded on the stringer-side skin surface. The diameter of the bonded optical fibers are 125 micro meter. The arrangement of FBG sensors is similar to a rosette type strain gage, aligned in the stringer direction, frame direction (perpendicular to the stringer) and at 45-degree direction as shown in Figure 7. FBG sensor signals were obtained at 800kHz sampling rate using high speed FBG measurement system AR5011A developed by Anritsu corporation in Japan. Localization errors were compared between three types of FBG alignment patterns and suitable sensor direction for impact localization was evaluated. 16 impacts were applied to the web and stringer foot of the stiffened panel, as shown in
