DETECTABILITY ASSESSMENT OF OPTICAL FIBER SENSOR BASED IMPACT DAMAGE DETECTION FOR COMPOSITE AIRFRAME STRUCTURE

KEYWORDS : *Optical fiber sensor, Fiber Bragg grating (FBG), Impact damage, Composite airframe structure*

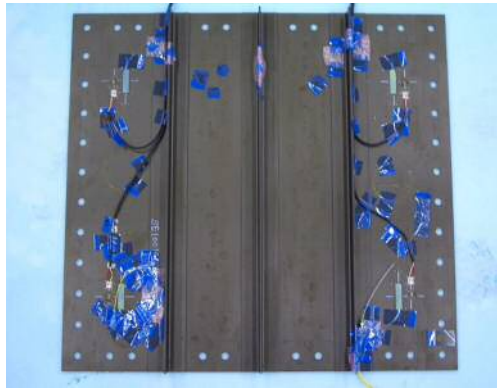
Figure 2: CFRP stiffened panel for simulated vibration test
(Looking from stringer side)

The impact tests under vibration were performed to assess the impact detectability of IDDS under simulated vibration condition. In this test, a quasi-isotropic Carbon Fiber Reinforced Plastics (CFRP) stiffened panel shown in Figure 2 was used. The panel has three T-shape stringers. The size of the skin is 600x630x3mm. One optical fiber with 4 FBG sensors was bonded on the stringer side surface of the specimen. The sensor directions were aligned parallel with the stringers. The diameter of bonded optical fiber is 125 micro meter. The applied vibration condition was vertical random vibration of 5.83 Grms with the frequency range of 10Hz to 2000Hz. This condition is based on RTCA DO-160, Section 8, Category R, which is applicable to the fuselage of fixed wing turbojet airplane. The stiffened panel was set to the shaker by the test fixture as shown in Figure 3. Impacts were applied using an impact hammer under the random vibration. The impact load was approximately 1.5kN, which did not cause any impact damage.
