Noriyoshi Hirano, Hiroshi Mamizu, Akira Kuraishi, Toru Itoh, Nobuo Takeda, Kiyoshi Enomoto

DETECTABILITY ASSESSMENT OF OPTICAL FIBER SENSOR BASED IMPACT DAMAGE DETECTION FOR COMPOSITE AIRFRAME STRUCTURE

Airframe structures, especially composite structures, are prone to damage by tool drops, bird strikes, hailstones, etc. The authors have developed an optical fiber based impact damage detection system for composite airframe structure since 1998. In this method, impact locations are measured with the signals of multiple Fiber Bragg Grating (FBG) sensors. In case of aircraft implementation, impact information should be detected under the actual vibration condition, and both detection capability for impact localization and damage level should be improved. This paper presents the detectability assessment result from the impact tests under a simulated vibration condition. In addition, study of optimal FBG sensor direction for localization and review of damage level detection method are conducted to enhance the accuracy of detection.

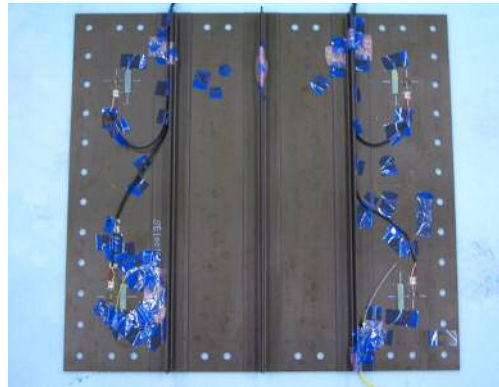
Figure 2: CFRP stiffened panel for simulated vibration test (Looking from stringer side)

The impact tests under vibration were performed to assess the impact detectability of IDDS under simulated vibration condition. In this test, a quasi-isotropic Carbon Fiber Reinforced Plastics (CFRP) stiffened panel shown in Figure 2 was used. The panel has three T-shape stringers. The size of the skin is 600x630x3mm. One optical fiber with 4 FBG sensors was bonded on the stringer side surface of the specimen. The sensor directions were aligned parallel with the stringers. The diameter of bonded optical fiber is 125 micro meter. The applied vibration condition was vertical random vibration of 5.83 Grms with the frequency range of 10Hz to 2000Hz. This condition is based on RTCA DO-160, Section 8, Category R, which is applicable to the fuselage of fixed wing turbojet airplane. The stiffened panel was set to the shaker by the test fixture as shown in Figure 3. Impacts were applied using an impact hammer under the random vibration. The impact load was approximately 1.5kN, which did not cause any impact damage.
