# Detectability Assessment of Optical Fiber Sensor Based Impact Damage Detection for Composite Airframe Structures

Noriyoshi Hirano, Hiroshi Mamizu, Akira Kuraishi, Toru Itoh, Nobuo Takeda, Kiyoshi Enomoto

## DETECTABILITY ASSESSMENT OF OPTICAL FIBER SENSOR BASED IMPACT DAMAGE DETECTION FOR COMPOSITE AIRFRAME STRUCTURE

<sup>1</sup> Aerospace Company, Kawasaki Heavy Industries, Ltd.,  
1 Kawasaki-Cho, Kakamigahara, Gifu, Japan

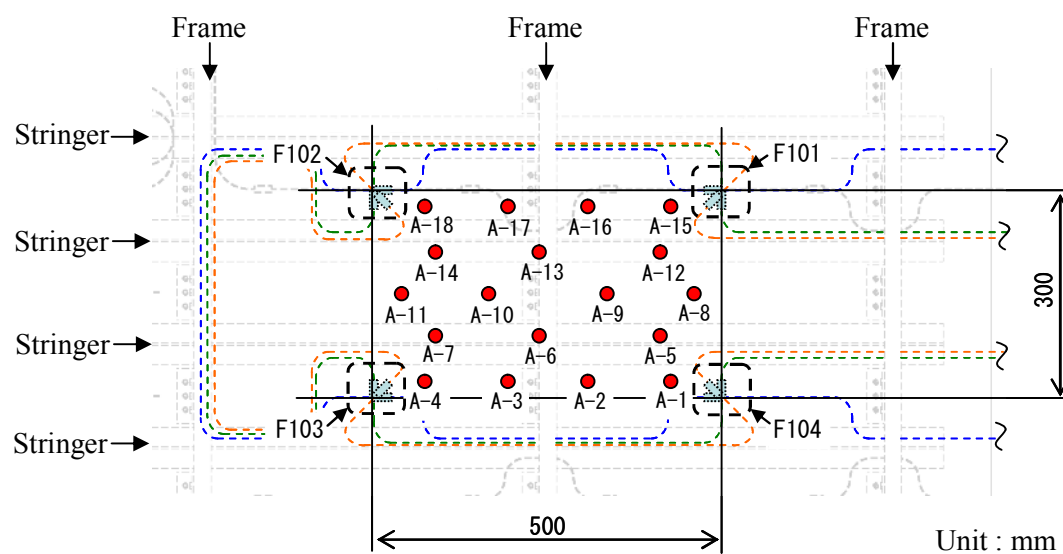
● : Impact location,

: FBG sensor, F101, F102, F103, F104 : FBG sensor group ID

Figure 8: Impact and FBG sensor locations of impact test  
(Looking from the impact side)

In the study on the optimal FBG sensor direction, impact tests were performed for three types of FBG sensor alignment patterns using a CFRP stiffened panel imitating an actual aircraft structure as shown in Figure 6. This stiffened panel consists of quasi-isotropic CFRP skin, 9 CFRP T shaped stringers, 4 aluminium frames and 32 aluminium shear ties. The frames were fastened to the skin via shear ties. The size of the skin is 1800x1300x3mm. 12 FBG sensors were bonded on the stringer-side skin surface. The diameter of the bonded optical fibers are 125 micro meter. The arrangement of FBG sensors is similar to a rosette type strain gage, aligned in the stringer direction, frame direction (perpendicular to the stringer) and at 45-degree direction as shown in Figure 7. FBG sensor signals were obtained at 800kHz sampling rate using high speed FBG measurement system AR5011A developed by Anritsu corporation in Japan. Localization errors were compared between three types of FBG alignment patterns and suitable sensor direction for impact localization was evaluated. 16 impacts were applied to the web and stringer foot of the stiffened panel, as shown in

Figure 8. Applied impact energy range from 50 to 80 J causing barely visible impact damage (BVID) or higher level damage.
