## DAMAGE DETECTION IN COMPOSITES BY NONCONTACT LASER ULTRASONIC

This study proposes an instantaneous damage localization technique for composite structures using noncontact laser ultrasonics. First, a velocity profile of the target composite structure is obtained by measuring wave velocities on paths with various directions. Second, laser ultrasonic responses from two excitation-sensing pairs, called inspection pairs, are obtained. Then possible damage locations are estimated through time-of-flight triangulation of damage reflected waves. Once possible damage locations are estimated, ultrasonic response collection is repeated near the estimated locations for precise damage localization. The proposed technique has following advantages over existing technique: (1) It does not require any sensor installation; (2) Wave velocity profile, which has been mandatory information for time-of-flight triangulation, can be easily experimentally constructed; and (3) It can localize damage with a high precision with its scanning capability. The feasibility of the proposed technique is examined by localizing a delamination in a real 10 kW wind turbine blade.

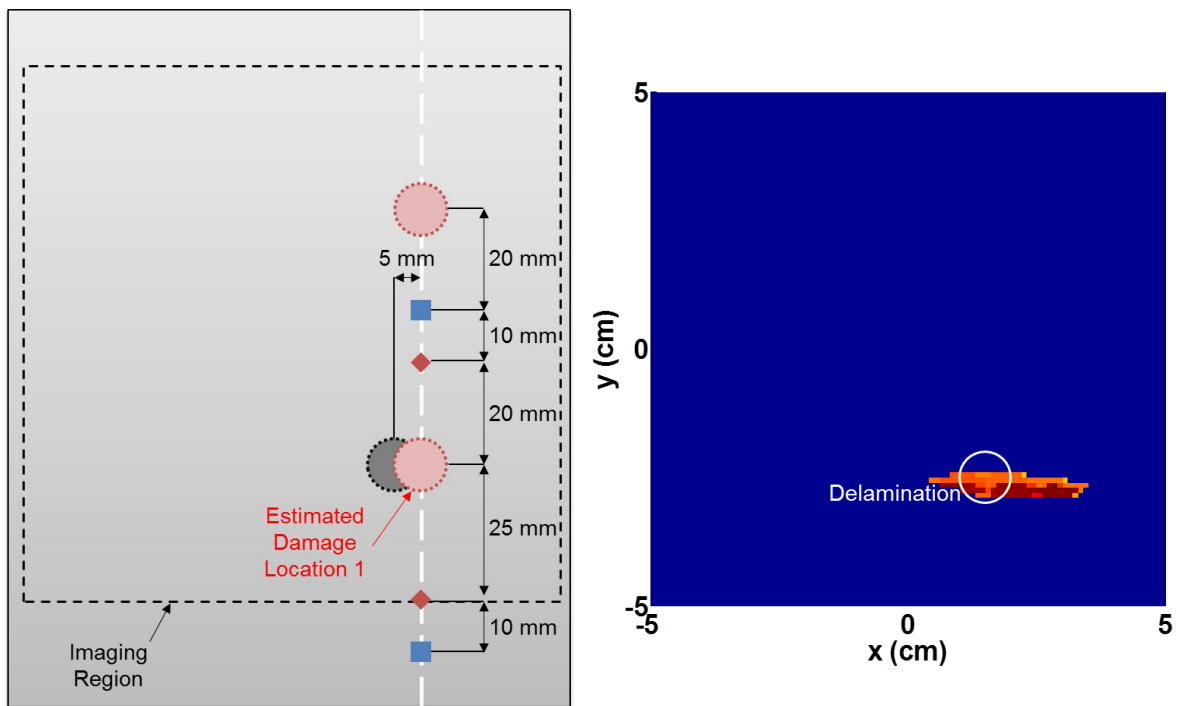
(a) Second two inspection pair selection

(b) Delamination localization result

Figure 5: (a) Second two inspection pairs selected near the estimated damage location 1 and (b) delamination localization result corresponding to the imaging region shown in (a).

Therefore, additional inspection is required to identify the exact delamination location from the estimated two. First, two inspection pairs are determined near the estimated delamination location 1 (lower one) as shown in Figure 5 (a). These inspection pairs are determined to be perpendicular to the first two and passing through the estimated delamination to avoid the symmetry problem. Another two inspection pairs are also determined near the estimated delamination location 2 (upper one) in a similar manner – Figure 6 (a). Corresponding delamination localization results are represented in Figure 5 (b) and Figure 6 (b), respectively.

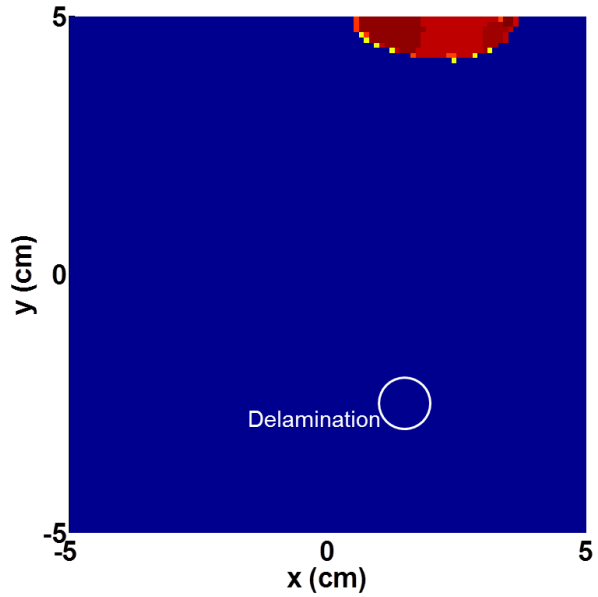
(a) Second two inspection pair selection

(b) Delamination localization result

Figure 6: (a) Second two inspection pairs selected near the estimated damage location 2 and (b) delamination localization result corresponding to the imaging region shown in (a).
