Damage Detection in Composites by Noncontact Laser Ultrasonic

Byeongjin Park, Hoon Sohn, Pawel Henryk Malinowski, Wieslaw Ostachowicz

Byeongjin Park, Hoon Sohn, Pawel Henryk Malinowski, Wieslaw Ostachowicz. Damage Detection in Composites by Noncontact Laser Ultrasonic. EWSHM - 7th European Workshop on Structural Health Monitoring, IFFSTTAR, Inria, Université de Nantes, Jul 2014, Nantes, France. hal-01020364

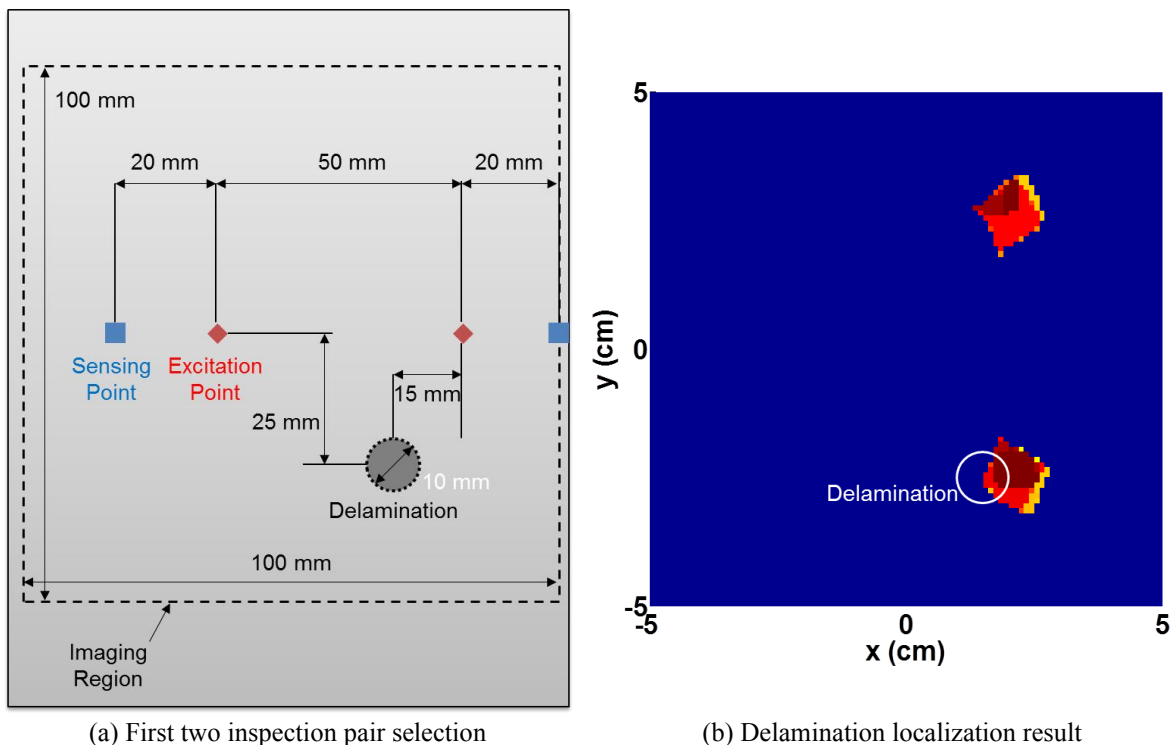
(a) First two inspection pair selection

(b) Delamination localization result

Figure 4: (a) First two inspection pairs and (b) delamination localization result corresponding to the imaging region shown in (a). Because of the symmetry, two possible damage locations in symmetric location are estimated.

Figure 4 (a) shows the arrangement of the first two inspection pairs and the delamination. With an assumption that the delamination location is unknown, two arbitrary inspection pairs were selected. Figure 4 (b) represents the damage localization results using the proposed technique and the measurement data from the selected pairs. White circle indicates actual delamination location and high possibility as the damage location is presented with red colour in the resultant image, which is corresponding to the imaging region indicated in Figure 4 (a). Here two regions are highlighted with red colour. The lower one is close to the actual delamination location but the upper one appears due to the symmetric arrangement between the inspection pairs and the delamination location.
