# DAMAGE DETECTION IN COMPOSITE STRUCTURES FROM FIBRE OPTIC DISTRIBUTED STRAIN MEASUREMENTS

#### ABSTRACT

Two approaches may be followed to obtain damage information from strain measurements:

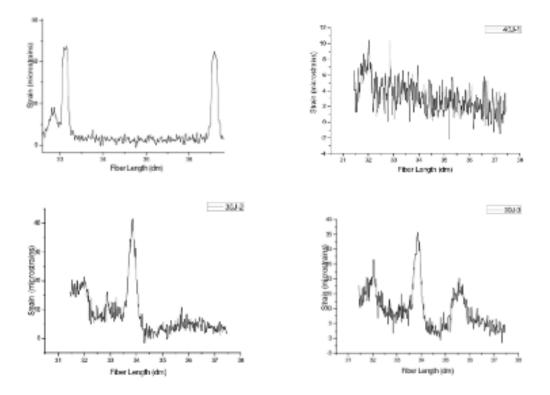
Figure 2. Strains along the optical fibre. Upper left: Local temp increase by two fingers, for localization. Upper right: Residual strains after a 40 J impact, 40 mm away from the fibre. Lower left: residual strains after a impact 30 J, 10 mm away form the fibre. Lower right: Strains after a second impact of 30 J

SHM is defined as the process of acquiring and analyzing data from on-board sensors to evaluate the health of a structure [2]. Damages are local cracks that will act as the failure initiation point, but do not change strongly the overall strain field, only a few cms around the crack are affected. Fiber optic sensors act primarily as strain sensors, so unless damage happens very close to the sensor location, damage may easily go undetected. Several articles were written on the changes in the shape of the spectral peak of an embedded FBG as consequence of cracks happening on top of the fiber, but these are not realistic structural damage cases. To highlight the situation, at figure 1 it is shown the damage done in a composite laminate by an impact, the surface had a bonded optical fibre only 40 mm away from the damage. The permanent strains at the optical fibre were not changed after the impact, and consequently this significant damage would not be detected by the OF. Only when the impact happened closer (10 mm), it produces a change in the strain field of the fibre that would then be detected. It is unconceivable to cover the whole surface of the aircraft with optical fibres, so some procedures have to be developed for doing damage predictions from strain measurements (at figure 2 the readings of residual strains after the impacts are given).

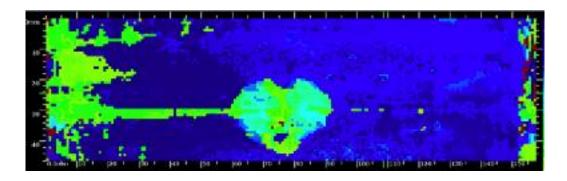
Figure 3: Ultrasonic inspection C-Scan after 2.4 J impact

The first plate was subject to a 2.4 J impact at the middle of the plate. With this energy level, fiber C-1 (embedded in the opposite side to the impact) was broken. The strain readings at the other two fibers show a peak in damage location with similar strain level. In Figure 3 the ultrasonic C-Scan inspection after the damage can be observed. The strain field is mainly affected in the delamination area, with a maximum of nearly 500 µE. The fibre embedded in the middle of the plate, between the 90° plies, presents a strain field variation limited to the delamination area. With an impact of 4.4 J, all the fibers were broken. Test performed with fibers with acrylate coating of 250 µm did not show an improvement of resistance to impacts.

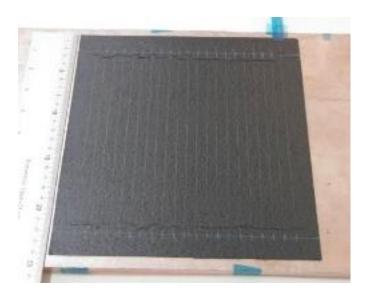
Figure 5: Optical fiber to be embedded with a crooked path in a composite laminate

Strain measurements obtained from the total surface can be used to create a strain map of the structure. In case that damage have promoted a change in the strain field, it is possible to obtain an image that represents the state of the structure. Figure 6 shows the effect of a delamination in a cross ply laminate of 200x200 mm. Strain data was obtained from a fiber in a crooked configuration that covered one of the sides.

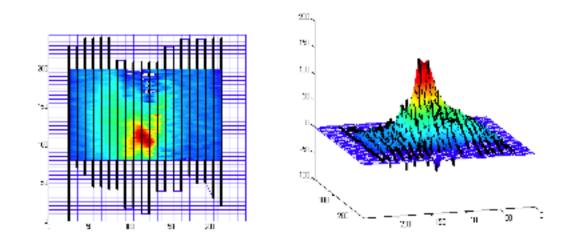
Figure 6: Strain map due to a delamination in 2D (left), and 3D (right)

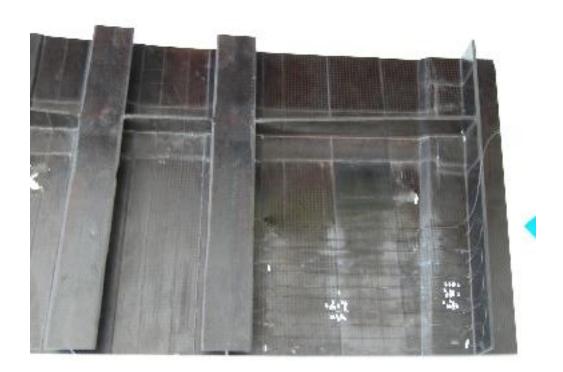
Figure 9 Cocured CFRP structure, with bonded optical fibre

Figure 9 shows a part of a real aircraft structure, done in CFRP. An optical fibre was bonded at the internal surface, with loops of radii higher than 2 cm, to avoid optical losses. A BVID (Barely Visible Impact Damage) was done on the external surface, just below the stiffener foot, at the positions marked with dotted white spots; occurrence of a delamination was verified by ultrasounds, figure 10 (right) shows the B-Scan of the area, the debonding of the stiffener foot is seen as a intermediate green line. On figure 10 (right) the change in the strain field is plotted, always for the unloaded structure, identifying the area were the impact was given.

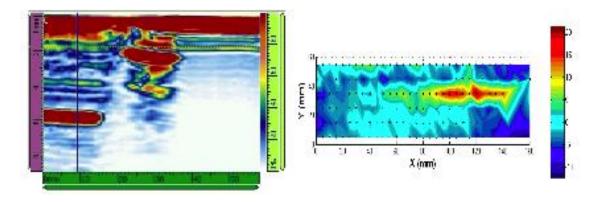
Figure 10 Map of the strains (left) and C-Scan image of the ultrasonic inspection (right)
