Repair Patch Monitoring with Embedded Optical Sensors by the Residual Strain Release

REPAIR PATCH MONITORING WITH EMBEDDED OPTICAL SENSORS BY A RESIDUAL STRAIN RELEASE TECHNIQUE

Malte Frövel¹, Javier Sanmillan¹, José Maroto¹, José María Pintado¹, Iddo Kressel², Jonathan Balter², Nachum Gorbato³ and Moshe Tur³

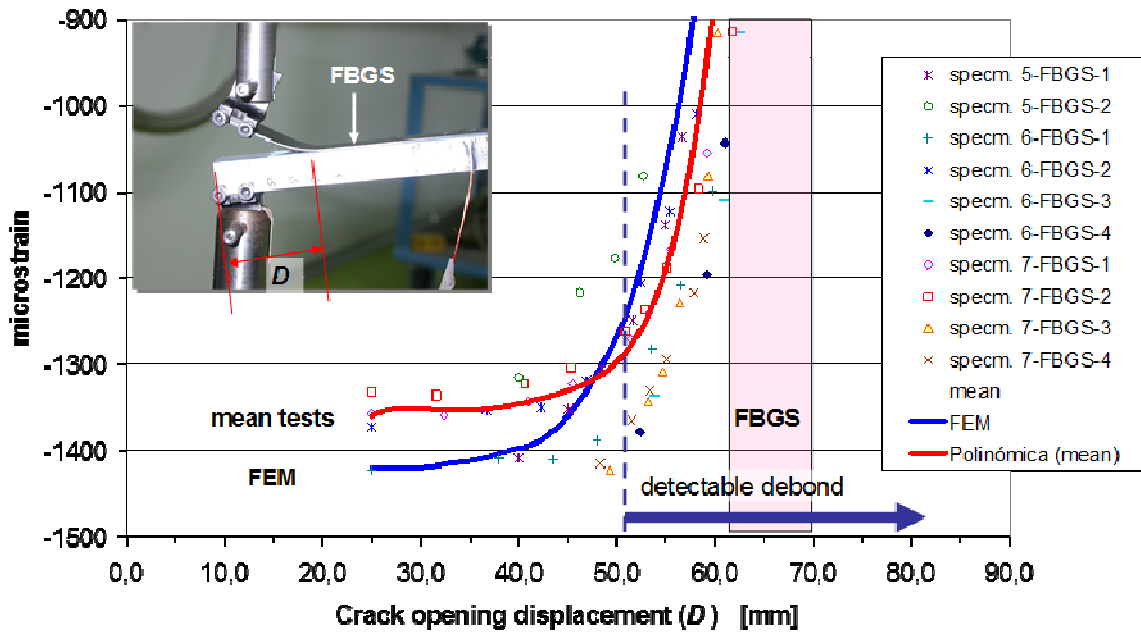
Figure 4: Test results of strain read by FBGSs of three specimens all measured without load applied during wavelength measurement, and comparison with FEM results. The red line shows the regression curve of the mean values of the measured results.

The residual strain releases in all the specimens with the increment of the crack length show good agreement with the FEM result (1st one, linear NASTRAN FEM). The closer the crack to sensor location the steeper is the slope of the graph, figure 4. At 10 mm to the sensor, about 100 microstrain are already released, and the debonding can be predicted using a standard FBGS lecture equipment. It has been shown that comparable results are obtained when the delamination length is initially longer, as in the case of the specimens 2 and 5 (40mm) and 3 (50mm) or if the delamination has been opened from the shorter initial 25 mm and has reached these values of 40 and 50 mm, respectively, after opening the crack.
