REPAIR PATCH MONITORING WITH EMBEDDED OPTICAL SENSORS BY A RESIDUAL STRAIN RELEASE TECHNIQUE

Malte Frövel¹, Javier Sanmillan¹, José Maroto¹, José María Pintado¹, Iddo Kressel², Jonathan Balter², Nachum Gorbato³ and Moshe Tur³

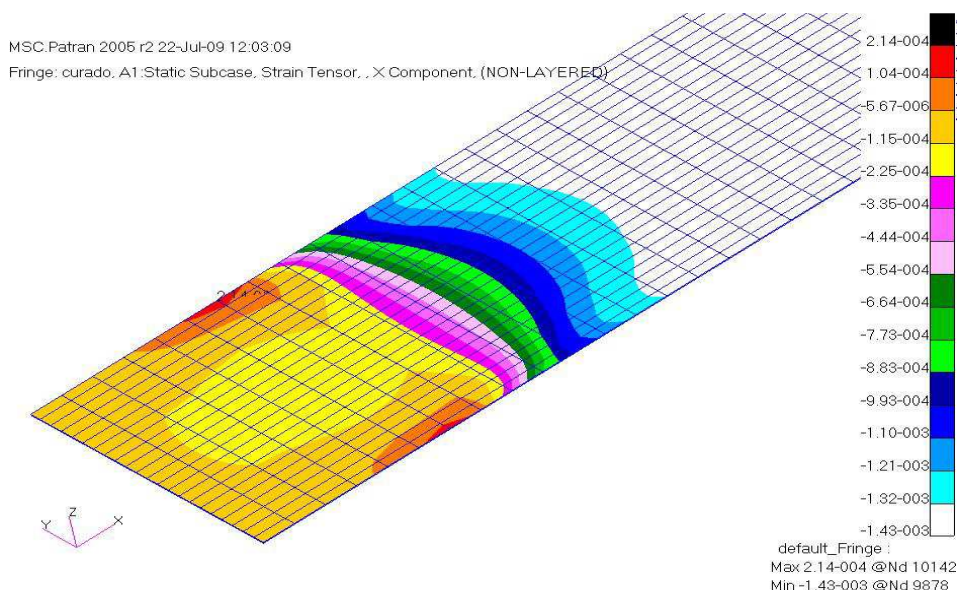
Figure 2: Residual strain in sensor layer for a debonding length of 25 mm.

The objective is to prove that when the debonding grows, the residual strain is progressively released, therefore FBGSs can be used to monitor the health of the repair, or in other words FBGS can be used to detect debonding growth before it gets critical. In figure 2 the FE residual strain at sensor layer is shown for a debonding length of 25 mm. The residual strain well inside the CFRP patch is around $-1430 \mu\epsilon$, this level decreases when approaching the debonding edge (becomes almost zero). At the FBG sensor position the residual strain change or drop is measurable. This FE analysis is useful to correlate mechanical tests performed on samples with different debonding lengths, and measuring residual strain with no load applied. The 2nd FEM is quite similar to the 1st

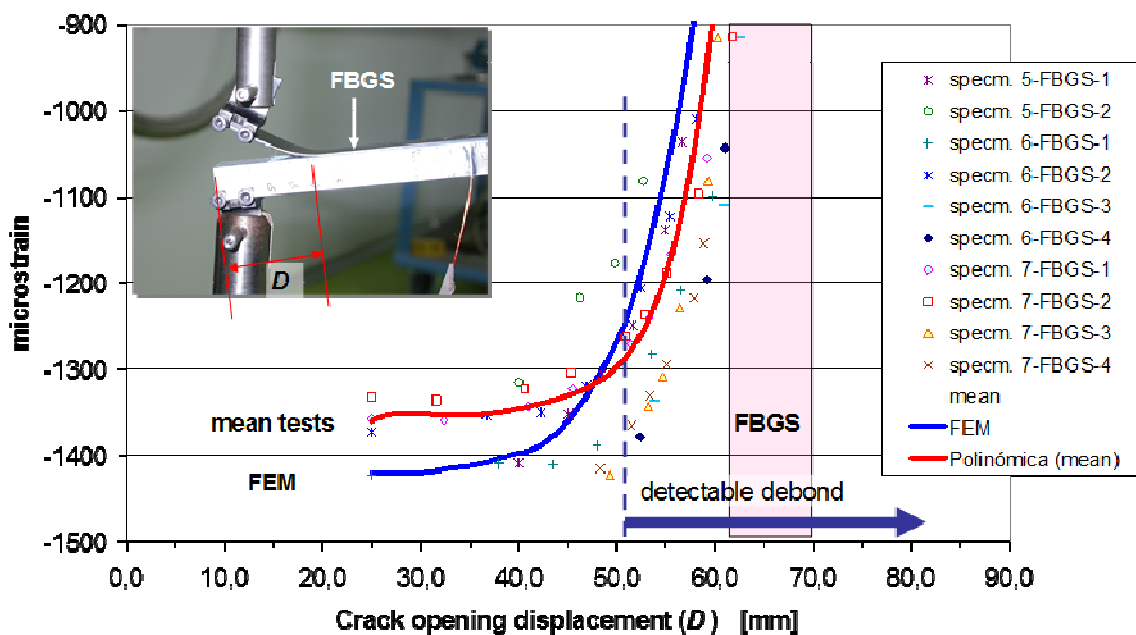
Figure 4: Test results of strain read by FBGSs of three specimens all measured without load applied during wavelength measurement, and comparison with FEM results. The red line shows the regression curve of the mean values of the measured results.

The residual strain releases in all the specimens with the increment of the crack length show good agreement with the FEM result (1st one, linear NASTRAN FEM). The closer the crack to sensor location the steeper is the slope of the graph, figure 4. At 10 mm to the sensor, about 100 microstrain are already released, and the debonding can be predicted using a standard FBGS lecture equipment. It has been shown that comparable results are obtained when the delamination length is initially longer, as in the case of the specimens 2 and 5 (40mm) and 3 (50mm) or if the delamination has been opened from the shorter initial 25 mm and has reached these values of 40 and 50 mm, respectively, after opening the crack.

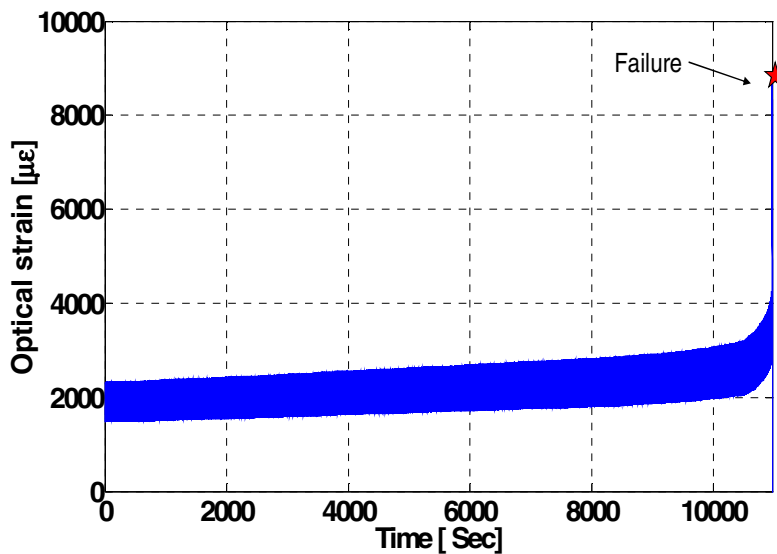
Figure 6: Typical FBG readings during final fatigue cycles of the demonstrator when the crack is approaching the sensor.

fatigue tests the patches on both sides did not debond although the crack was growing slowly under the patches which demonstrates the good quality of the bonded patch. The integrated FBGs were used during the tests to monitor the crack growth. The distributions of the loads are changing in the panel when the crack is growing and sensor close to the crack front are exposed to higher strains and strain gradients. Typical demonstrator FBG readings during the last phase of the fatigue tests are shown in figure 6. The slow but steady stain increase, induced by the growing crack as demonstrated in this experiment, gives enough time for taking corrective action before failure.
