## Repair Patch Monitoring with Embedded Optical Sensors by the Residual Strain Release

Malte Frövel, Javier Sanmillan, José Maroto, José María Pintado, Iddo Kressel, Jonathan Balter, Nachum Gorbato, Moshe Tur

## REPAIR PATCH MONITORING WITH EMBEDDED OPTICAL SENSORS BY A RESIDUAL STRAIN RELEASE TECHNIQUE

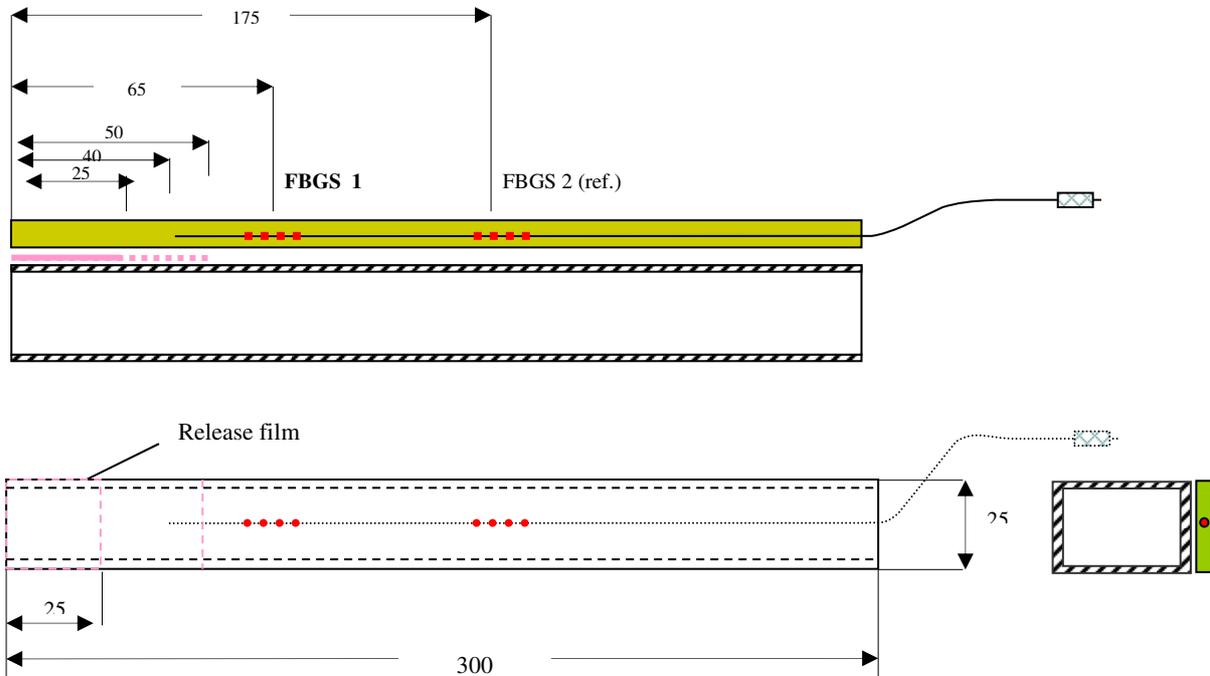
Figure 1: Simple specimen design with three delamination lengths of 25, 40 and 50 mm. The red dots represent the position of the FBGSs

The specimens are made of two materials, of aeronautic 2024 T3 aluminum that represents the stiff aircraft structure and of a 1 mm thick CFRP layer with quasi isotropic stacking sequence that represents the repair patch. High thermal induced residual strains of about  $-1400 \mu\epsilon$  are introduced during the  $120^\circ\text{C}$  hot bonding process between both materials due to the different thermal expansion coefficients of the CFRP and the aluminum. These residual strains are released when a debonding of the CFRP patch happens. The change of the residual strains provokes an expansion of the CFRP patch material and hence a measurable strain in the embedded FBGS located near the edge. The FBGS in the middle of the specimen far to the edge delamination allows a thermal compensation of the near the edge located FBGS.

An initial delamination provoked by a release film located between the CFRP-patch and the aluminum tube enables to initiate the delamination for the mode-I tests. Three different configurations of delamination lengths have been prepared to simulate the advance of the delamination. The first delamination is 25 mm from the edge of the specimen and is still 'far' from

the FBGS whose center is located at 65 mm from the edge. No strain gradients are expected, so that the sensors still measure the full thermoelastic residual strain of  $-1400 \mu\epsilon$  calculated by a finite element model, FEM. In the second and third configuration, a 40 mm and a 50 mm long delamination came nearer to the sensor and a release of the residual strain is expected. Marks have been inscribed in the specimen lateral sides for easier identification of the crack advance.

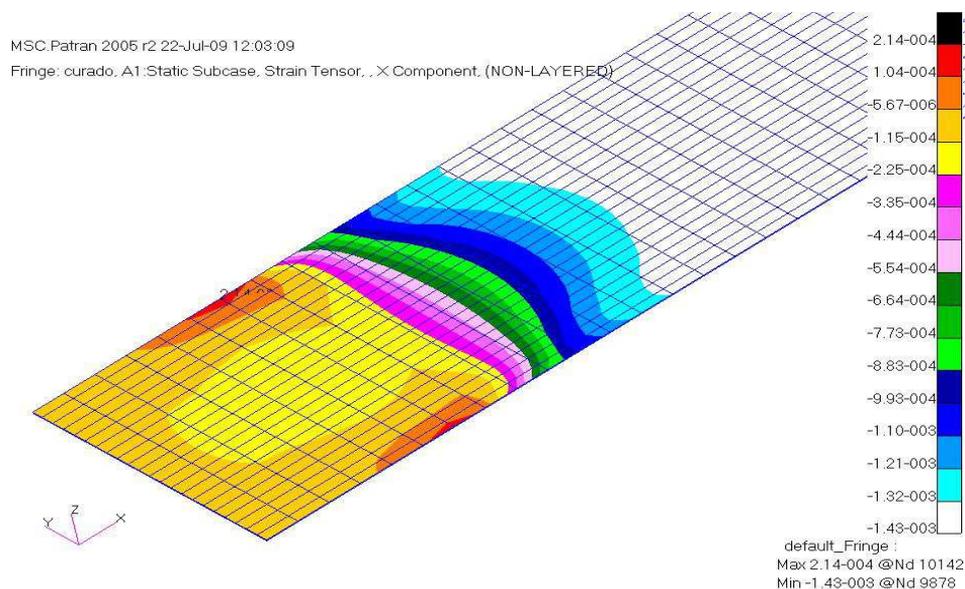
Figure 2: Residual strain in sensor layer for a debonding length of 25 mm.

The objective is to prove that when the debonding grows, the residual strain is progressively released, therefore FBGSs can be used to monitor the health of the repair, or in other words FBGS can be used to detect debonding growth before it gets critical. In figure 2 the FE residual strain at sensor layer is shown for a debonding length of 25 mm. The residual strain well inside the CFRP patch is around  $-1430 \mu\epsilon$ , this level decreases when approaching the debonding edge (becomes almost zero). At the FBG sensor position the residual strain change or drop is measurable. This FE analysis is useful to correlate mechanical tests performed on samples with different debonding lengths, and measuring residual strain with no load applied. The 2<sup>nd</sup> FEM is quite similar to the 1<sup>st</sup>

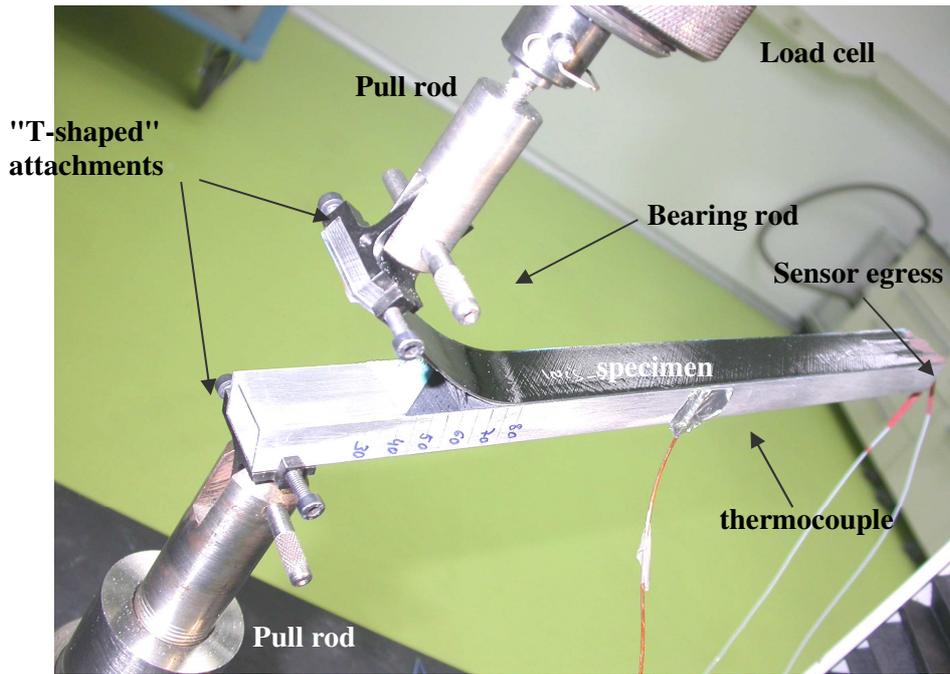
Figure 3: Specimens during test

The specimens have been tested in a universal testing machine from INSTRON type 5583. To open the initial delamination under mode-I, load has been introduced in the specimen by means of "T-shaped" attachments screwed tight to the specimen edges, as can be seen in figure 3.

The metal squares are introduced in bearings of pull rods of the testing machine. Due to the bearings no bending moments are introduced in the specimens during the mode I tests. A load cell measured the tensile load during test. A type K thermocouple has been attached to the specimens to register the specimen temperature and compare the results with the second FBGSs that are far from the delamination and are used for temperature compensation. The machine opened the crack at a constant pull speed of 2 mm/min. The machine was stopped and the crack length was measured with a digital caliper when the crack has advanced between 1,5 mm to 5 mm. The measurement has been performed on both specimens' lateral sides by visual inspection using magnifier glasses. It was necessary to measure on both sides of the specimen because the crack front was not perpendicular to its length axis, but inclined by an angle of about 10°. Consequently, the crack length was determined as the mean of both measured values.

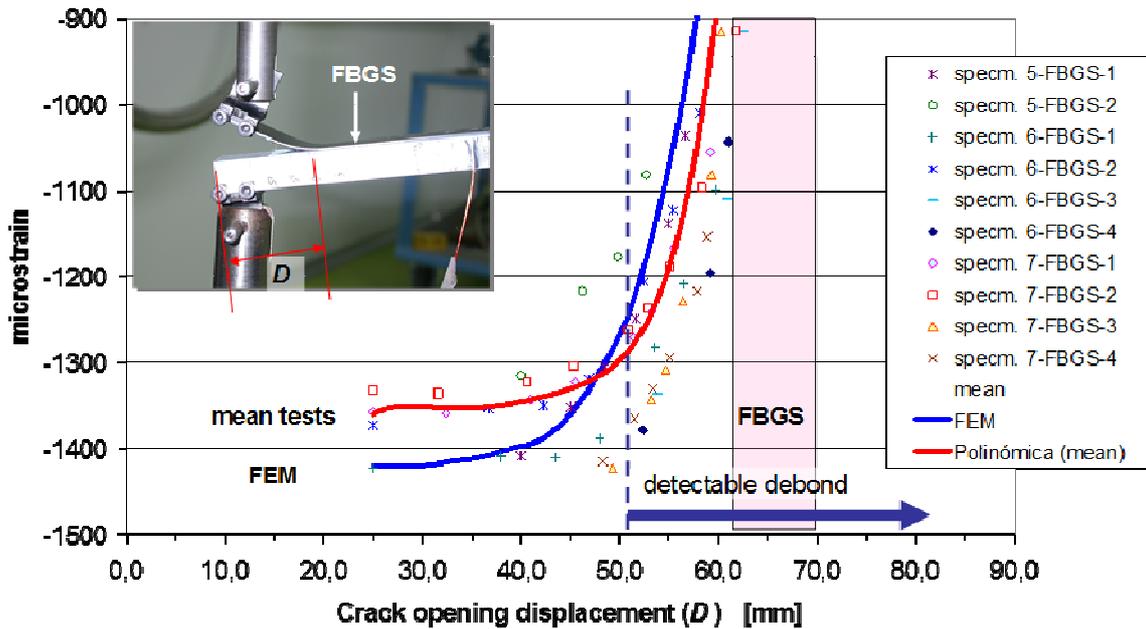
Figure 4: Test results of strain read by FBGSs of three specimens all measured without load applied during wavelength measurement, and comparison with FEM results. The red line shows the regression curve of the mean values of the measured results.

The residual strain releases in all the specimens with the increment of the crack length show good agreement with the FEM result (1<sup>st</sup> one, linear NASTRAN FEM). The closer the crack to sensor location the steeper is the slope of the graph, figure 4. At 10 mm to the sensor, about 100 microstrain are already released, and the debonding can be predicted using a standard FBGS lecture equipment. It has been shown that comparable results are obtained when the delamination length is initially longer, as in the case of the specimens 2 and 5 (40mm) and 3 (50mm) or if the delamination has been opened from the shorter initial 25 mm and has reached these values of 40 and 50 mm, respectively, after opening the crack.

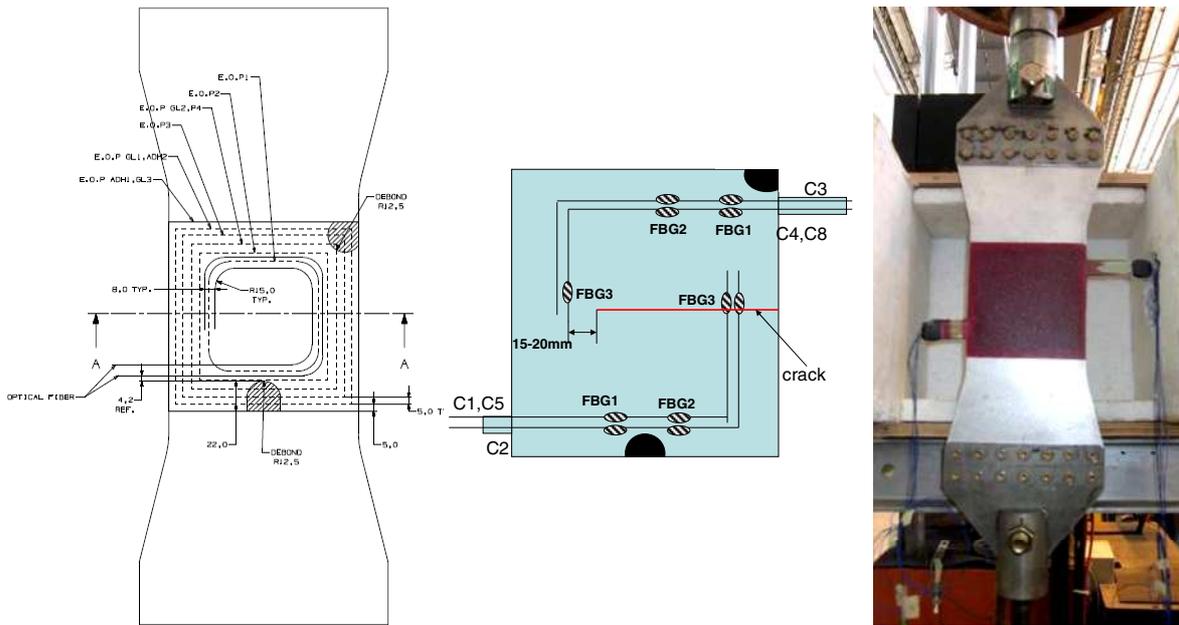
Figure 5: Left: Design of the Second Demonstrator. Middle: Bonding of the sensor mat and the repair patch on the second demonstrator. Right: second demonstrator in the fatigue test rig.

An instrumented demonstrator has been manufactured and tested. The demonstrator is composed of a CFRP patch on each side with embedded FBGSs, co-bonded on a typically aeronautic 7075 T7351 aluminum plate with a crack just under the center of both patches, figure 5. The FBGS are pre-embedded in a sensing mat with rugged fiber egress to enable reliable sensor integration even in field conditions. Each sensing mat has four fibers and every fiber is equipped with three FBGSs. An initial debond was artificially created between the CFRP-patch and the aluminum plate. The debond size was 25mm in accordance to the simple specimen tests that were performed. The demonstrator was submitted to fatigue tension loads and different environmental conditions in order to propagate the debonds.

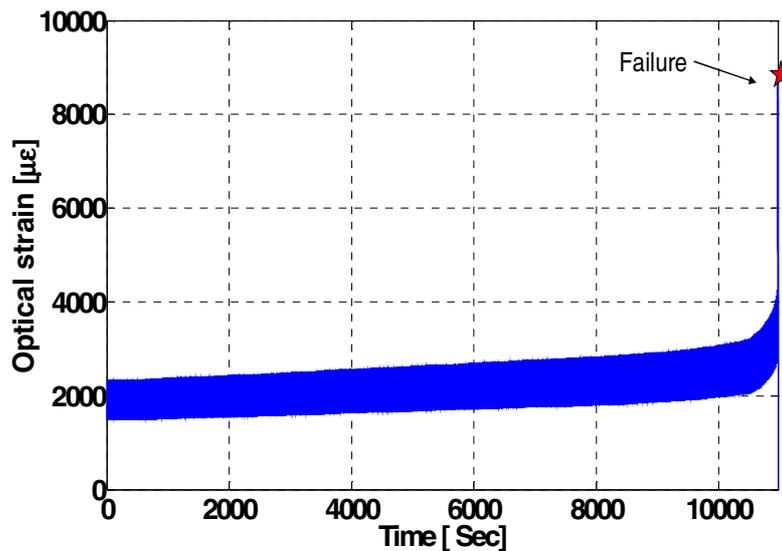
Figure 6: Typical FBG readings during final fatigue cycles of the demonstrator when the crack is approaching the sensor.

fatigue tests the patches on both sides did not debond although the crack was growing slowly under the patches which demonstrates the good quality of the bonded patch. The integrated FBGs were used during the tests to monitor the crack growth. The distributions of the loads are changing in the panel when the crack is growing and sensor close to the crack front are exposed to higher strains and strain gradients. Typical demonstrator FBG readings during the last phase of the fatigue tests are shown in figure 6. The slow but steady stain increase, induced by the growing crack as demonstrated in this experiment, gives enough time for taking corrective action before failure.
