Effets d'environnement sur la fatigue de l'acier inoxydable 304L en milieu primaire REP sous chargement cyclique

THESE

*Environmental effect on cracking of a 304L austenitic
stainless steel in PWR primary environment under cyclic
loading*

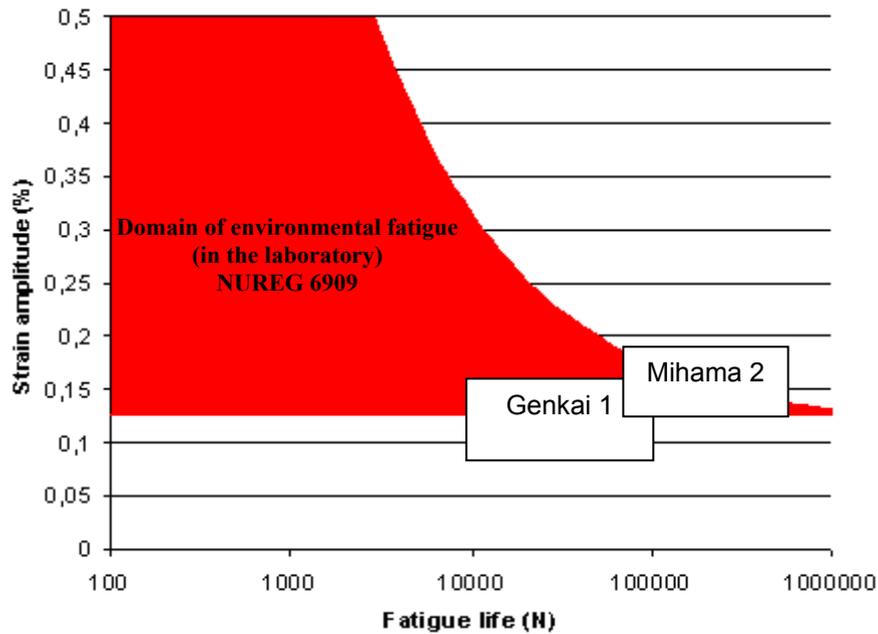
Figure 4 □ International field experience (Genkai 1 and Mihama 2) compared to the NUREG 6909 [8].

The international field experience includes cases of fatigue crack initiation in stainless steels exposed to PWR primary water. Detailed observations are presented in Appendix 1. After examinations, it was never concluded that the root cause of the degradations was EAF, except at Loviisa 2 where a crack growth assisted by the environment was reported [4]. In addition, it can be noticed that loading and environmental conditions that lead to degradations observed at Mihama 2 [5] and Genkai 1 [6] are in good agreement with the current international codification of EAF (Figure 4). Civaux [7] and Genkai 1 degradations involved weld metals which usually exhibit residual stresses and may be susceptible to primary water stress corrosion cracking (PWSCC). It is important to notice that EAF cracks are often overlooked in component examinations due to the fact that fracture surface looks like SCC or Fatigue features. In addition, EAF underlying mechanisms remains unclear.

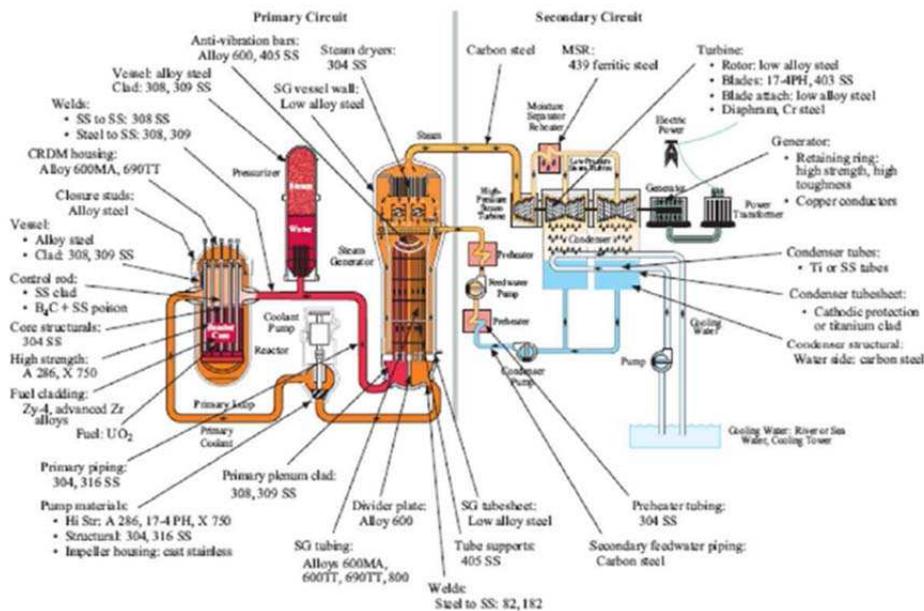
Figure 5- PWR Reactor [13].

Figure 5 presents an overview of the metallic materials used in a PWR power plant. The field experiences related to fatigue degradations [12] are mainly located in the auxiliary pipes connected to the primary piping. These circuits are mainly made of 304 and 316 austenitic stainless steels.

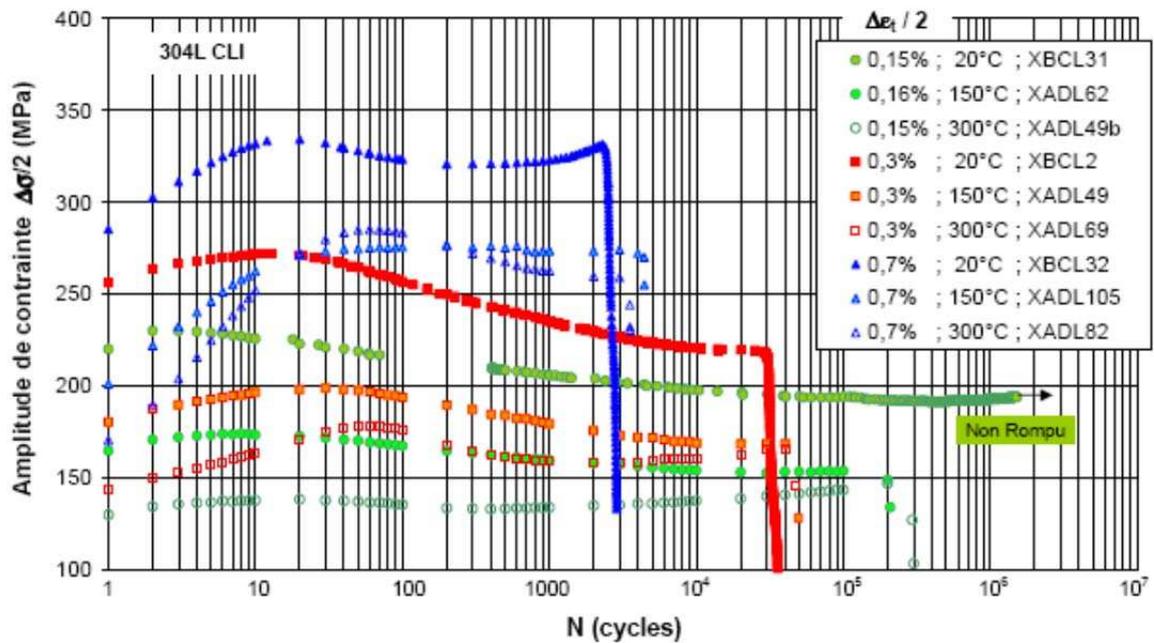
Figure 27 - Evolution of stress amplitude in function of number of cycle at different strain amplitude levels at room temperature, 150°C and 300°C, on heat XY182 (T218) [39].

arrangement of dislocations in volume, followed by a period of softening and then a quasi-stabilization of stress. Finally, a secondary hardening may eventually appear (Figure 27) [38].

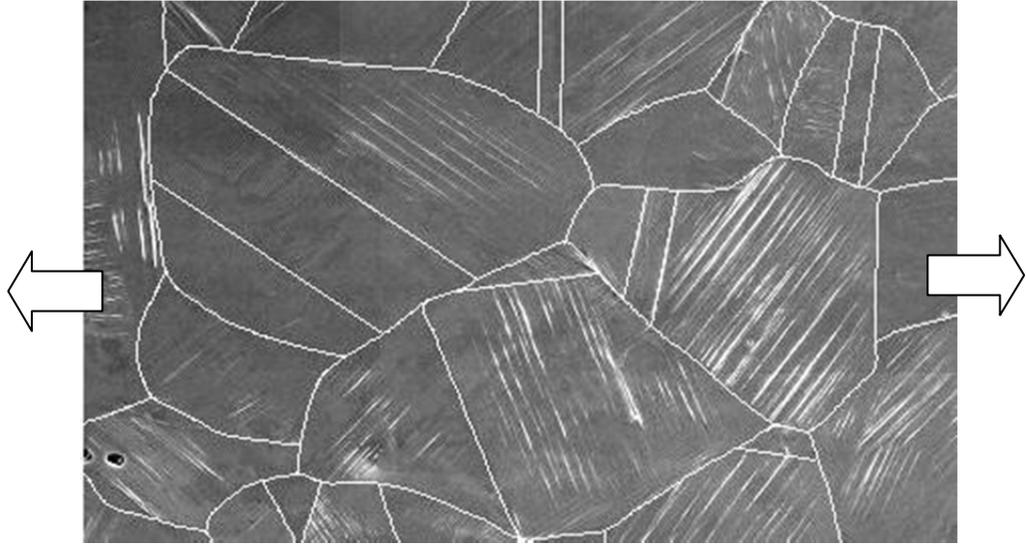
Figure 30- Slip occurring at the surface, 316L, 20°C, $\Delta\epsilon_p/2 = 0.2\%$ [48].

As previously described, the surface of the material plays an important role in fatigue crack initiation. Preferential crack initiation sites are areas where local strain induced by cycling is high. The crystallographic orientation of each individual grain plays an important role in the process of emerging PSBs. Indeed, during a fatigue test, some grains are not so much plastically strained, while others are strongly deformed, with essentially only one slip system being activated (Figure 30) [48].

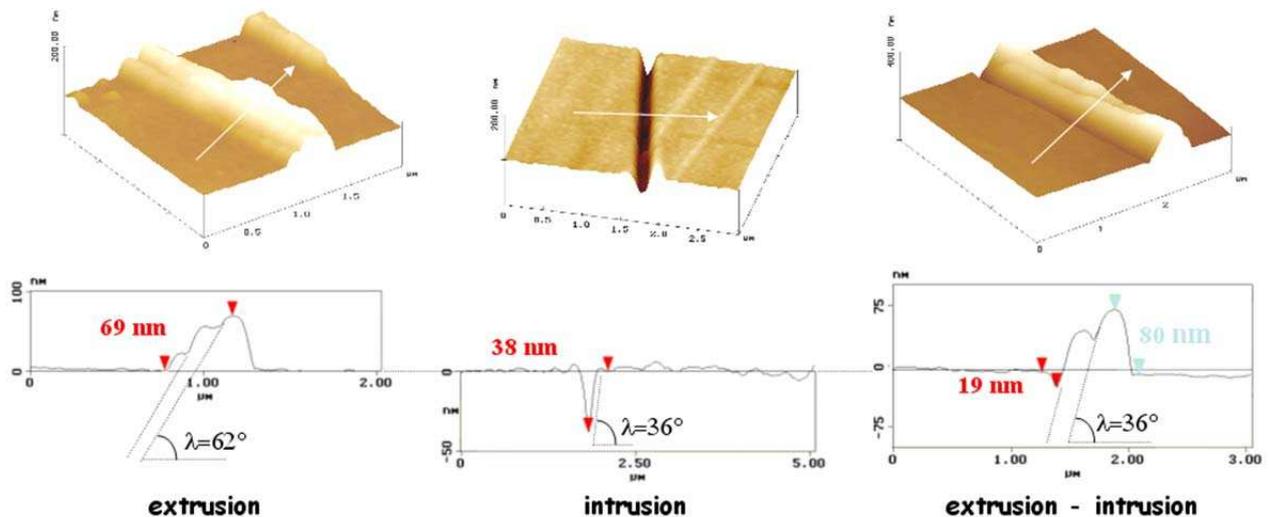
Figure 33 □ Examples of intrusion/extrusion configuration 316L, 20°C, $\Delta\varepsilon_p/2 = 0.2\%$ [48].

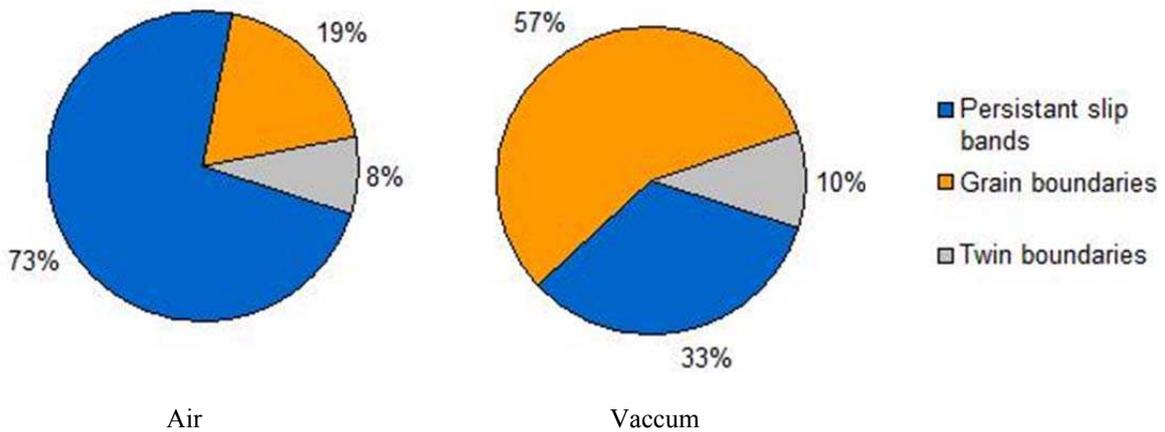
Figure 35 □ Statistical analysis of initiation localization on a 316L , $\Delta\epsilon_p/2 = 0.2\%$, 20°C, air [49].

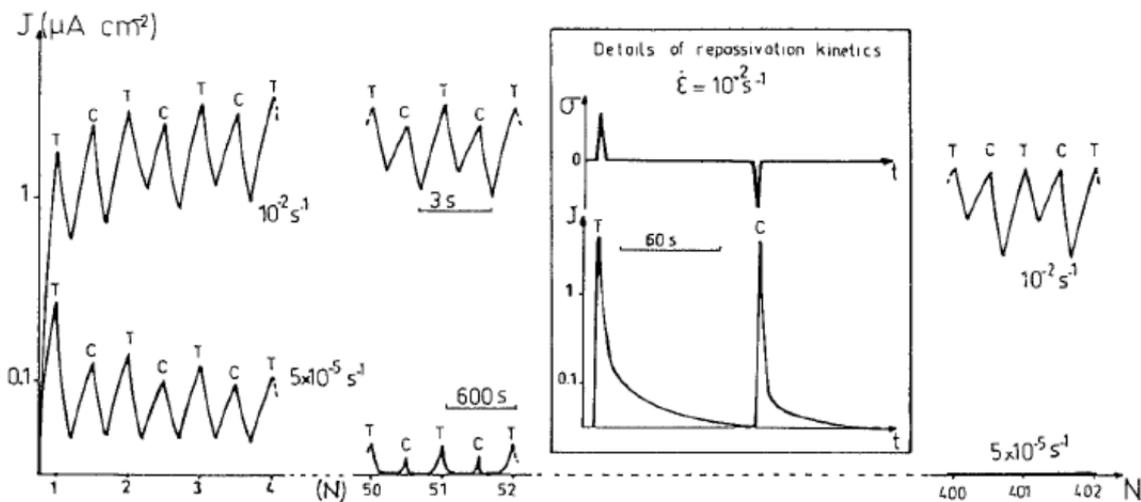
Figure 39 □ Influence of strain rate on the cyclic evolution of J for different values of N and two different strain rates at $\Delta\epsilon_p/2=0.4\%$ of a Fe-26Cr-1Mo alloy in 30g/l NaCl [50].

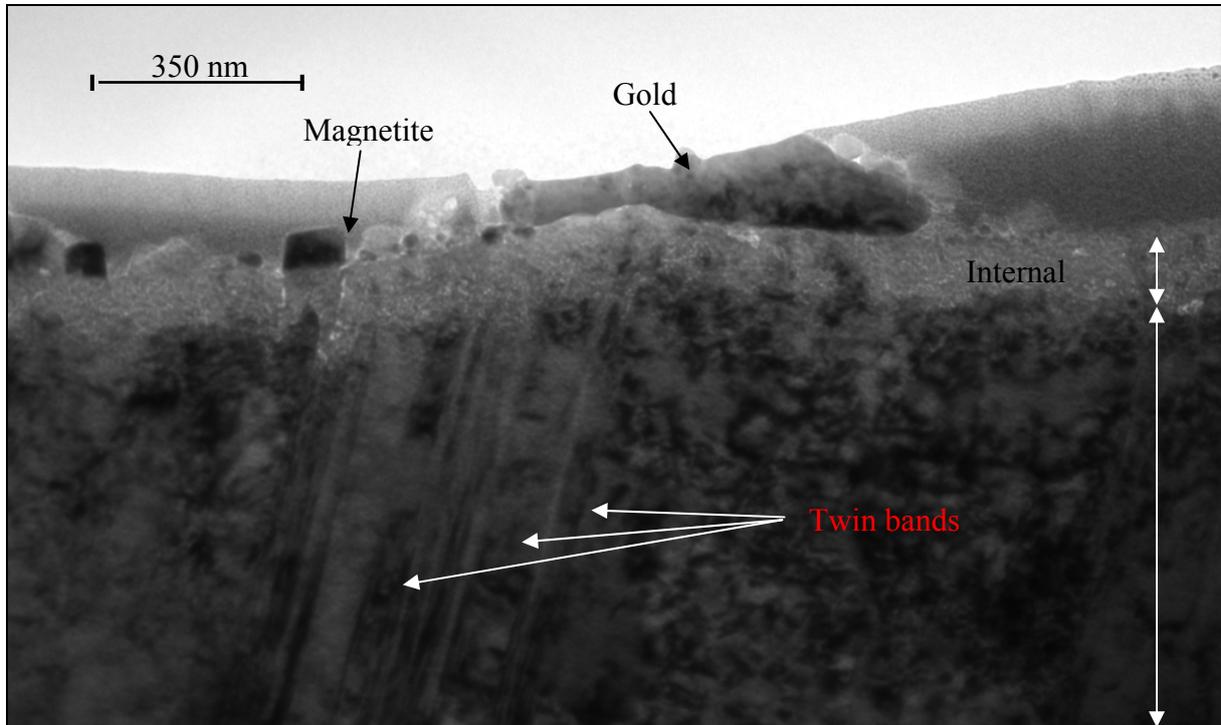
Figure 40 - Oxide observation (STEM, bright field) at the surface of a 304L specimen exposed to the primary water (360°C during 500 h $\square 2 \times 10^{-8} \cdot s^{-1}$, Constant Elongation Rate Test) [51].

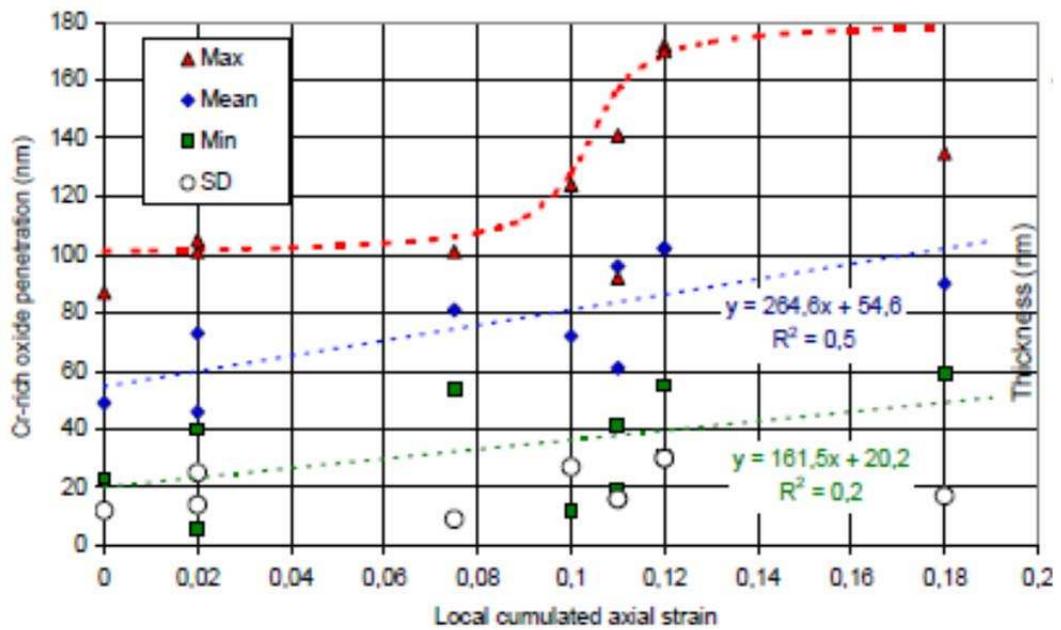
Figure 41 - Cr-rich oxide penetration against local cumulated strains of stainless steels [53].

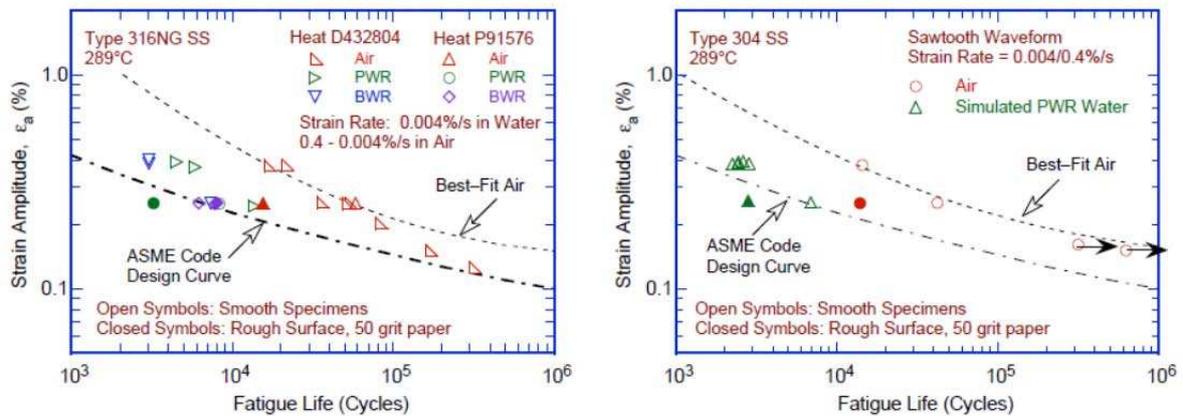
Figure 52 \square Effect of surface roughness on fatigue life of 316NG (left) and 304 (right) SS in air and high-purity water [1].

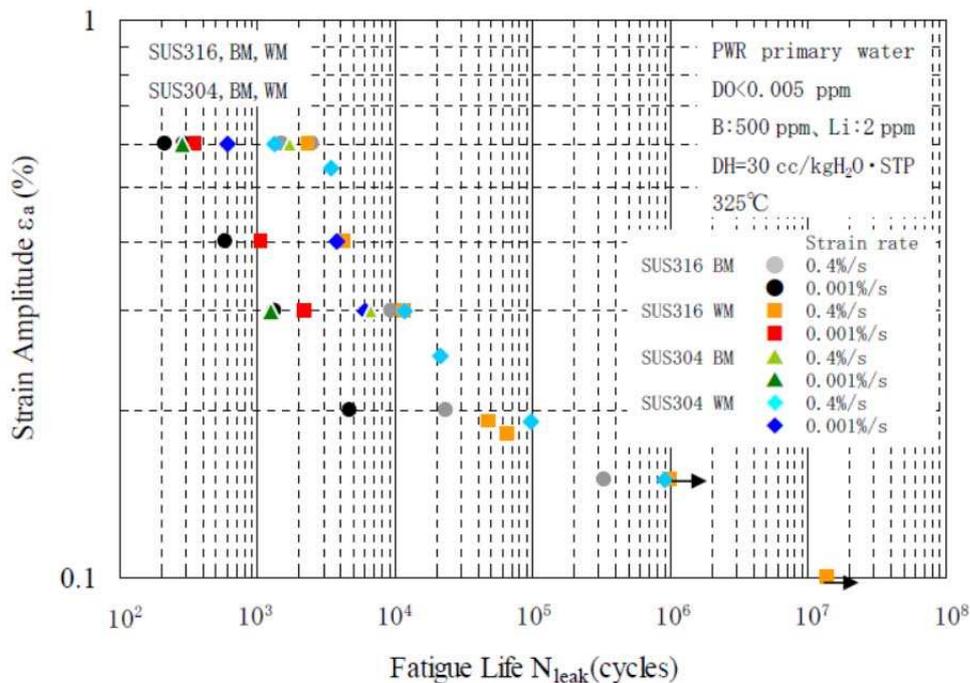
Figure 57 □ Effect of materials on fatigue life for austenitic stainless steels in PWR water [8].

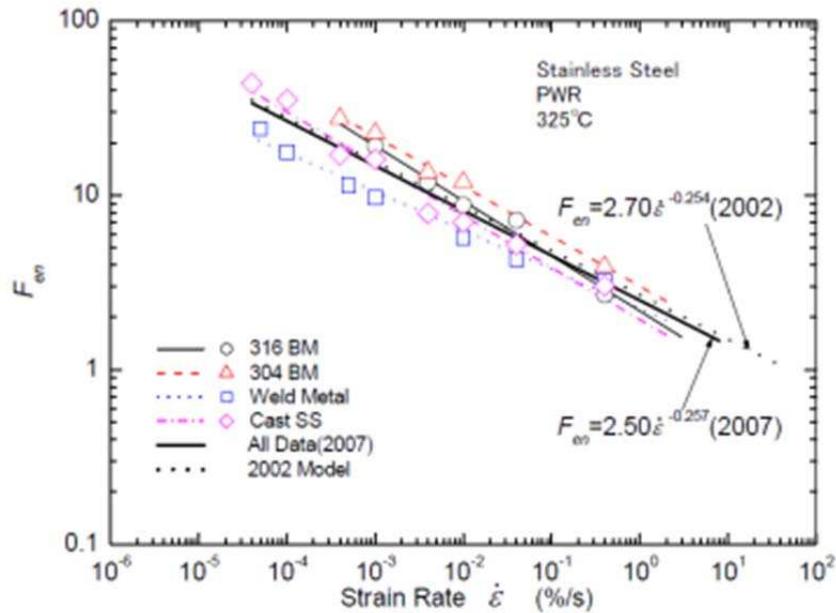
Figure 58 □Relation of strain rate to F_{en} for austenitic stainless steels in PWR water (average value) [11].

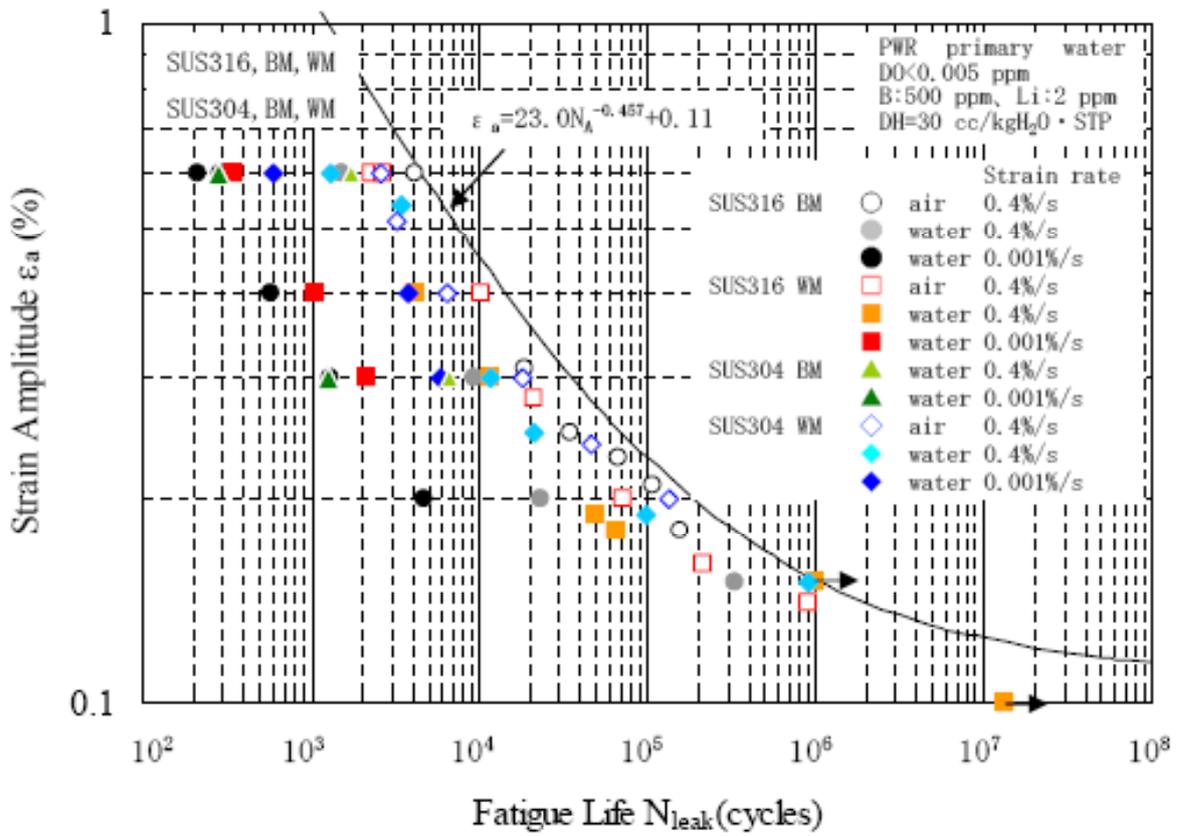
Figure 67 □ PWR primary environmental effect on fatigue life at 325°C [100].

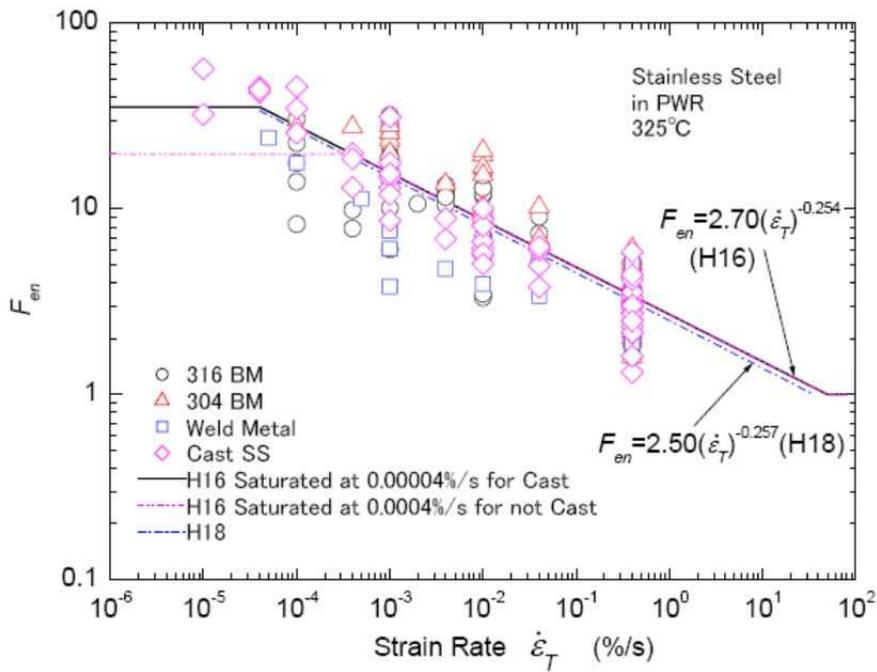
Figure 73 Effect of strain rate in F_{en} of stainless steels in PWR primary environment ($\Delta\epsilon_t/2= 0.2-0.6 R=-1$) [100].

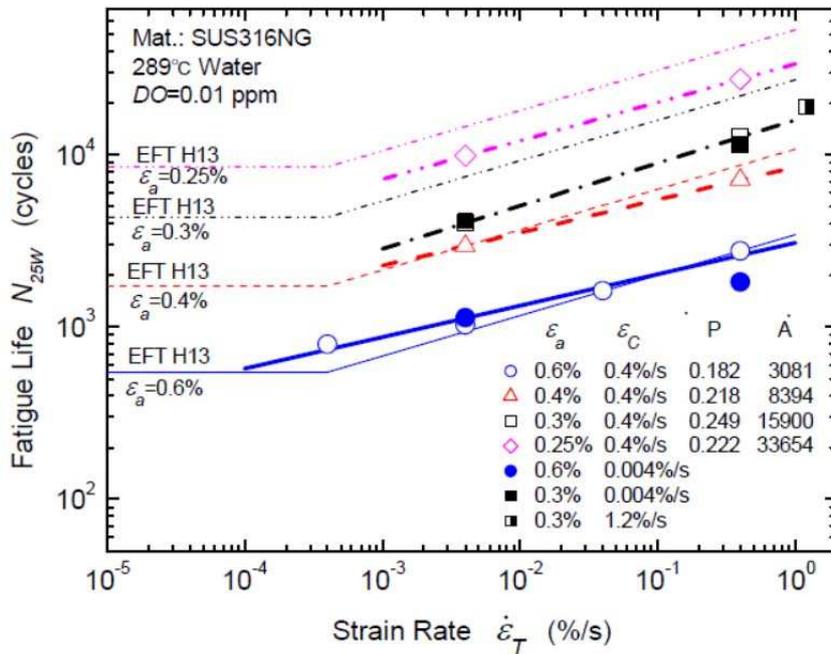
Figure 75 □ Effect of strain rate in compression on fatigue life of stainless steels in BWR conditions [8].

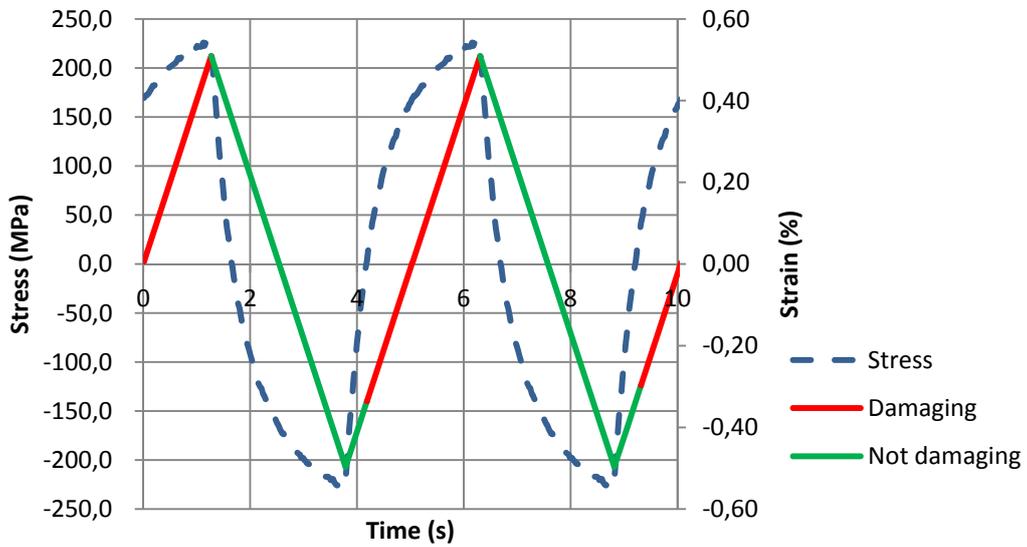
Figure 78 □ Damaging areas where strain rate has an effect

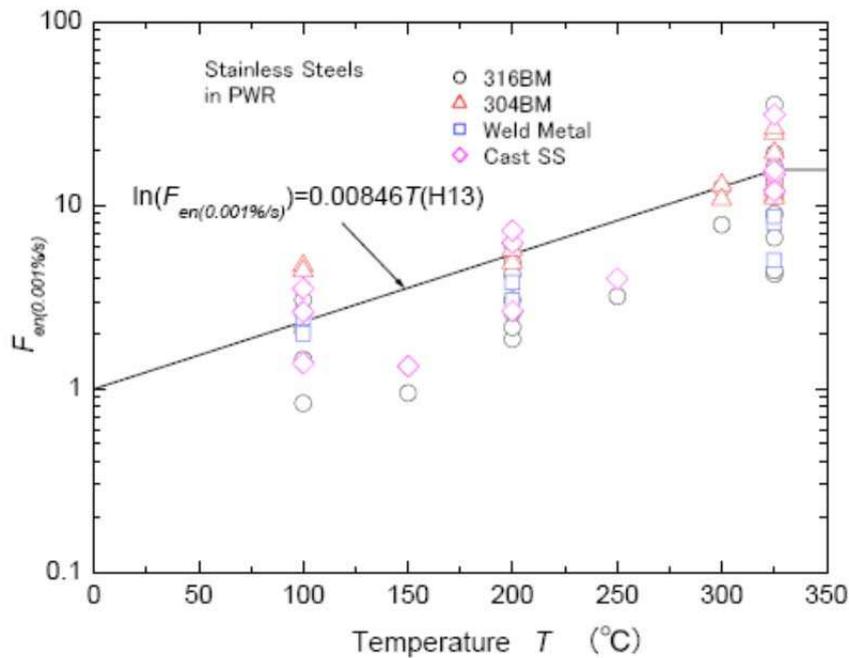
Figure 85 □ Evaluation of the temperature effect on fatigue life of austenitic stainless steels in PWR primary environment. ($\Delta\varepsilon_p/2=0.2\%$ □ 0.6% , $\dot{\varepsilon}=0.001\%/s$) [100].

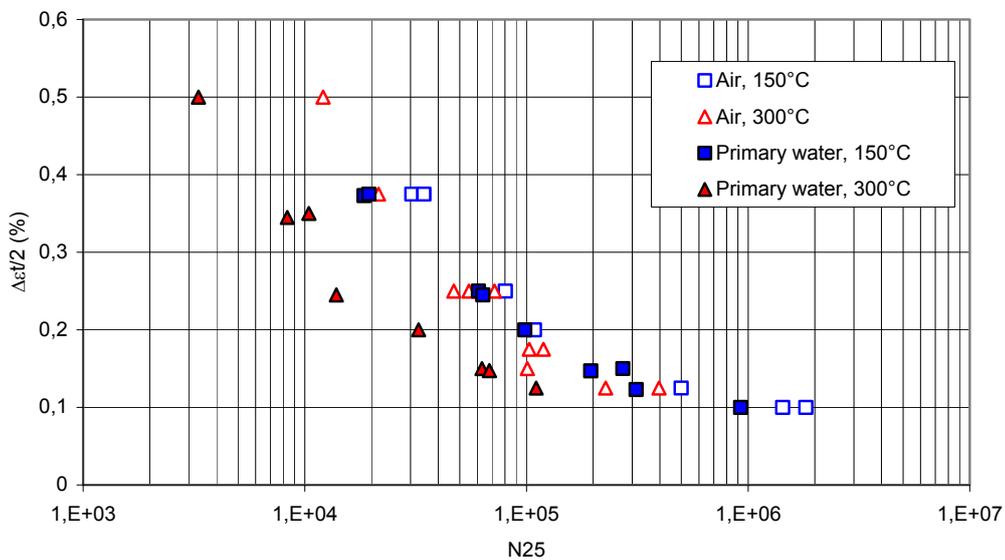
Figure 86 □ Temperature effect in air and in primary water (1000ppm B, 2ppm Li, 25-35 $\text{cm}^3.\text{kg}^{-1}$) on fatigue life ($\dot{\varepsilon}=0.4\%/s$, $R=-1$) [102].

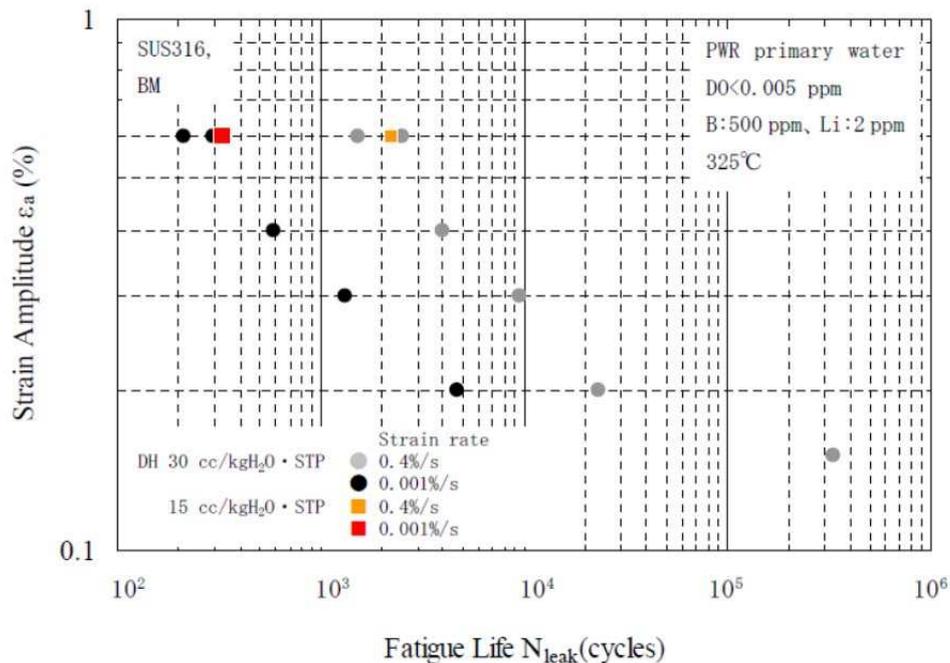
Figure 94 - Effects of DH of water on fatigue life of Type 316 SS in PWR water [8].

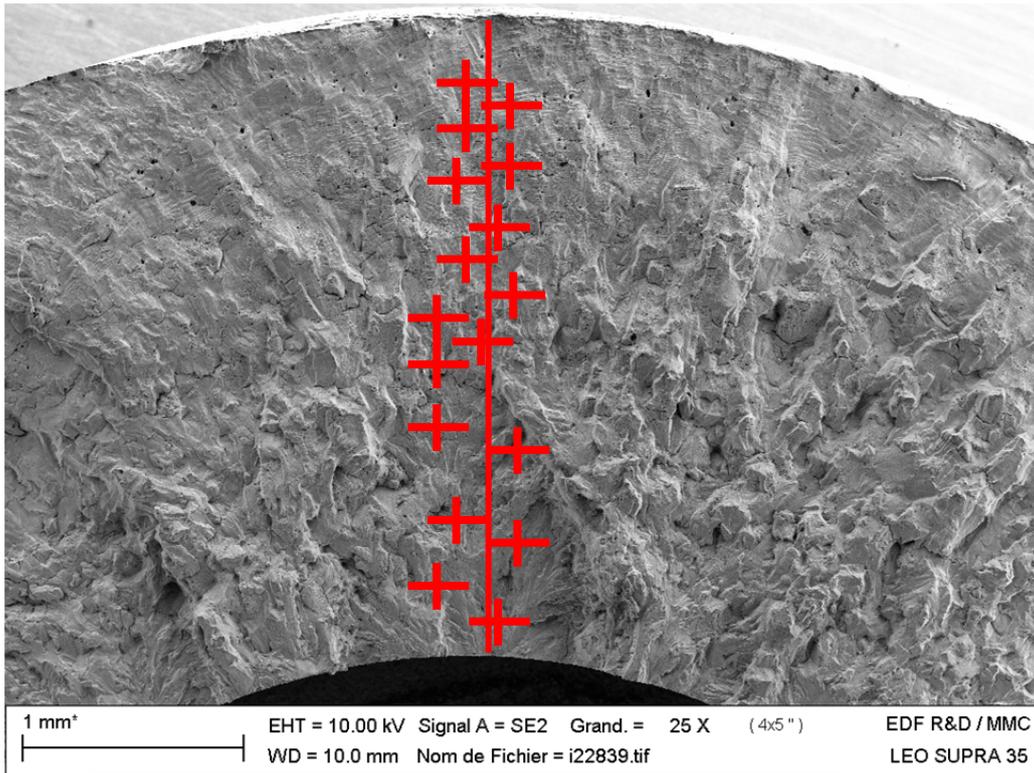
Figure 14 □ Fracture surface of 1630 MHI 04, $\Delta\epsilon_t/2=0.5\%$, $0.004\%/s$, As-received, PWR primary water at 300°C, general view.

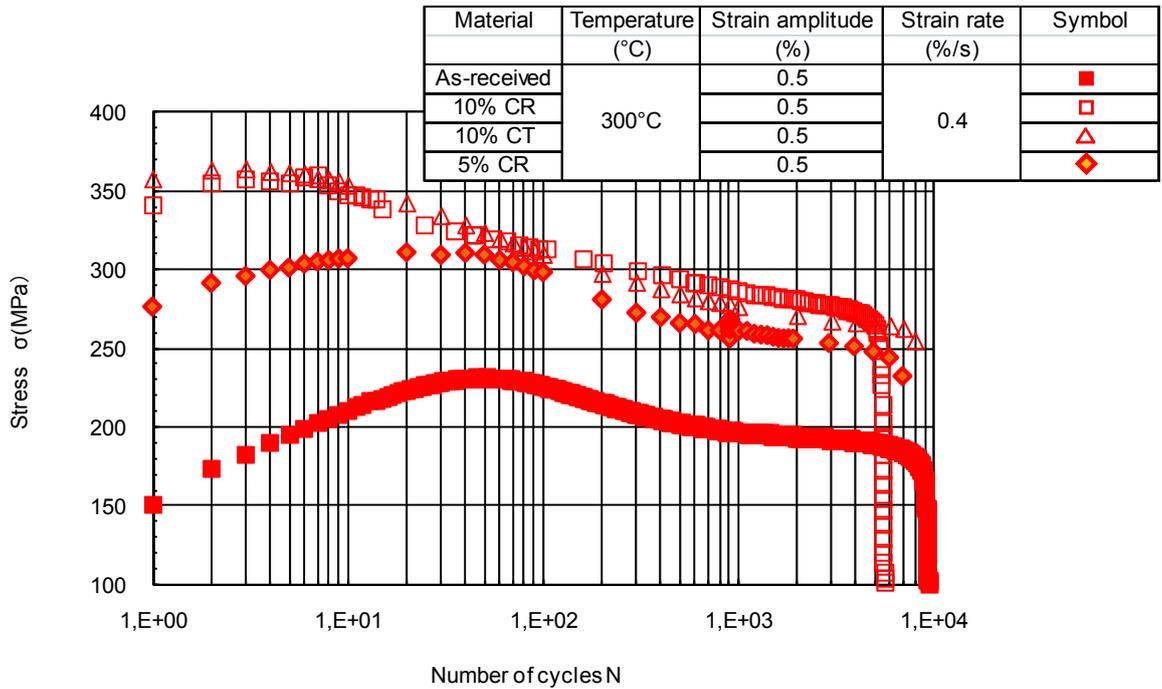
Figure 9 □ Maximum stress evolution during cycling for the 10% CR, 10% CT, 5% CR and as-received material at a total strain amplitude of 0.5%.

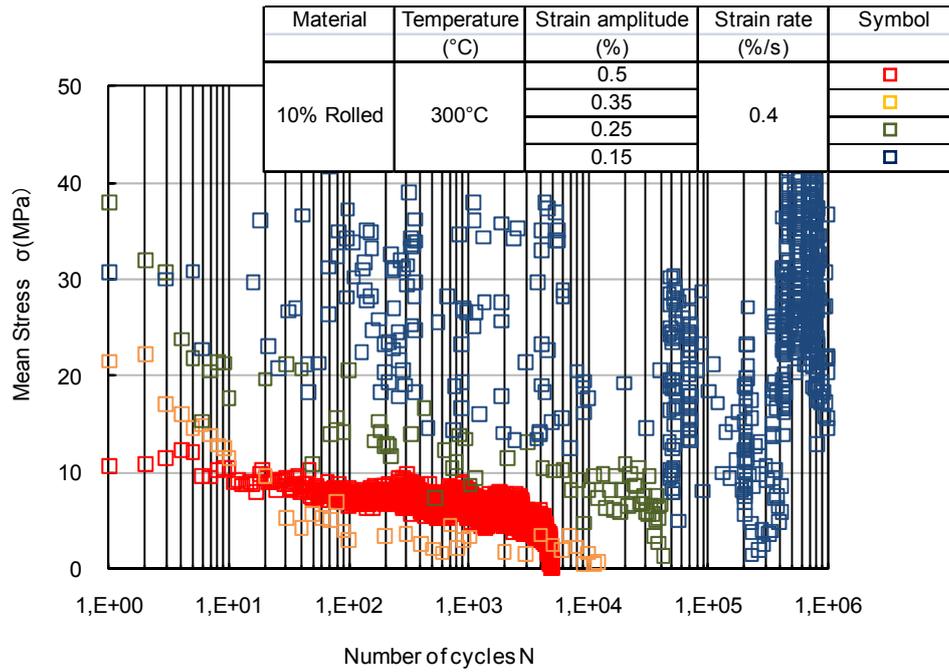
Figure 10 Evolution of mean stress as a function of number of cycles on the 10% CR material.

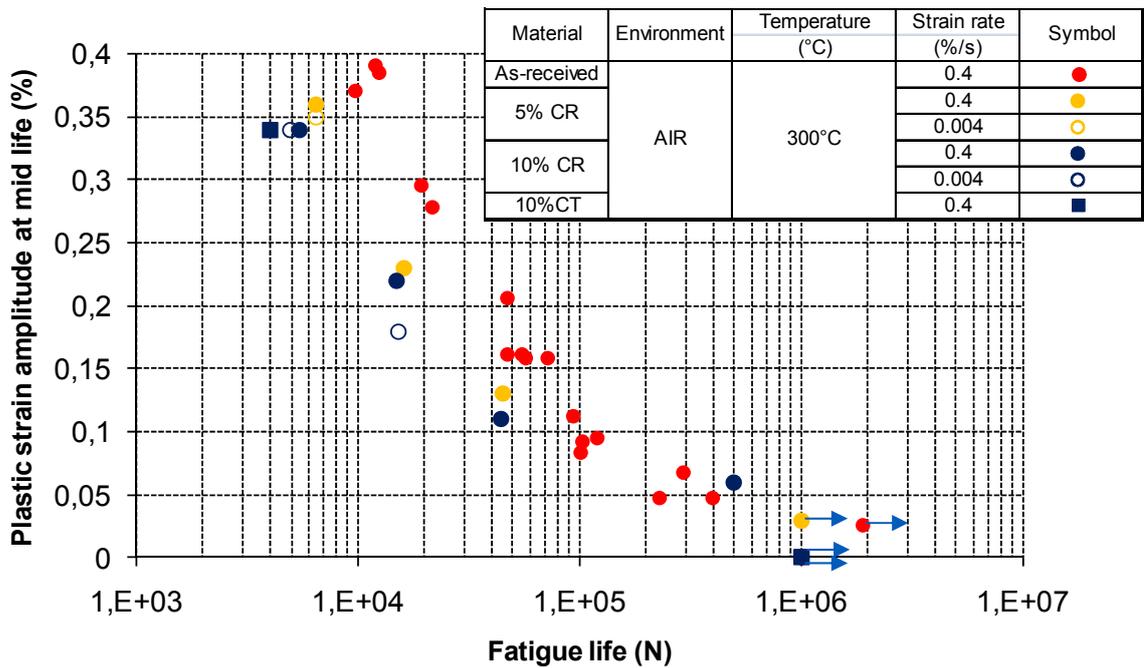
Figure 14 □ Plastic strain amplitude at mid life vs. fatigue lives in air of as-received, 5% CR and 10% CR 304L.

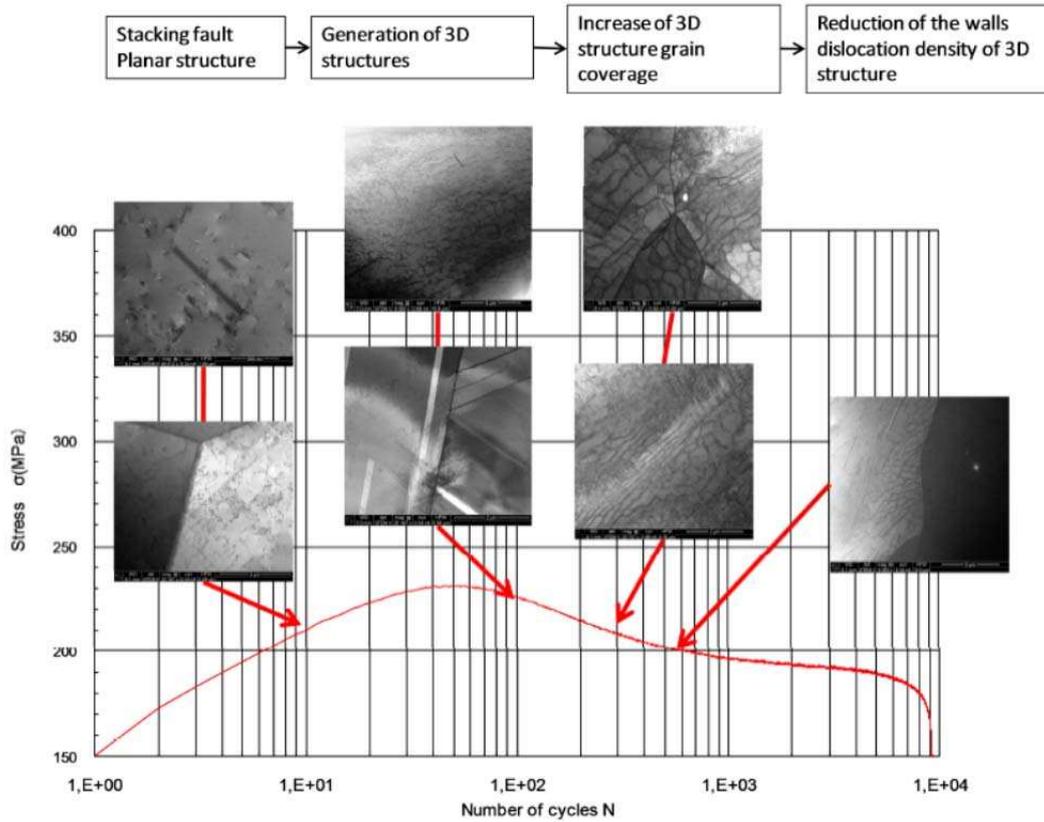
Figure 69 □ Evolution of the microstructure during cycling at $\Delta\epsilon_t/2 = 0.5\%$ and on the as-received material.

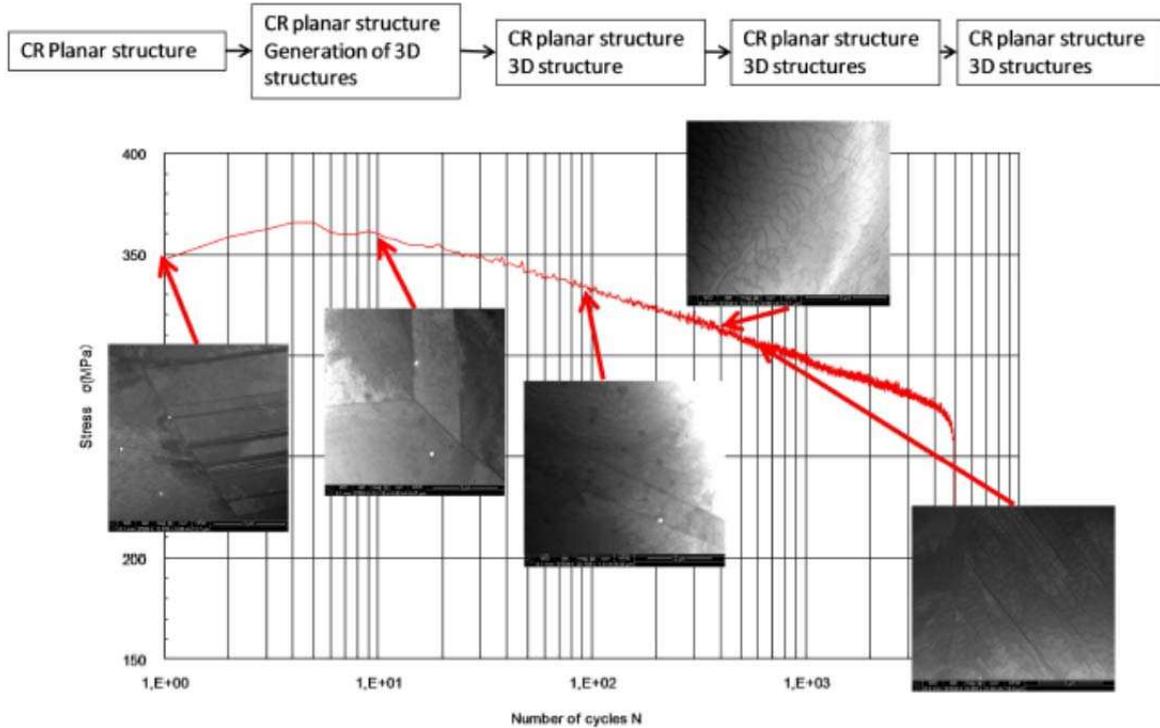
Figure 70 □ Evolution of the microstructure during cycling at $\Delta\epsilon_t/2 = 0.5\%$ and on the 10% CR.

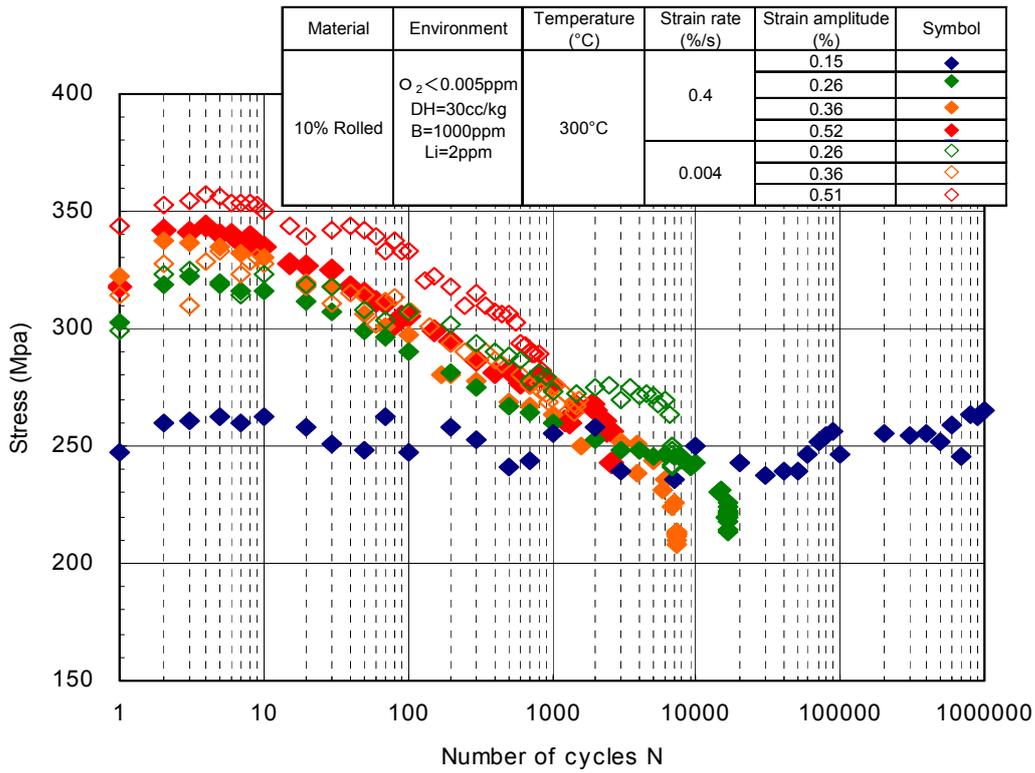
Figure 1 □ Evolution of stress as function of number of cycles on the cold-worked material.

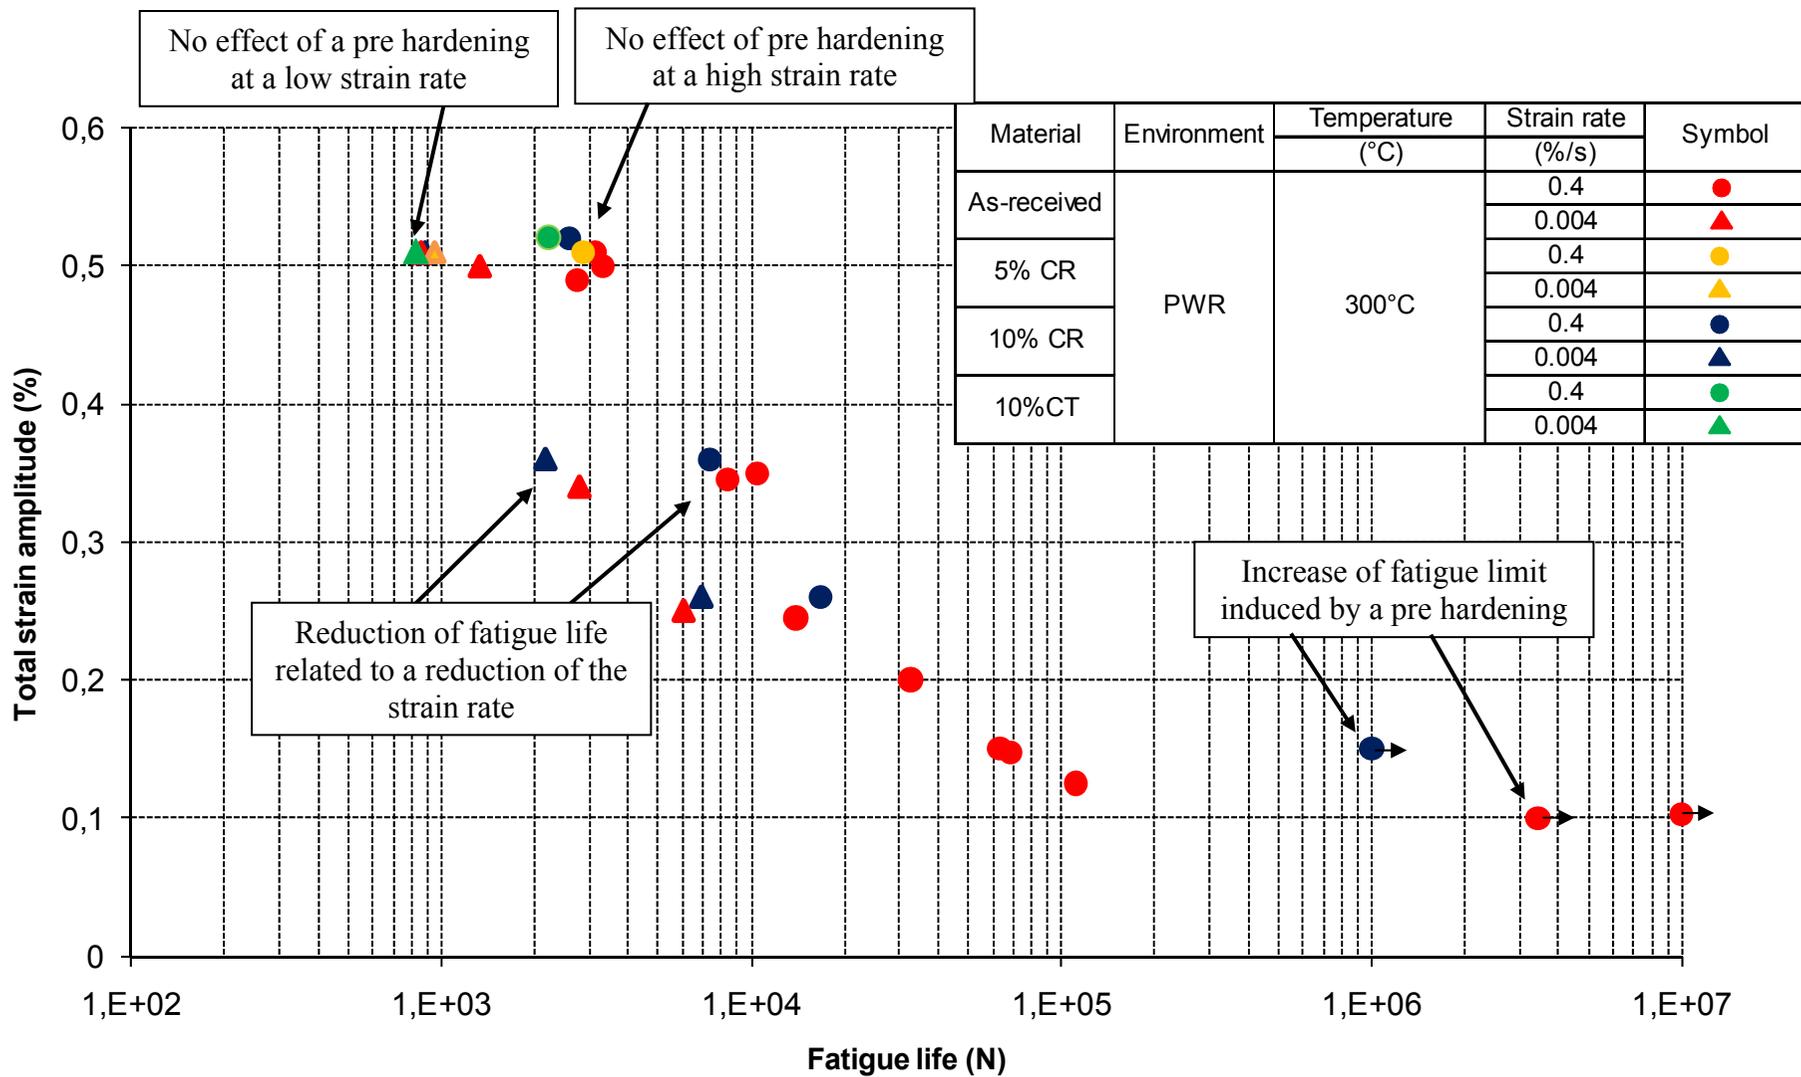
Figure 5 - Strain amplitude vs. fatigue life data for XY182 at 300°C in simulated PWR water

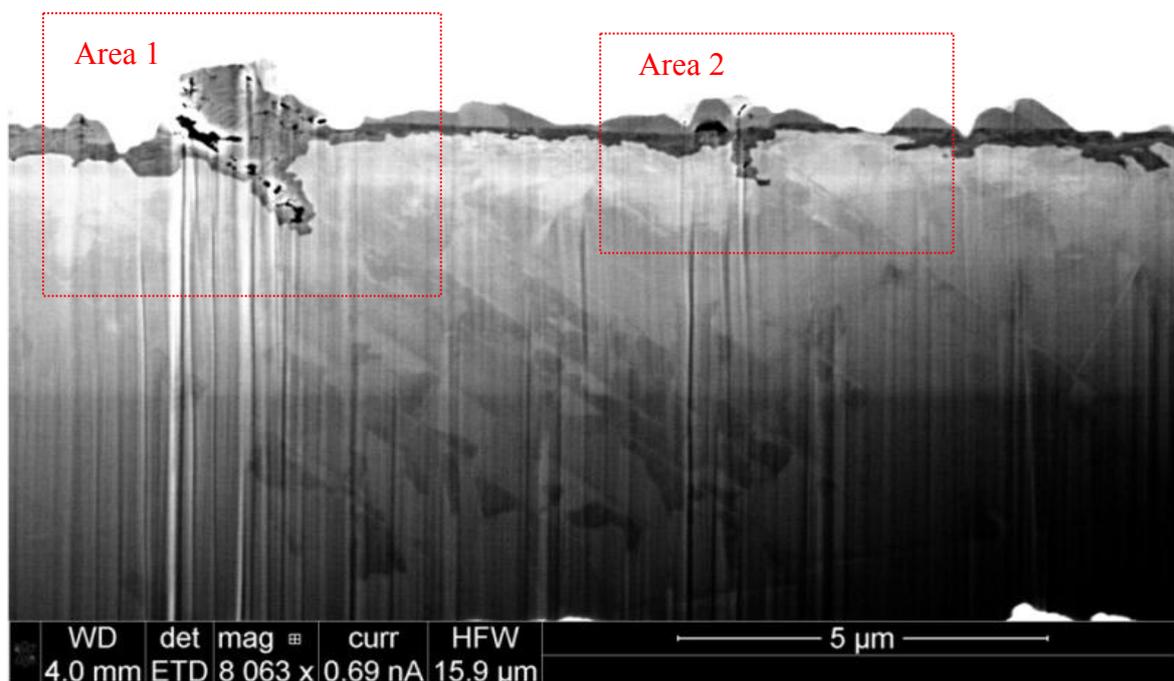
Figure 22 □ Cross section on a sample tested in PWR primary environment at 300°C, at $\Delta\varepsilon_t/dt=0.004\%/s$, $\Delta\varepsilon_t/2=0.5\%$, as-received, failure. Observed with electronic beam at 5 kV.

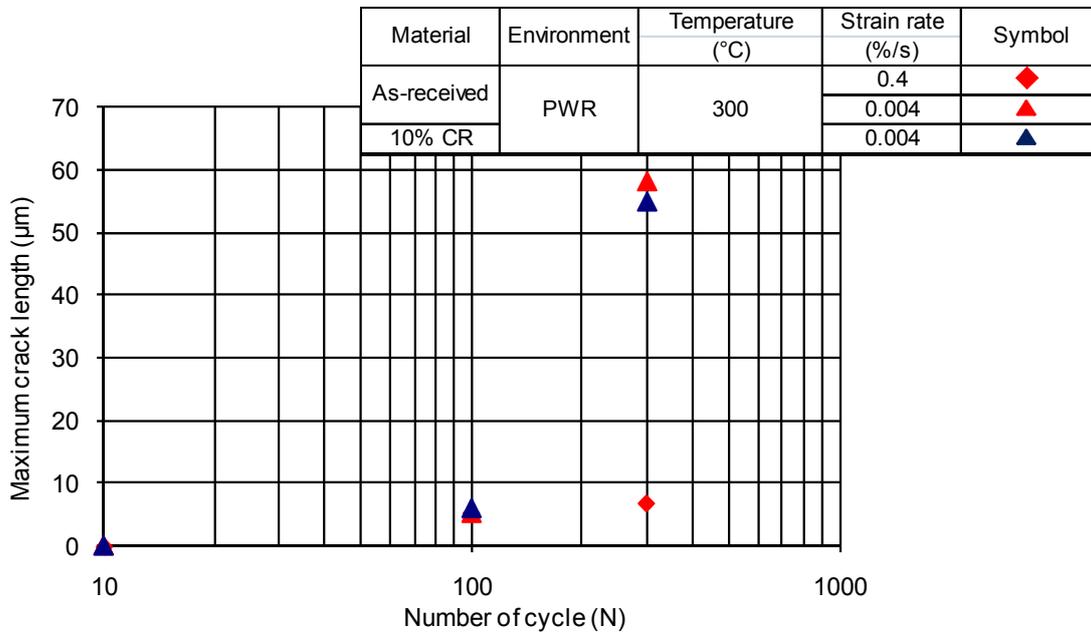
Figure 34 Evolution of maximum crack length as a function of number of cycles in PWR primary environment.

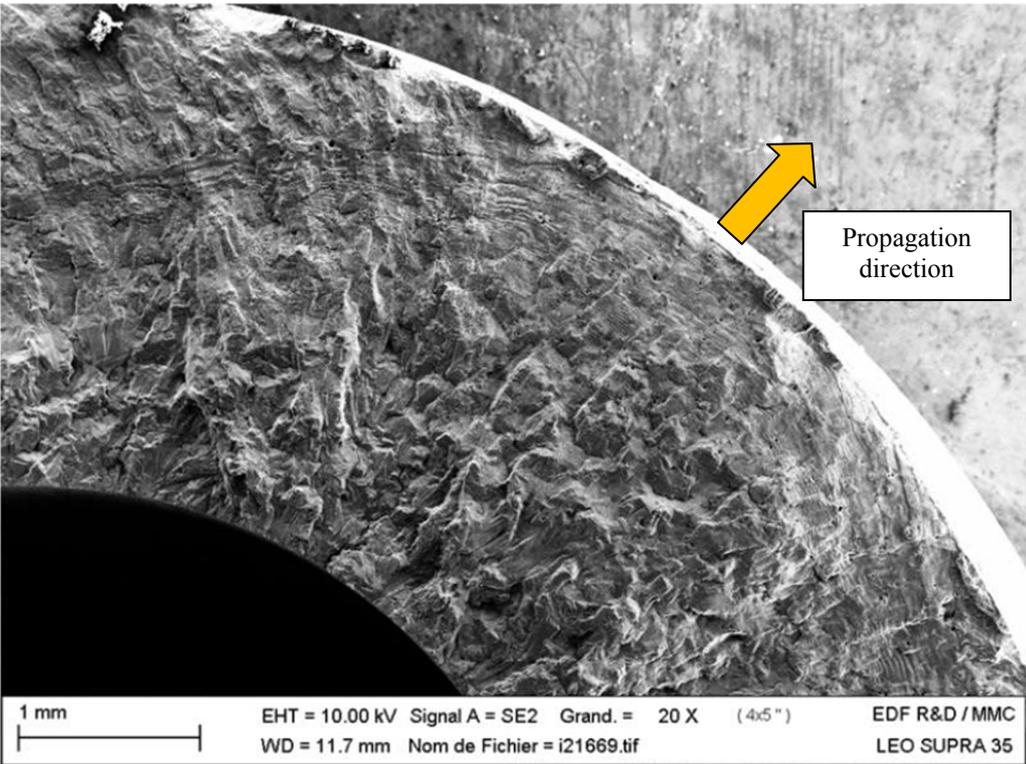
Figure 83 □ Fracture surface of 1630 MHI 01, $\Delta\epsilon_t/2=0.5\%$, $\Delta\epsilon_t/dt=0.4\%/s$, as-received, PWR primary water at 300°C , general view.
