Effets d'environnement sur la fatigue de l'acier inoxydable 304L en milieu primaire REP sous chargement cyclique

THESE

*Environmental effect on cracking of a 304L austenitic
stainless steel in PWR primary environment under cyclic
loading*

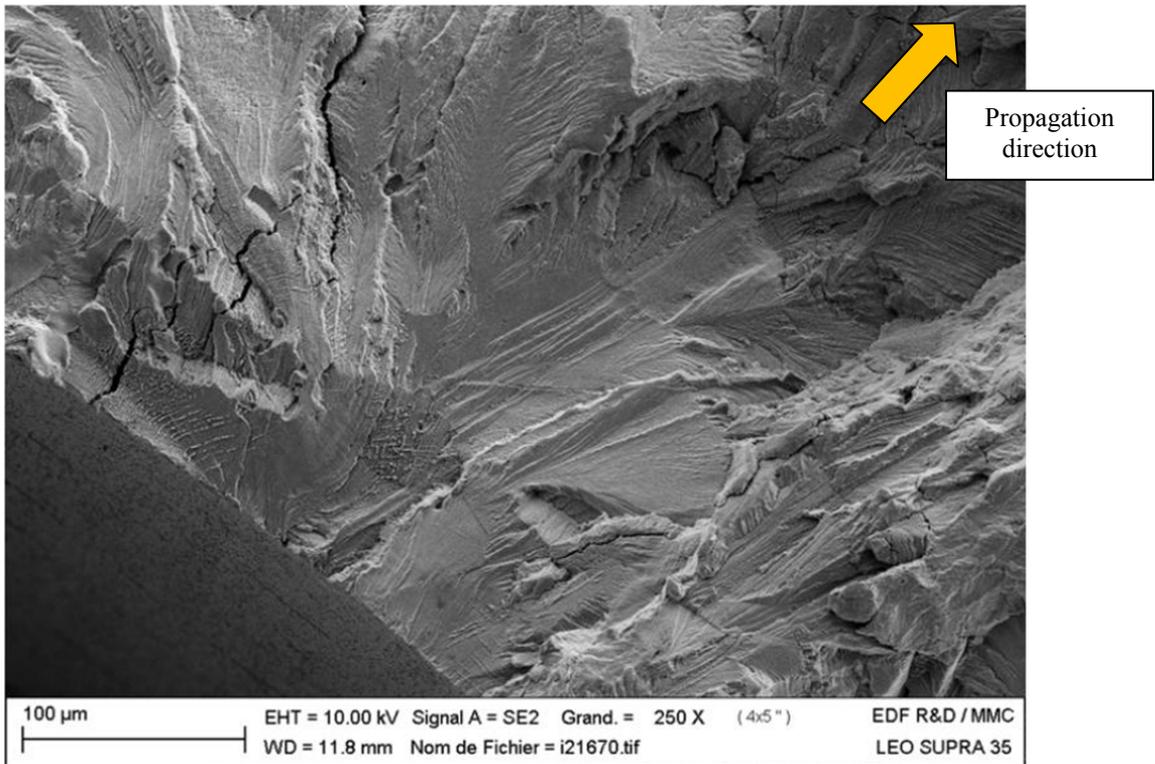
Figure 84 □ Fracture surface of 1630 MHI 01, $\Delta\epsilon_t/2=0.5\%$, $\Delta\epsilon_t/dt=0.4\%/s$, as-received, PWR primary water at 300°C, initiation area.

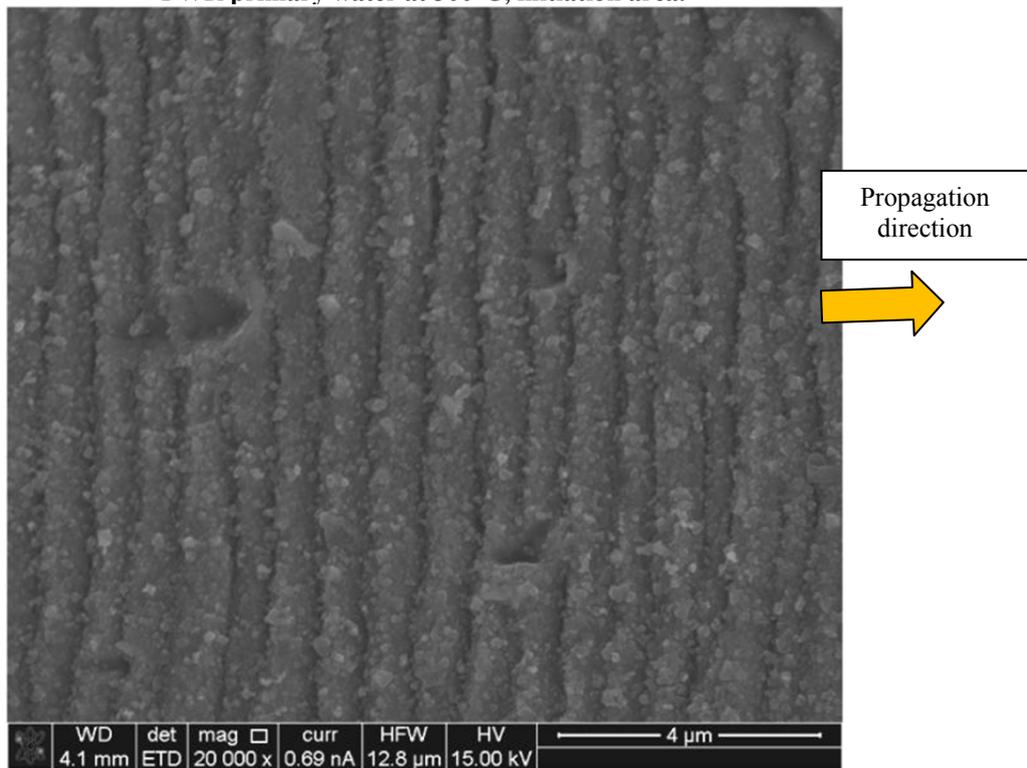
Figure 85 □ Fracture surface of 1630 MHI 01, $\Delta\epsilon_t/2=0.5\%$, $\Delta\epsilon_t/dt=0.4\%/s$, as-received, PWR primary water at 300°C, 500μm from initiation area.

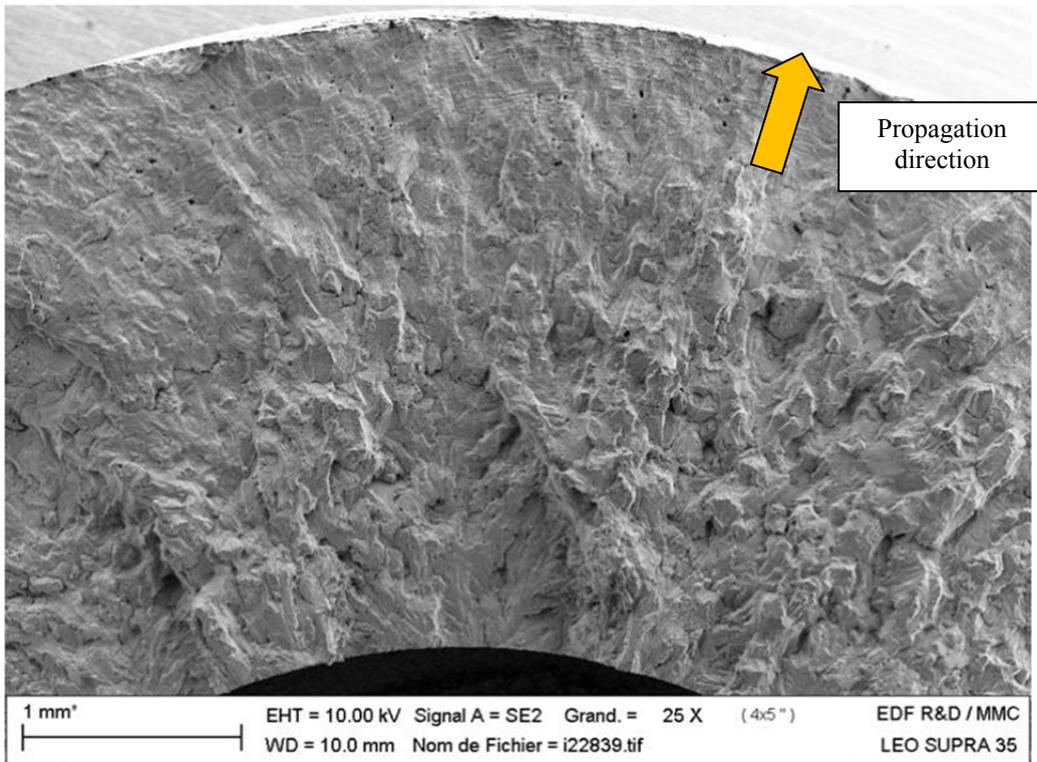
Figure 86 □ Fracture surface of 1630 MHI 04, $\Delta\epsilon_t/2=0.5\%$, $\Delta\epsilon_t/dt=0.004\%/s$, as-received, PWR primary water at 300°C, general view.

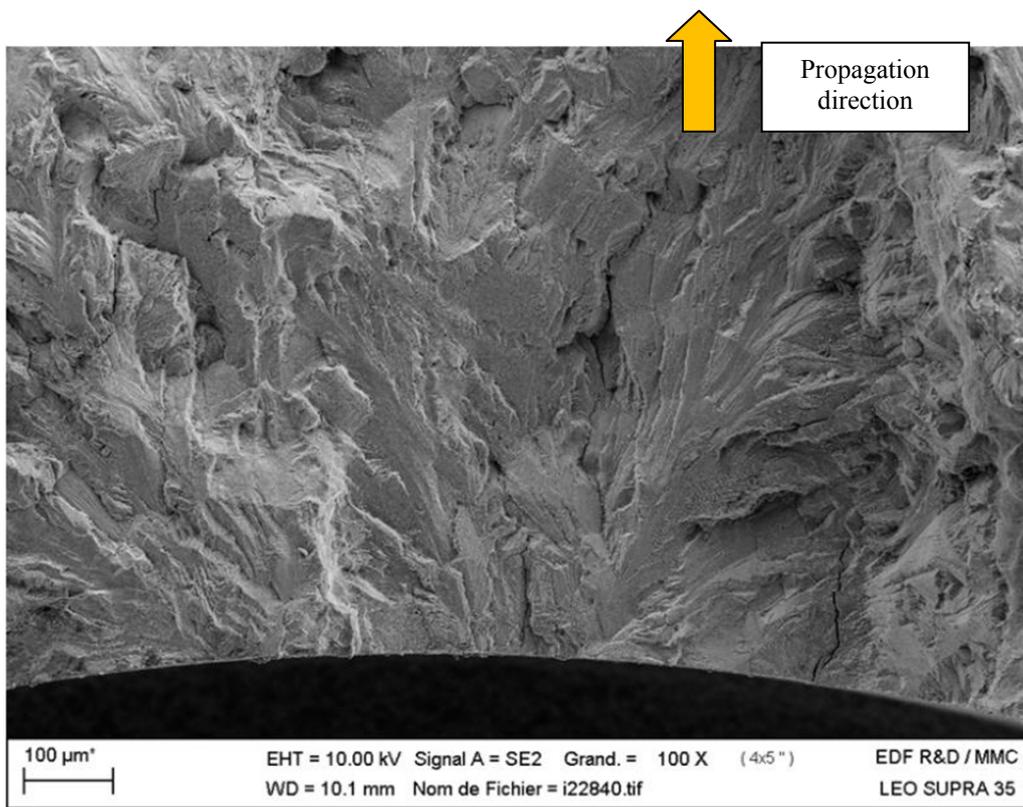
Figure 87 □ Fracture surface of 1630 MHI 04, $\Delta\epsilon_t/2=0.5\%$, $\Delta\epsilon_t/dt=0.004\%/s$, as-received, PWR primary water at 300°C, initiation area.

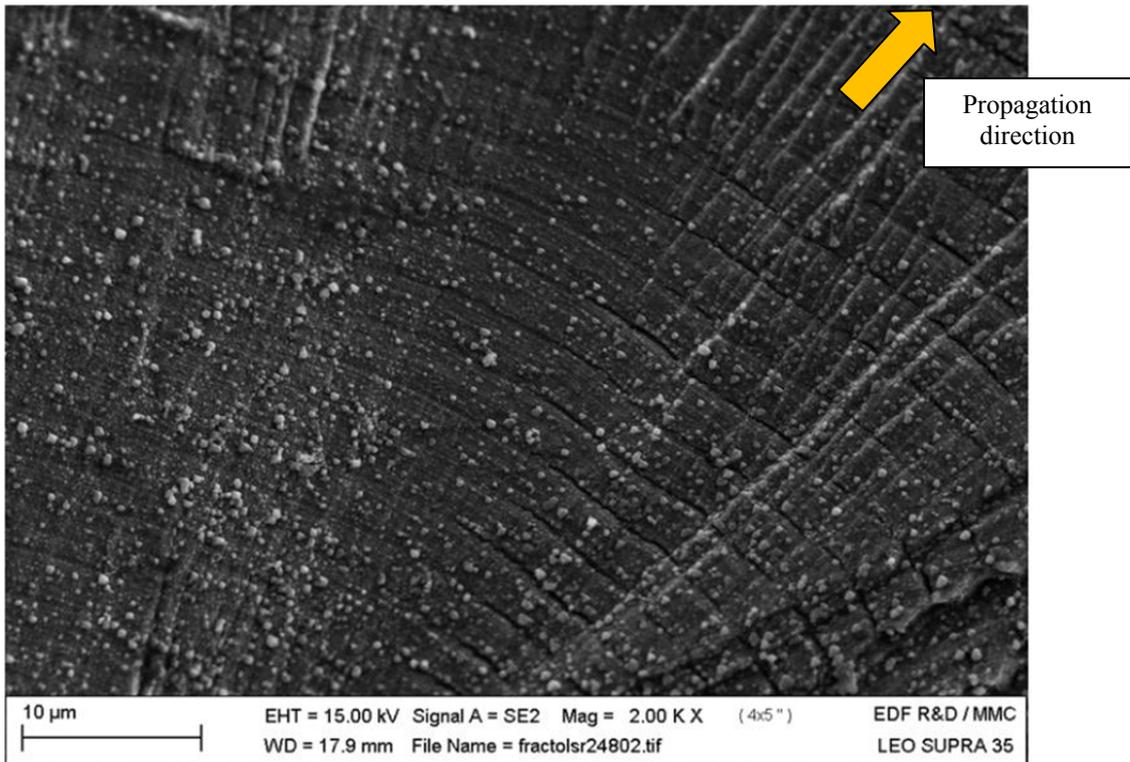
Figure 88 □ Fracture surface of 1630 MHI 04, $\Delta\epsilon_t/2=0.5\%$, $\Delta\epsilon_t/dt=0.004\%/s$, as-received, PWR primary water at 300°C, 500μm from initiation area.

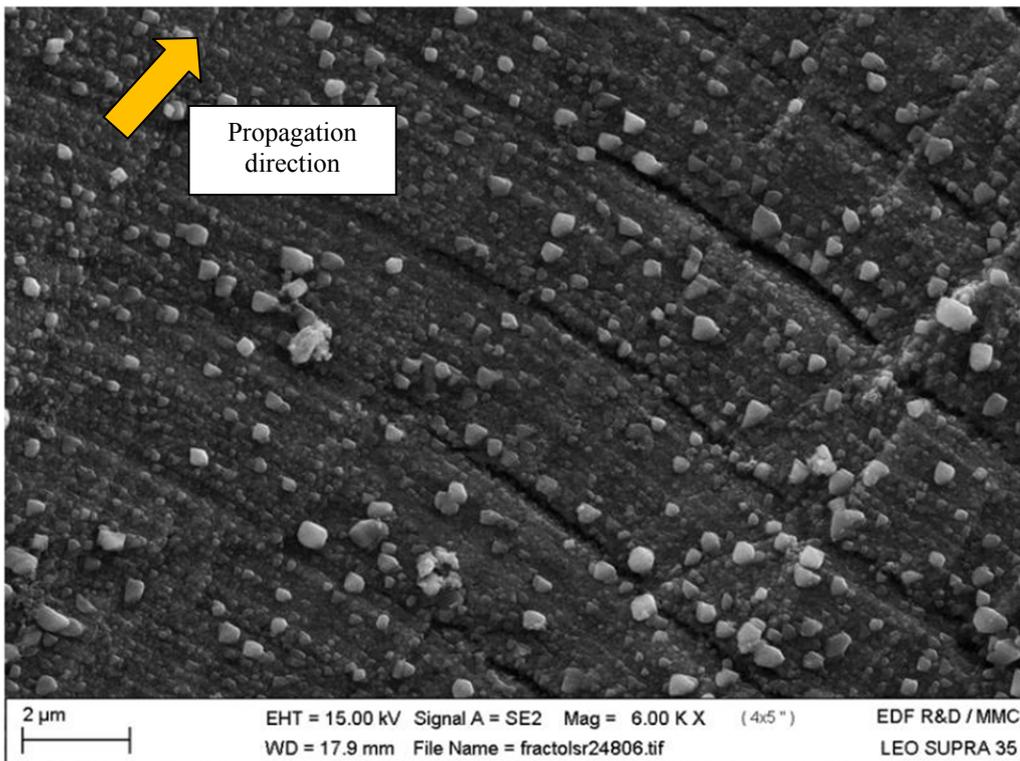
Figure 89 □ Fracture surface of 1630 MHI 04 focusing on sub striations, $\Delta\epsilon_t/2=0.5\%$, $\Delta\epsilon_t/dt=0.004\%/s$, as-received, PWR primary water at 300°C, 500μm from initiation area.

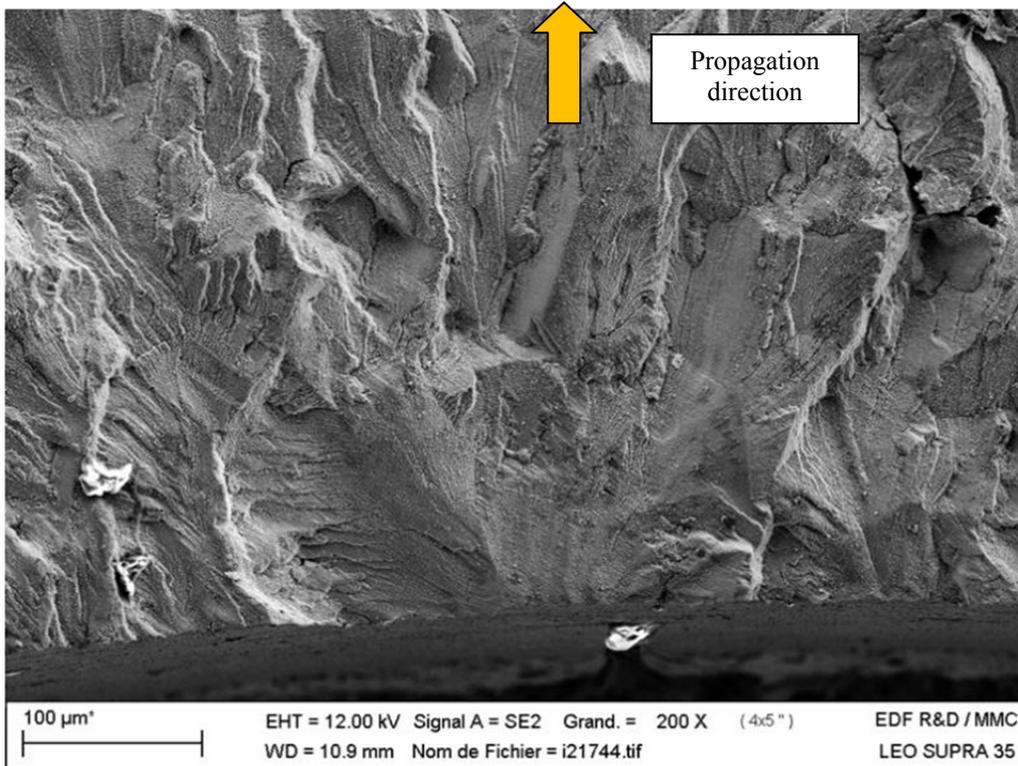
Figure 90 □ Fracture surface of 1630 MHI 03, $\Delta\epsilon/2=0.5\%$, $\Delta\epsilon_t/dt=0.004\%/s$, 10% Tension, PWR primary water at 300°C, initiation area.

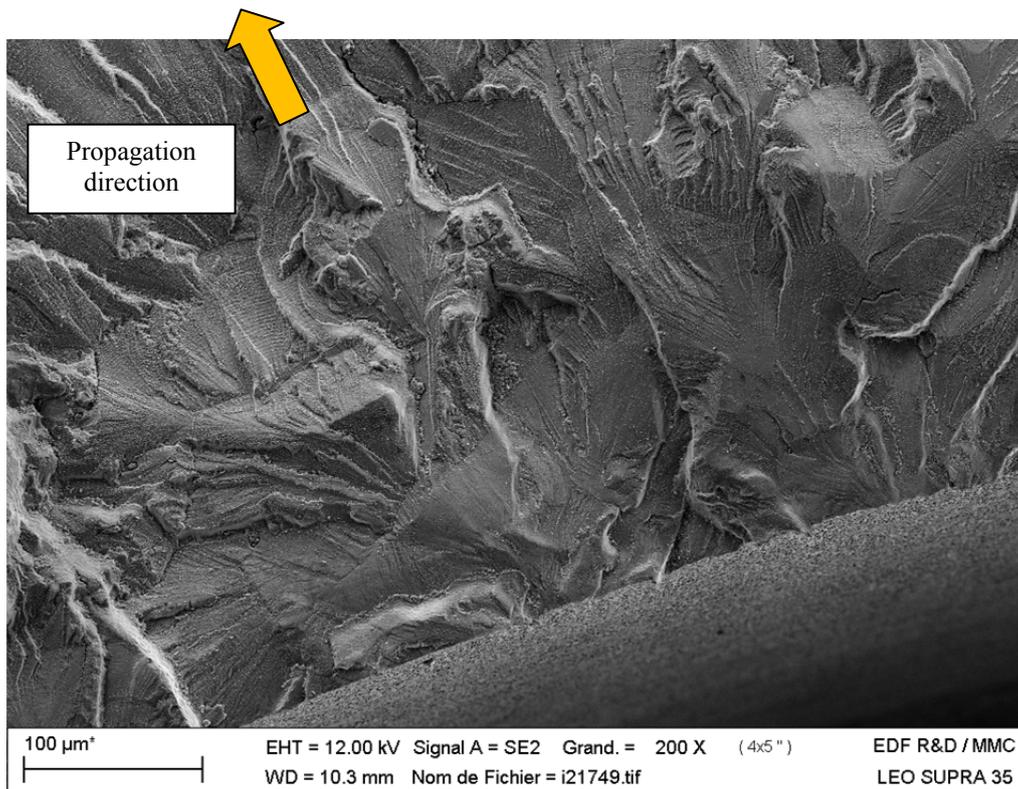
Figure 91 □ Fracture surface of 1630 MHI 14, $\Delta\epsilon/2=0.5\%$, $\Delta\epsilon_t/dt=0.004\%/s$, 10% Rolled, PWR primary water at 300°C, initiation area.

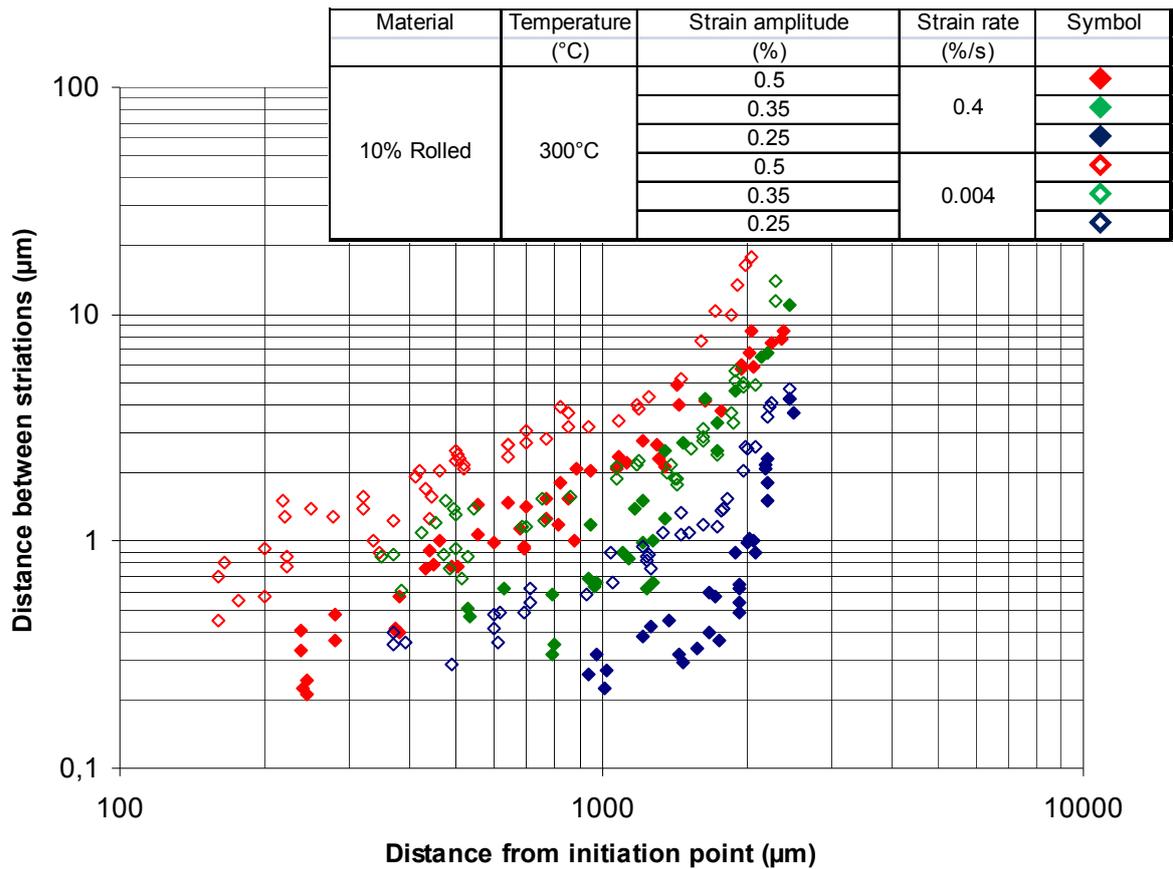
Figure 94 - Effect of strain rate and strain amplitude on crack propagation of 10% rolled material, 300°C, PWR Primary environment.

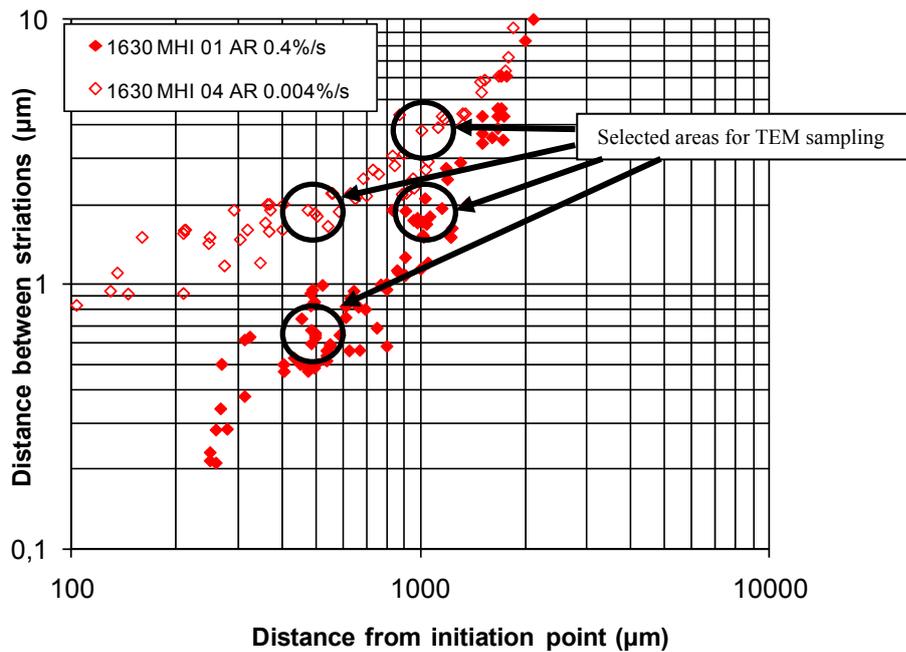
Figure 96 □ Propagation curves of 1630MHI01 and 1630MHI04 ($\Delta\epsilon_t/2=0.5\%$, $\Delta\epsilon_t/dt=0.004\%/s$ and $0.4\%/s$, as-received, PWR primary water at 300°C).

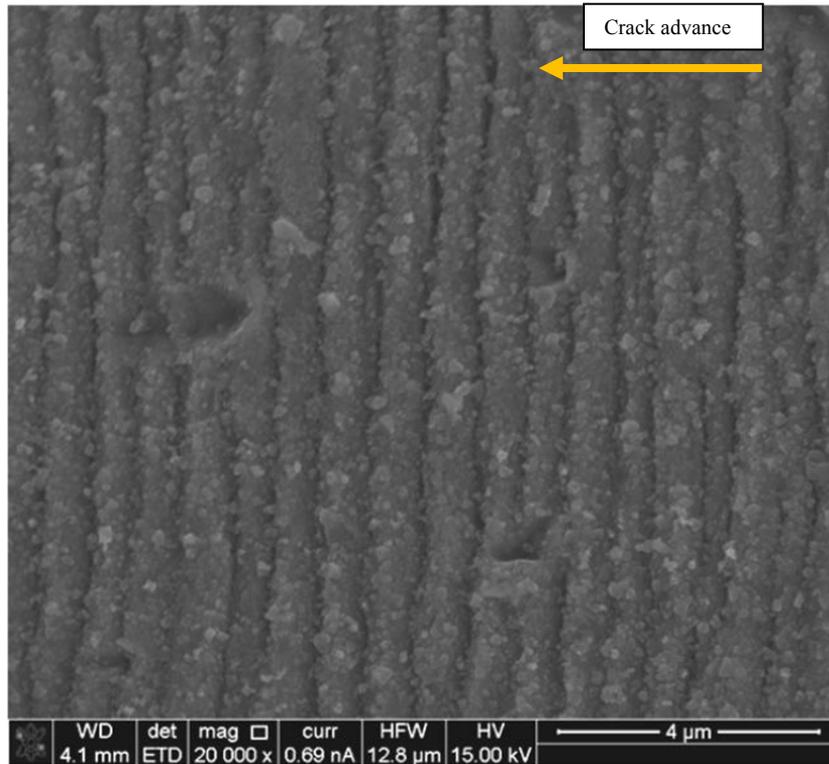
Figure 97 □ Fatigue striations 1630MHI01 $\Delta\epsilon_t/2=0.5\%$, $\Delta\epsilon_t/dt=0.4\%/s$, as-received, PWR primary water, 300°C, 500μm crack depth.

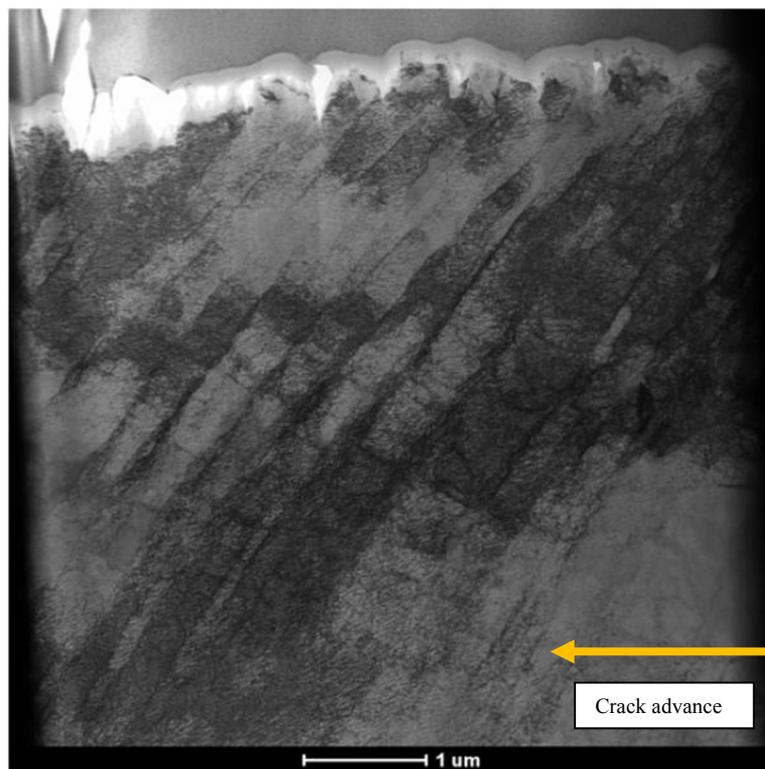
Figure 98 □ Fatigue striations 1630MHI01 $\Delta\epsilon_t/2=0.5\%$, $\Delta\epsilon_t/dt=0.4\%/s$, as-received, PWR primary water, 300°C, 500μm crack depth, STEM.

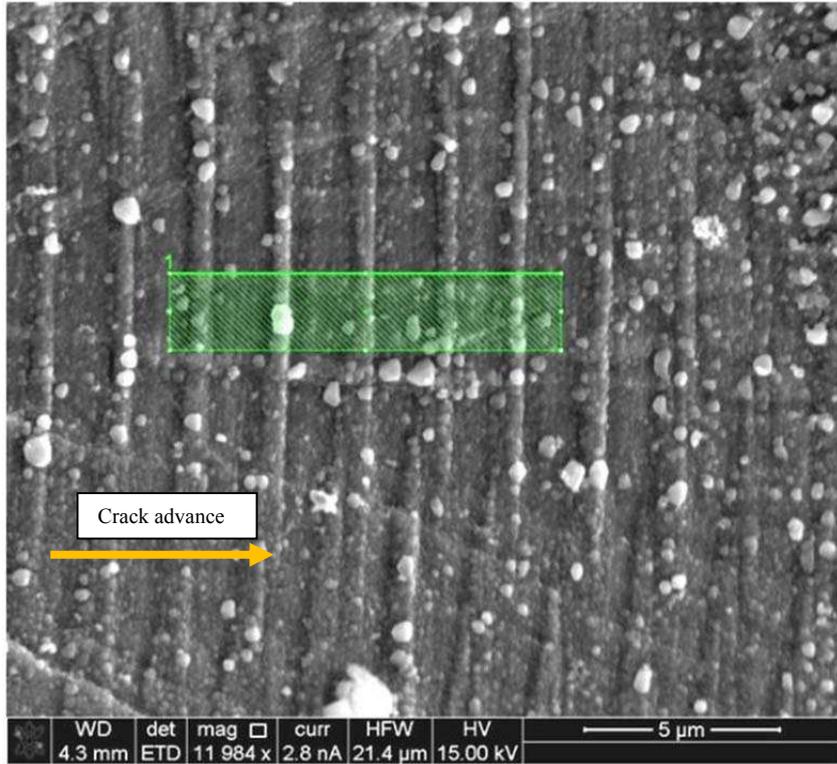
Figure 99 □ Fatigue striations 1630MHI04 $\Delta\epsilon_t/2=0.5\%$, $\Delta\epsilon_t/dt=0.004\%/s$, as-received, PWR primary water, 300°C, 500 μm crack depth.

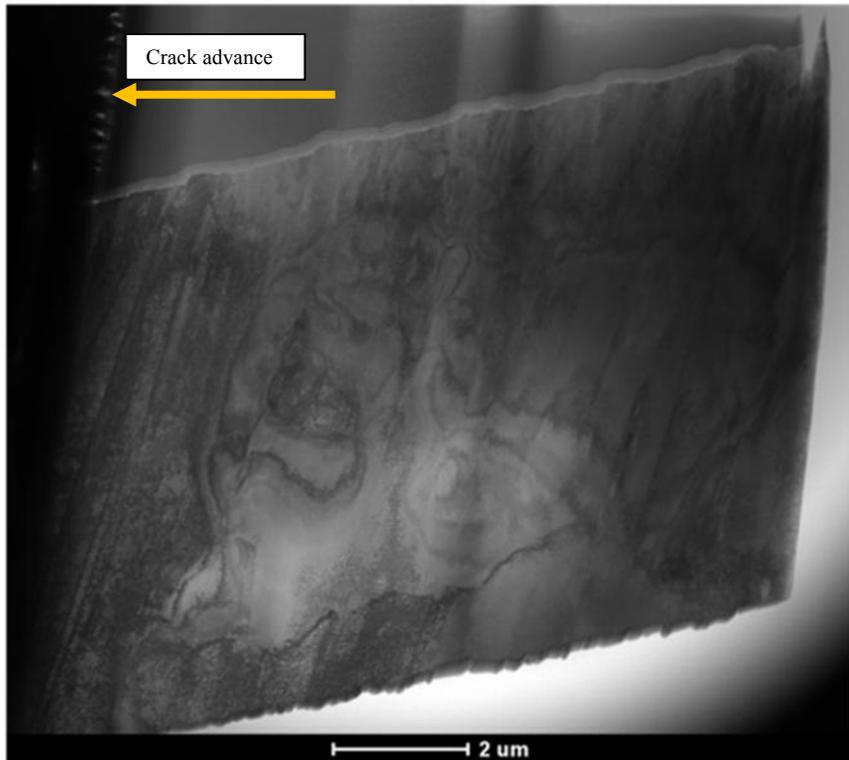
Figure 100 □ Fatigue striations 1630MHI04 $\Delta\epsilon_t/2=0.5\%$, $\Delta\epsilon_t/dt=0.004\%/s$, as-received, PWR primary water, 300°C, 500 μm crack depth, STEM

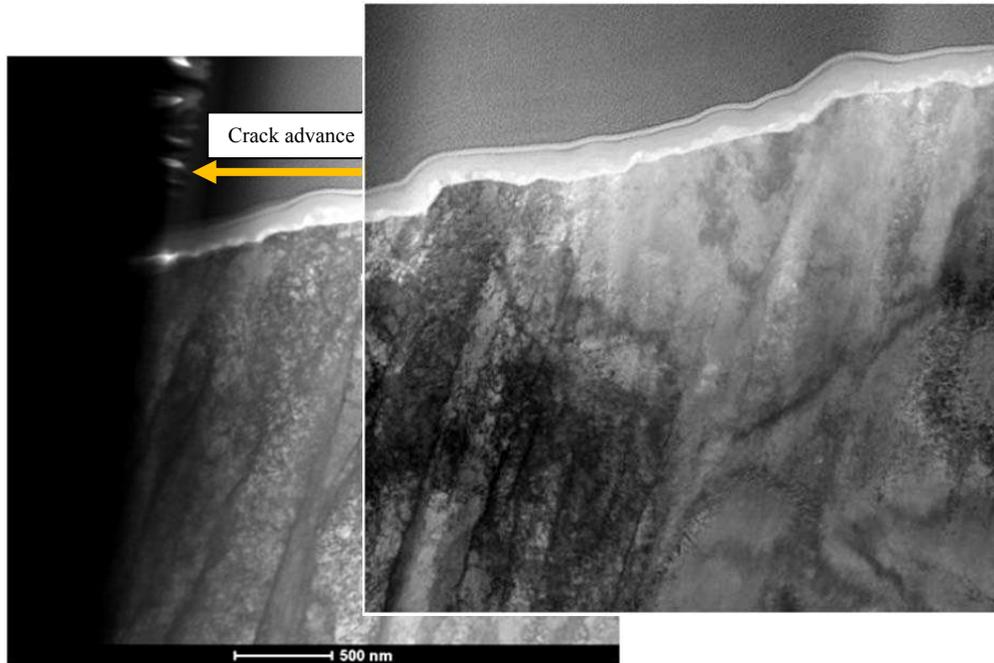
Figure 101 □ Fatigue striations 1630MHI04 $\Delta\epsilon/2=0.5\%$, $\Delta\epsilon/dt=0.004\%/s$, as-received, PWR primary water, 300°C, 500 μm crack depth, STEM, focusing on striations

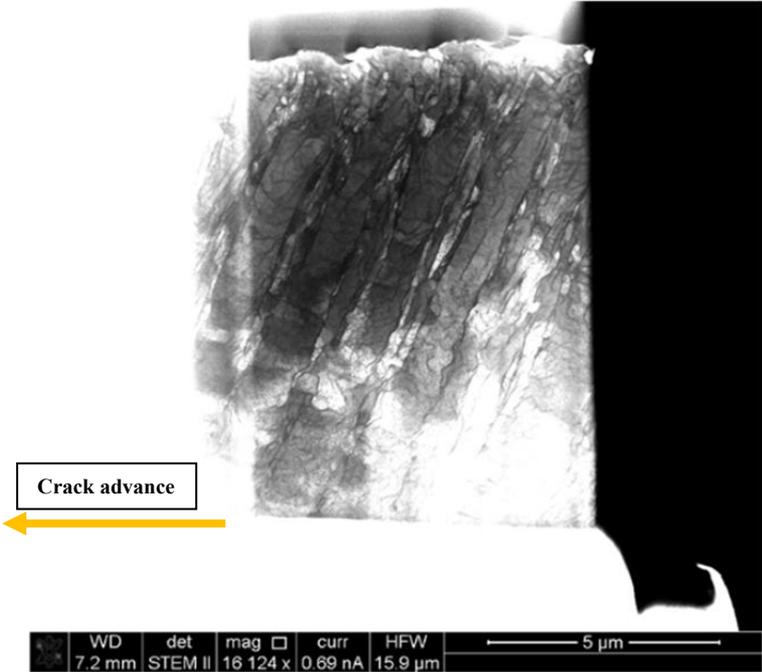
Figure 102 □ Fatigue striations on specimen 1630MHI01 $\Delta\epsilon_t/2=0.5\%$, $\Delta\epsilon_t/dt=0.4\%/s$, as-received, PWR primary water, 300°C, 1 mm crack depth, STEM.

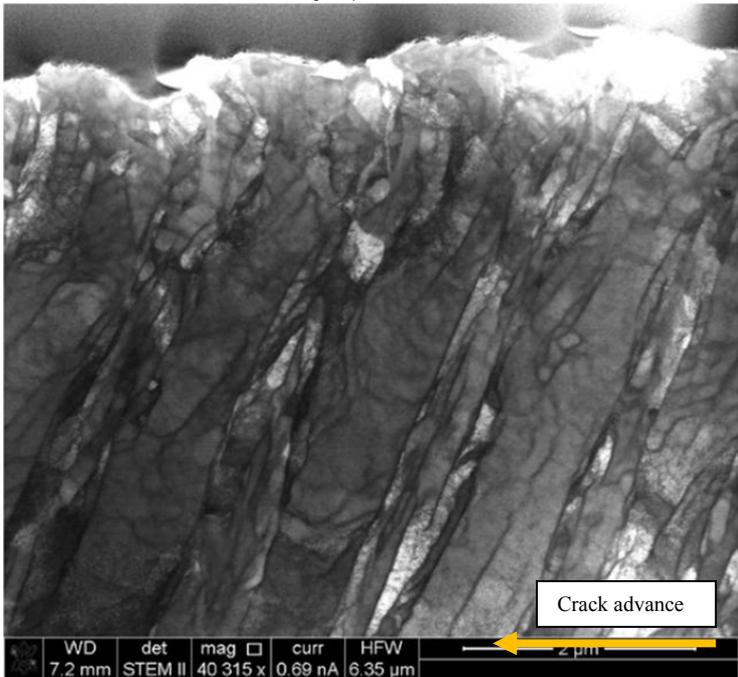
Figure 103 □ Fatigue striations on specimen 1630MHI01 $\Delta\epsilon_t/2=0.5\%$, $\Delta\epsilon_t/dt=0.4\%/s$, as-received 304L, PWR primary water, 300°C, 1 mm crack depth, STEM, focused area.

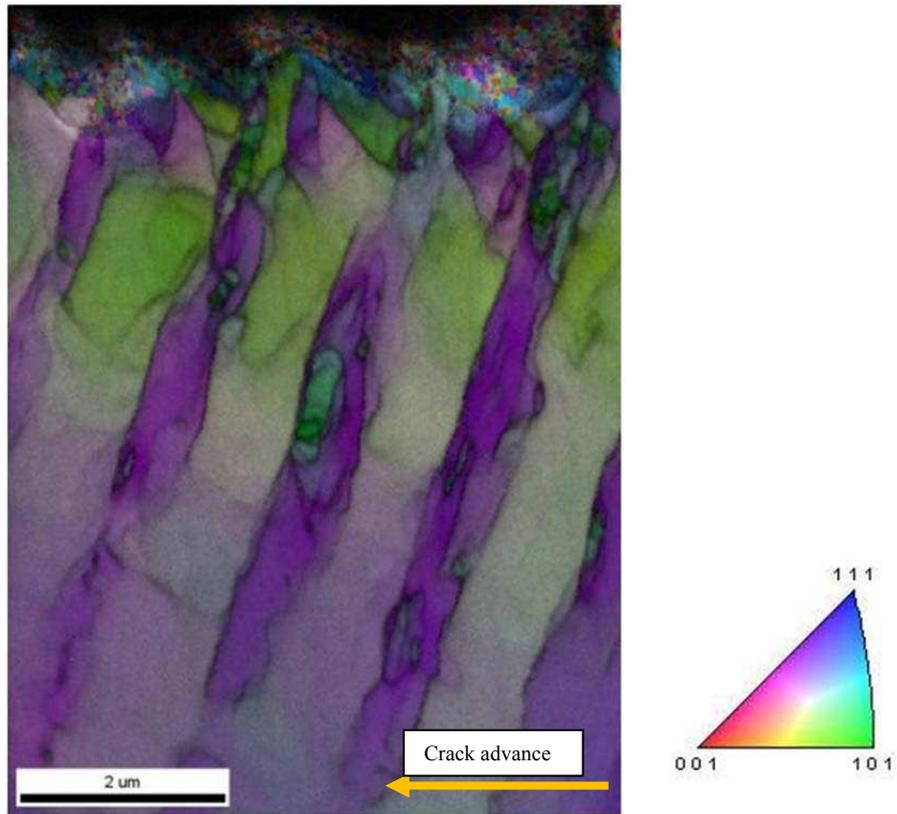
Figure 104 □ Fatigue striations on specimen 1630MHI01 $\Delta\epsilon/2=0.5\%$, $\Delta\epsilon/dt=0.4\%/s$, As-received, PWR primary water, 300°C, 1 mm crack depth, EBSD.

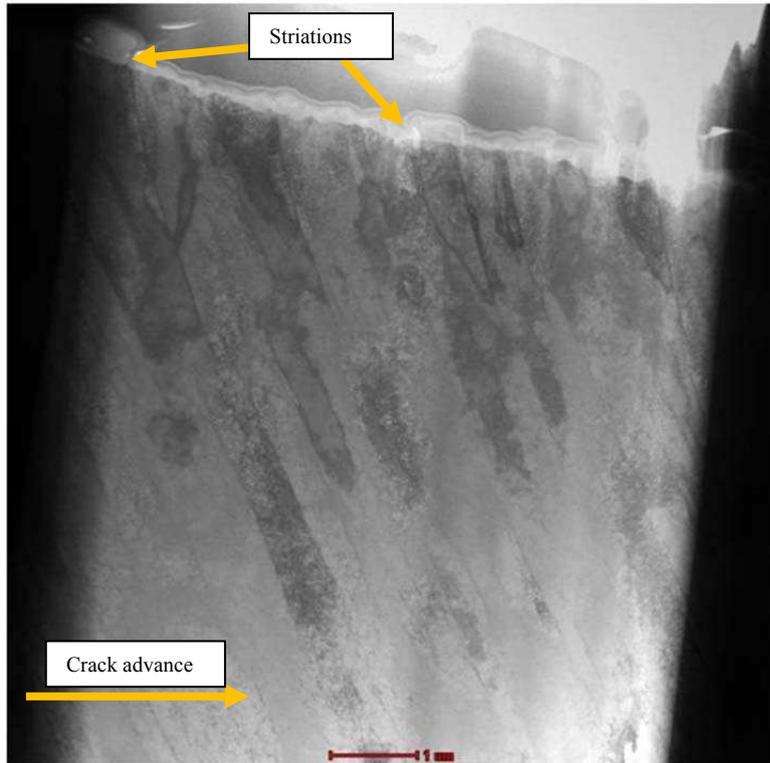
Figure 106 □ Fatigue striations on specimen 1630MHI04 $\Delta\epsilon/2=0.5\%$, $\Delta\epsilon/dt=0.004\%/s$, as-received, PWR primary water, 300°C, 1 mm crack depth, STEM.

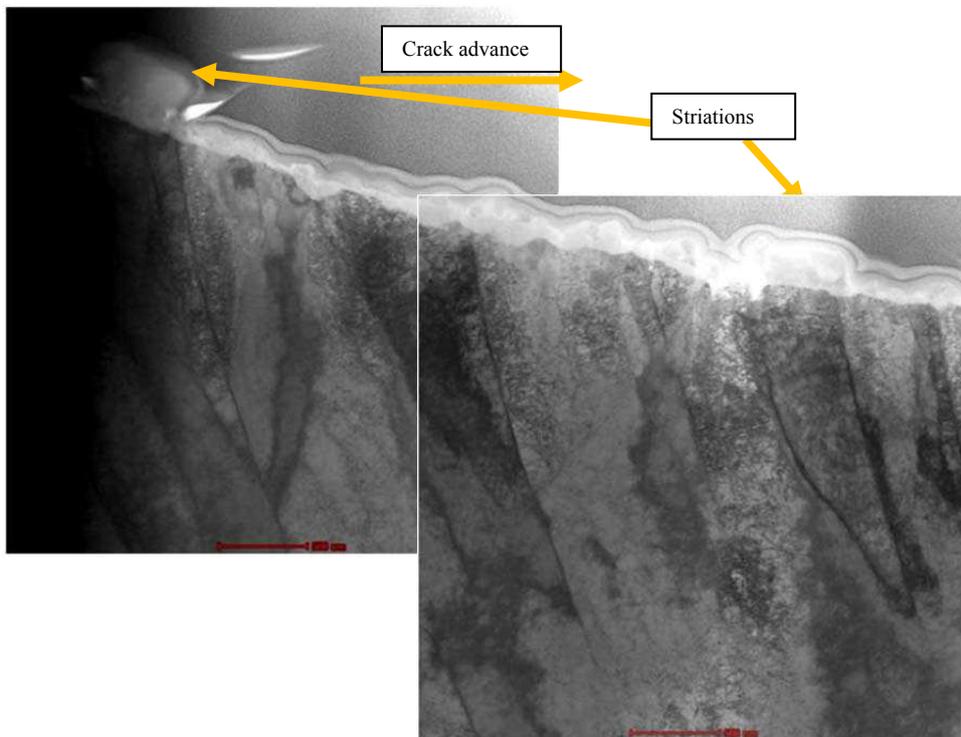
Figure 107 □ Fatigue striations on specimen 1630MHI04, $\Delta\epsilon/2=0.5\%$, $\Delta\epsilon/dt=0.004\%/s$, as-received 304L, PWR primary water, 300°C, 1 mm crack depth, STEM, focused area.

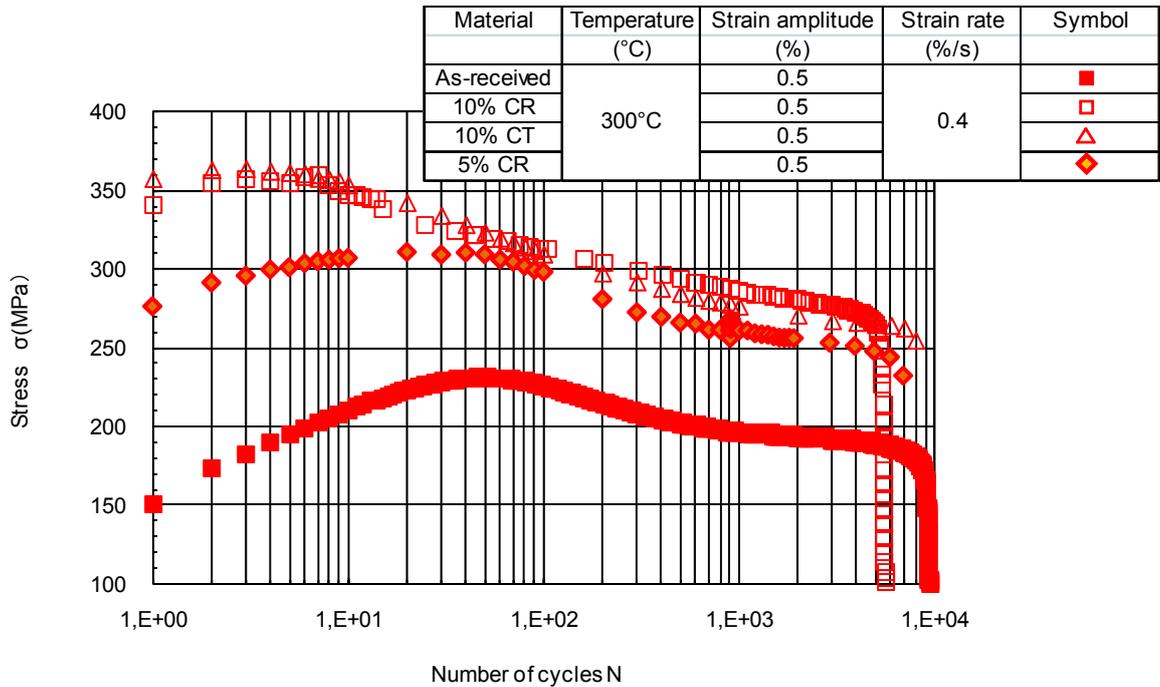
Figure 1 □ Maximum stress evolution during cycling for the 10% CR, 10% CT, 5% CR and as-received material at a total strain amplitude of 0.5%.

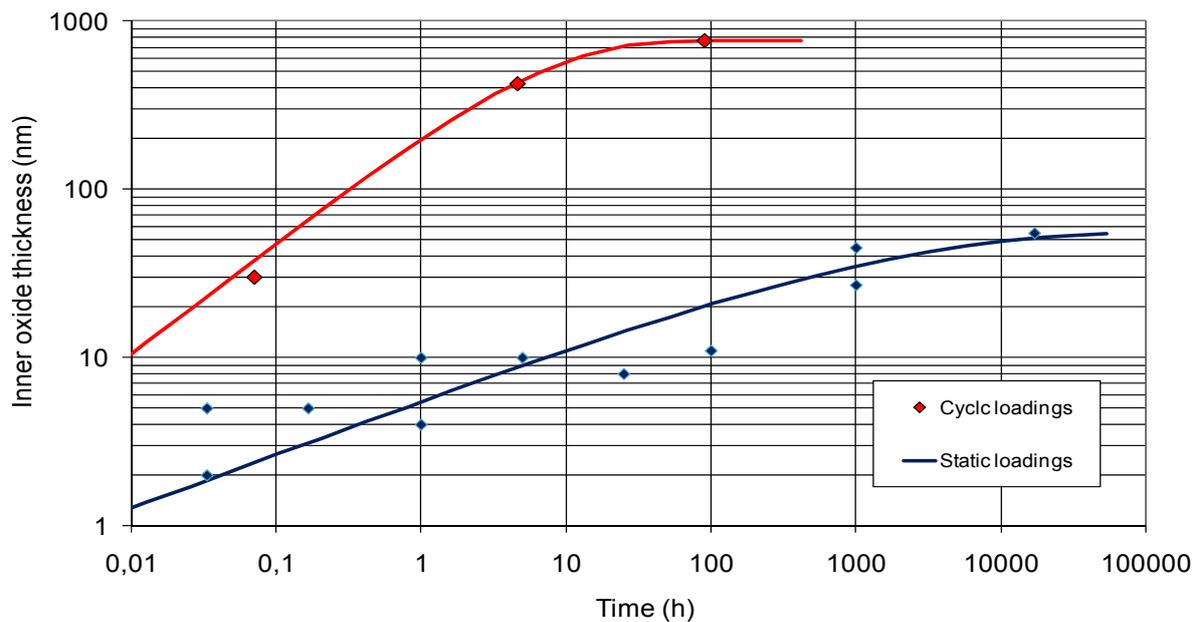
Figure 6 □ Mean inner Cr-rich oxide penetration against time to exposure to primary water. Austenitic stainless steels (304L and 316L) for various static deformation < 30% and in the case of cyclic loading. Saturating law (Evans-type) (red and blue curve) [21]

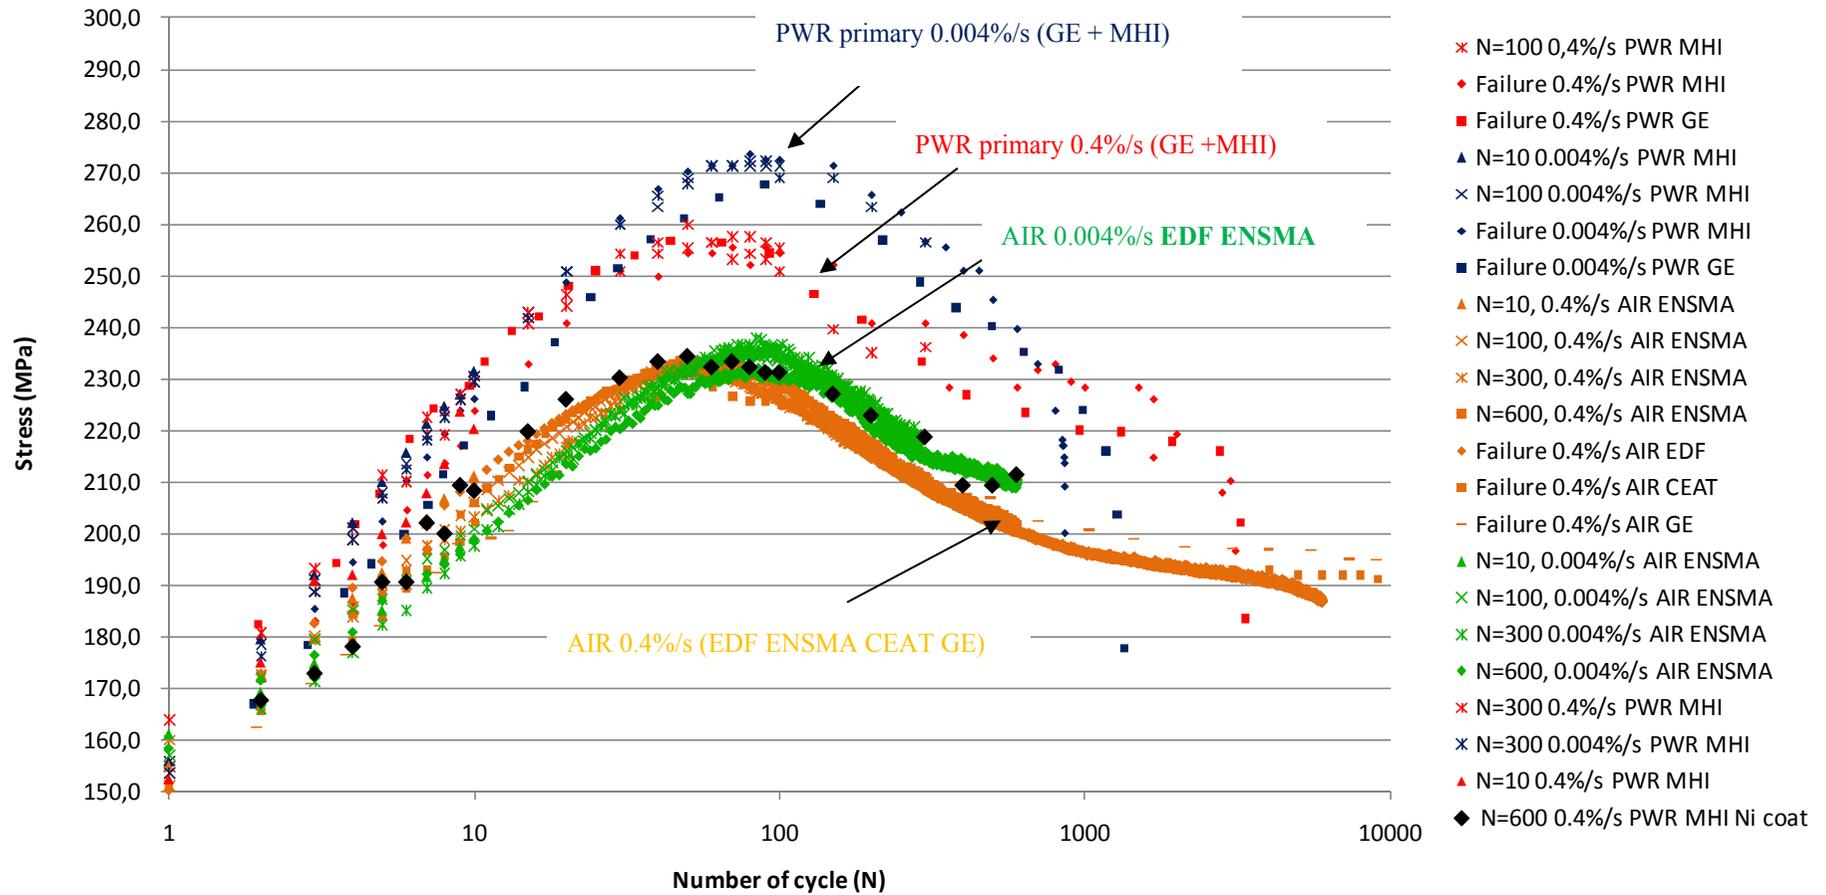
Figure 7 - Evolution of maximum stress as a function of number of cycles, $\Delta\epsilon/2=0.5\%$, 300°C , as-received material.

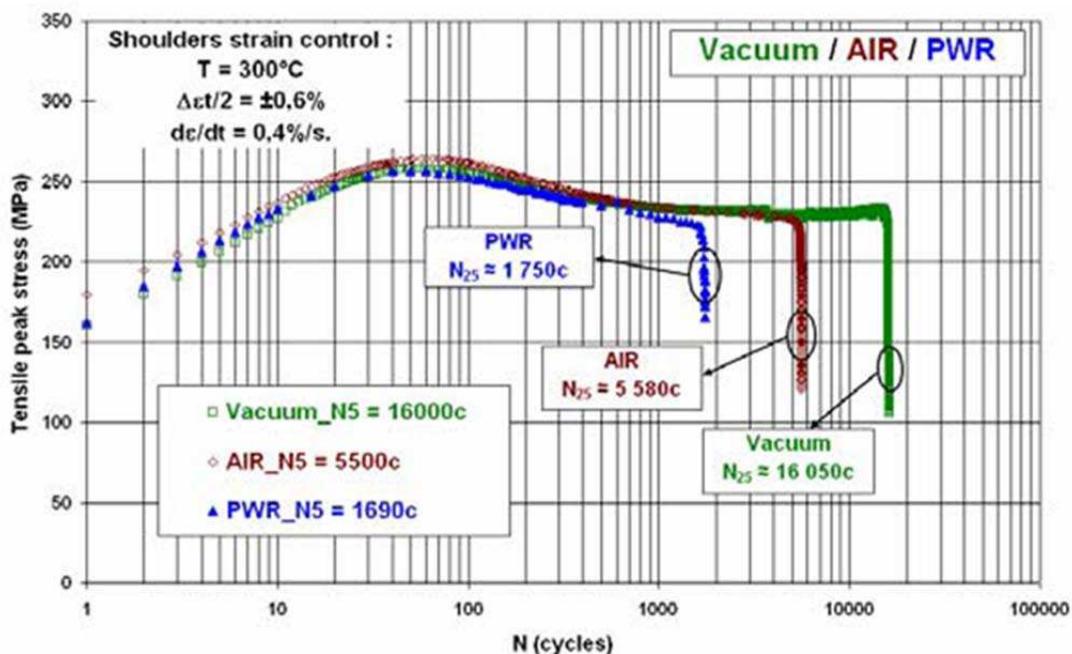
Figure 8 □ Tensile Peak Stress versus cycles for LCF tests conducted at $T = 300^{\circ}\text{C}$, $\Delta\varepsilon_t/dt = 0,4\%/s$ and $\Delta\varepsilon_t/2 = \pm 0.6\%$; Comparison between Vacuum, Air and PWR water [22]

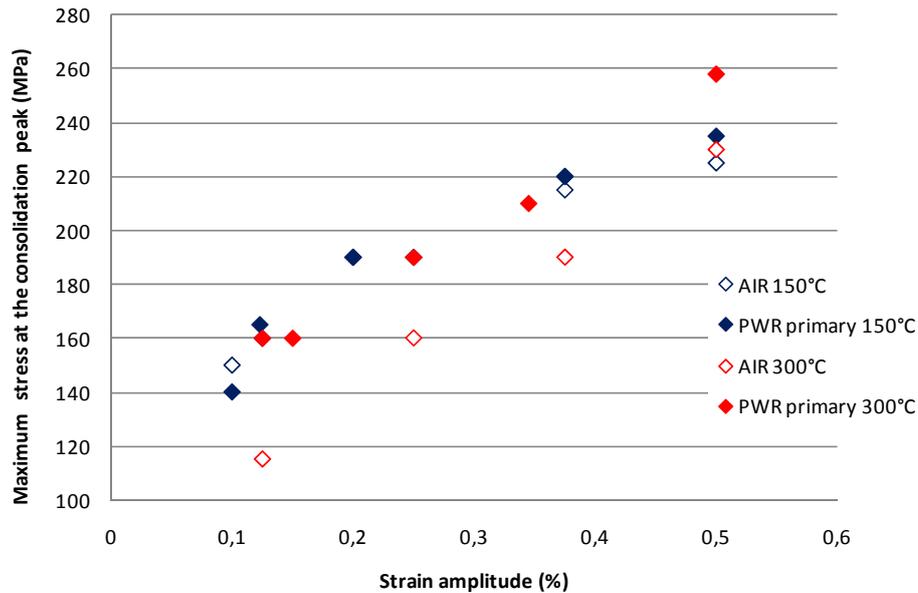
Figure 9 Evolution of the maximum stress reaches at the consolidation peak for different loading strain amplitude at $T = 300^{\circ}\text{C}$ and 150°C , $\Delta\epsilon/\text{dt}$, Comparison between air and PWR primary environment

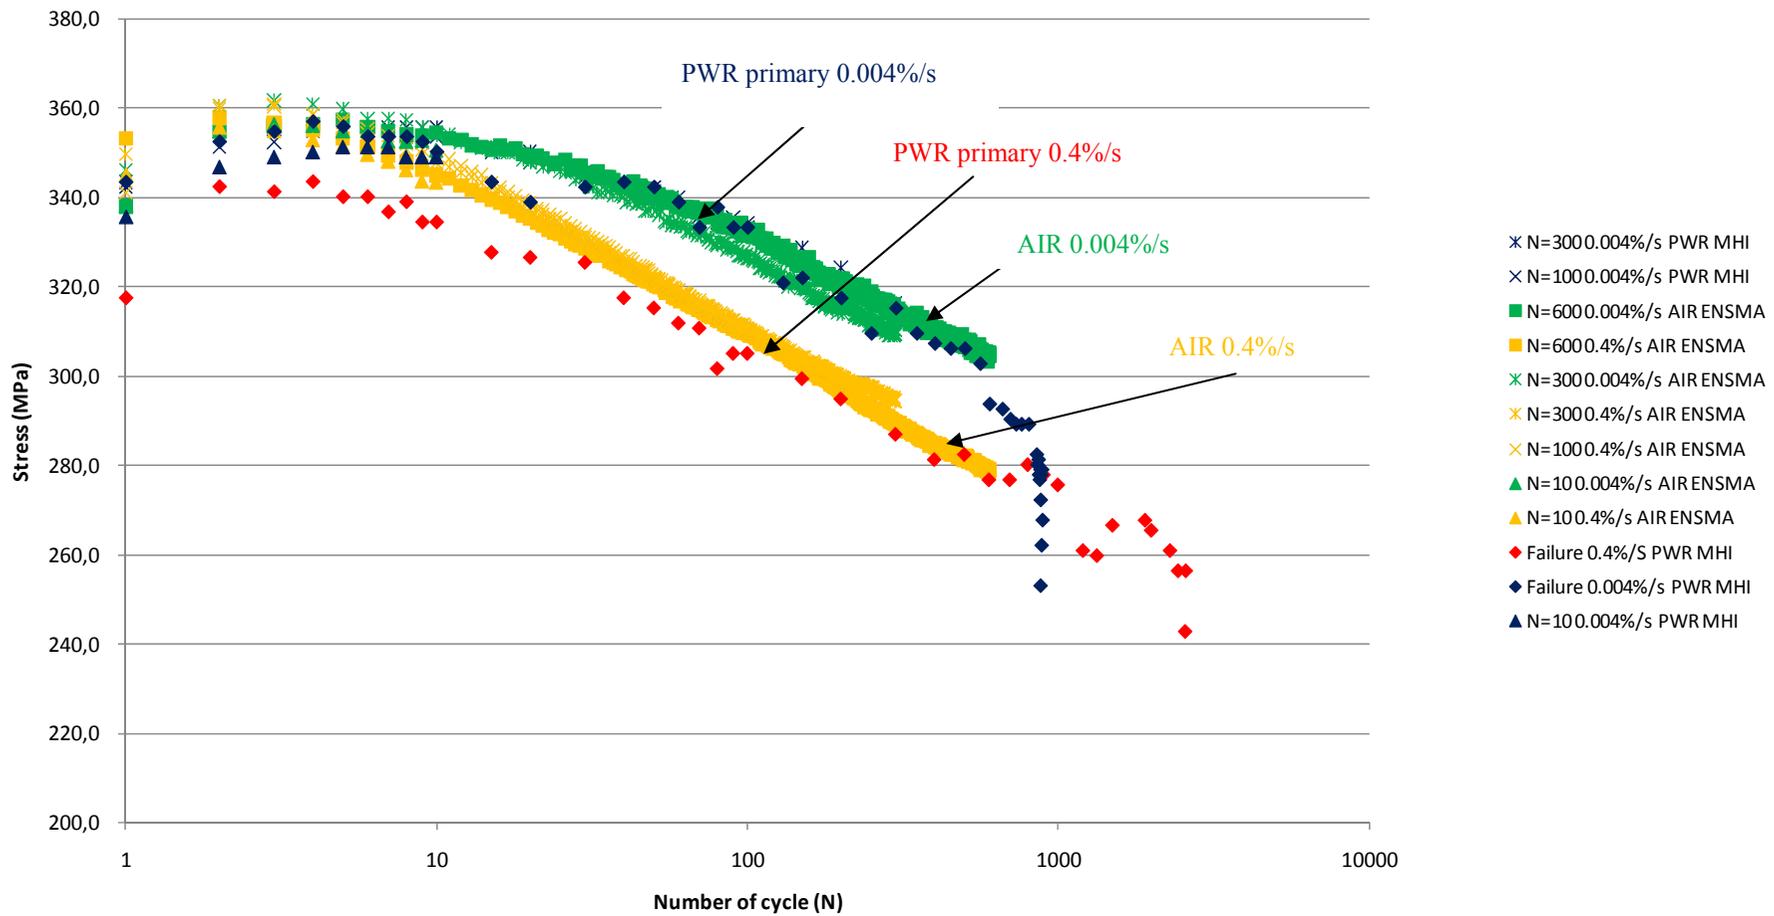
Figure 10 - Evolution of maximum stress as a function of number of cycles, $\Delta\epsilon/2=0.5\%$, 300°C , 10% rolled material.
