Effets d'environnement sur la fatigue de l'acier inoxydable 304L en milieu primaire REP sous chargement cyclique

THESE

*Environmental effect on cracking of a 304L austenitic
stainless steel in PWR primary environment under cyclic
loading*

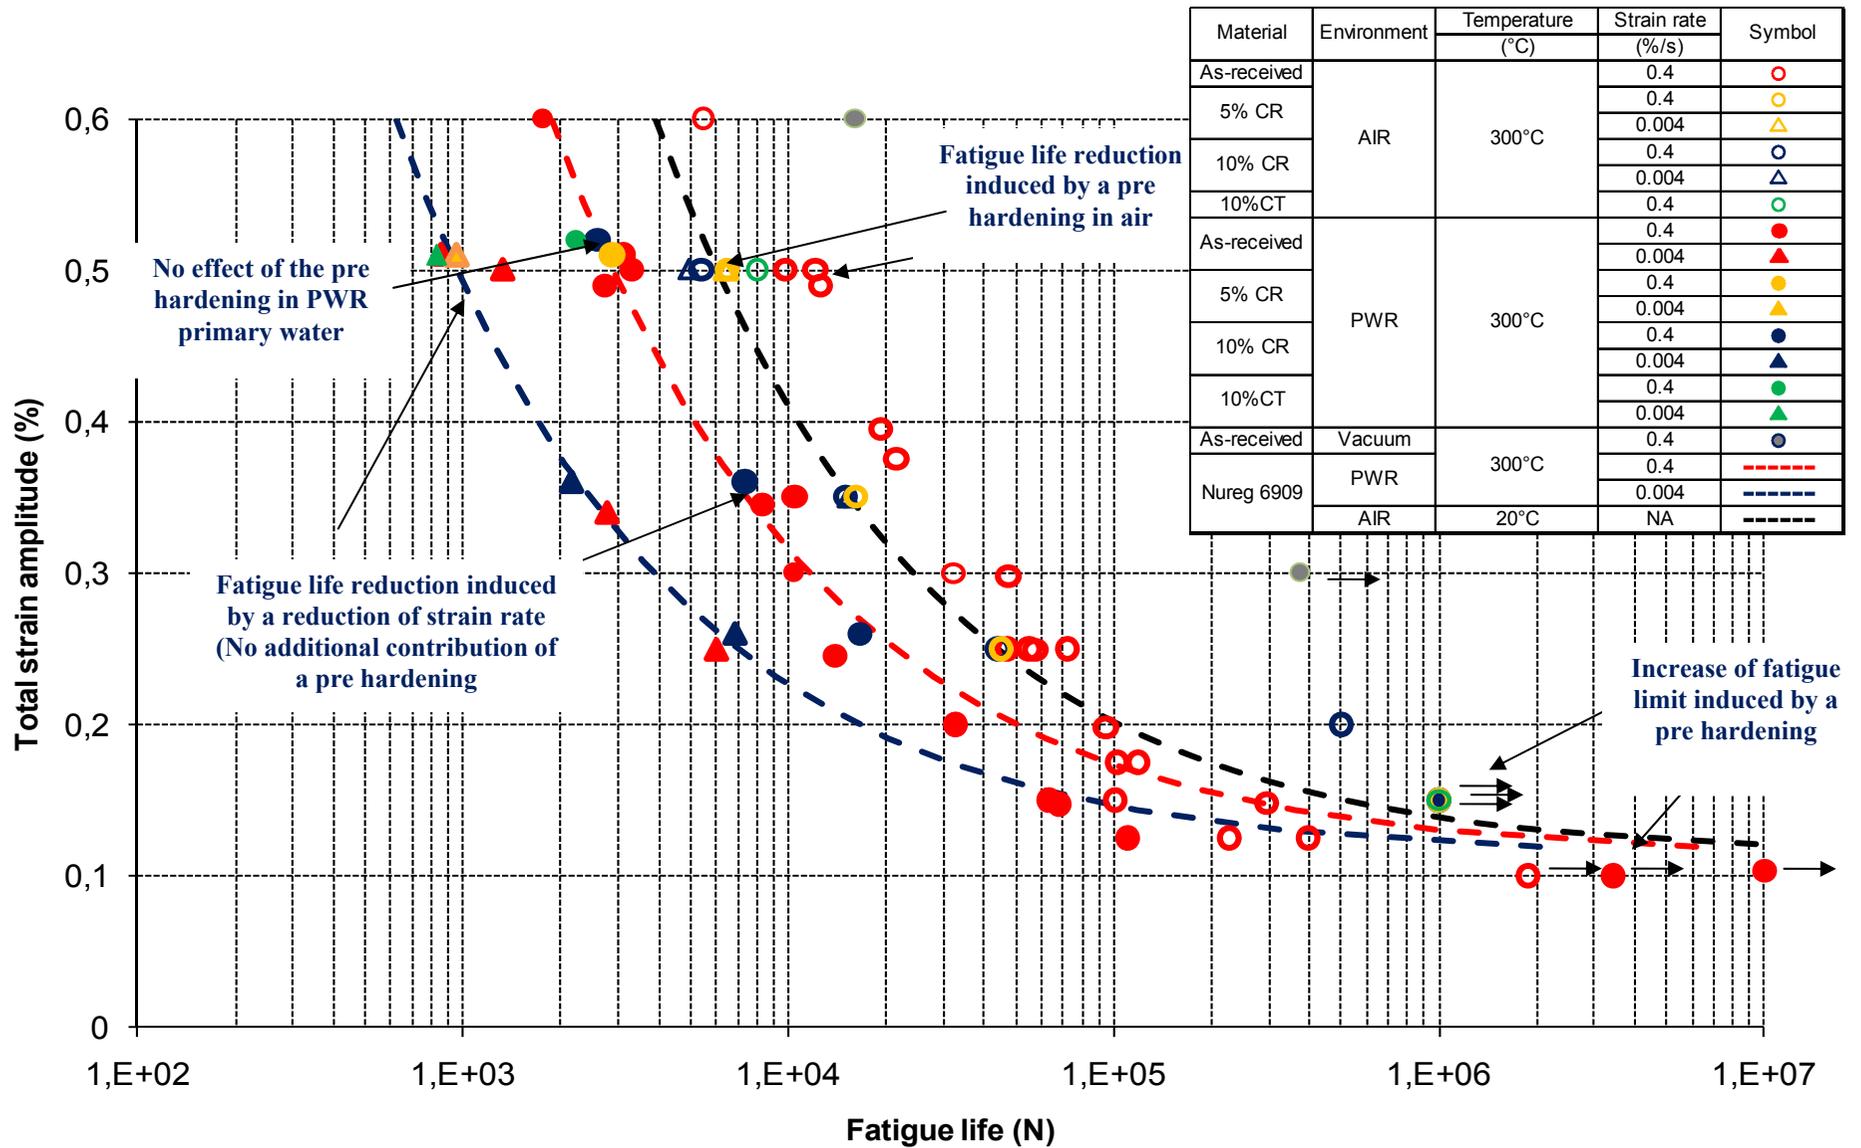
Figure 11 - Total amplitude vs. fatigue life data for XY182 at 300°C in simulated PWR water.

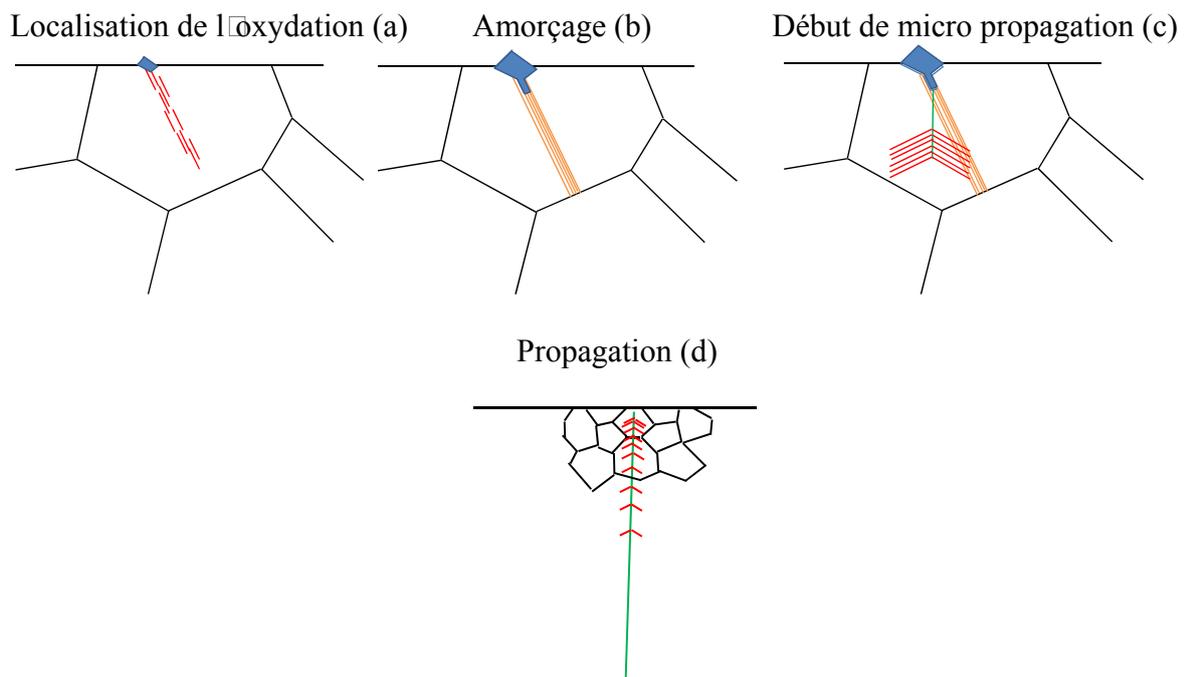
Figure 2 - Fatigue life description

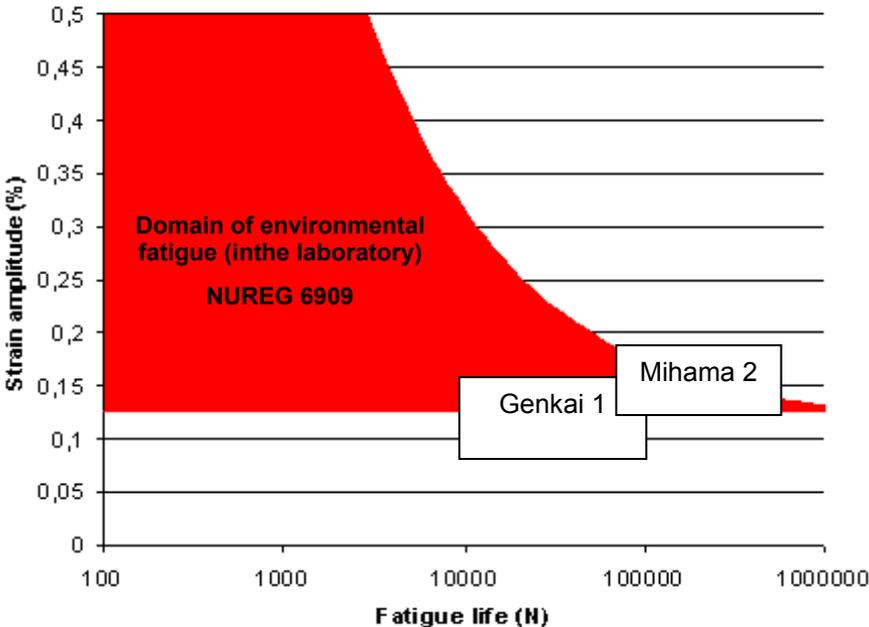
Figure 14 □ Field experience compared to the NUREG 6909.

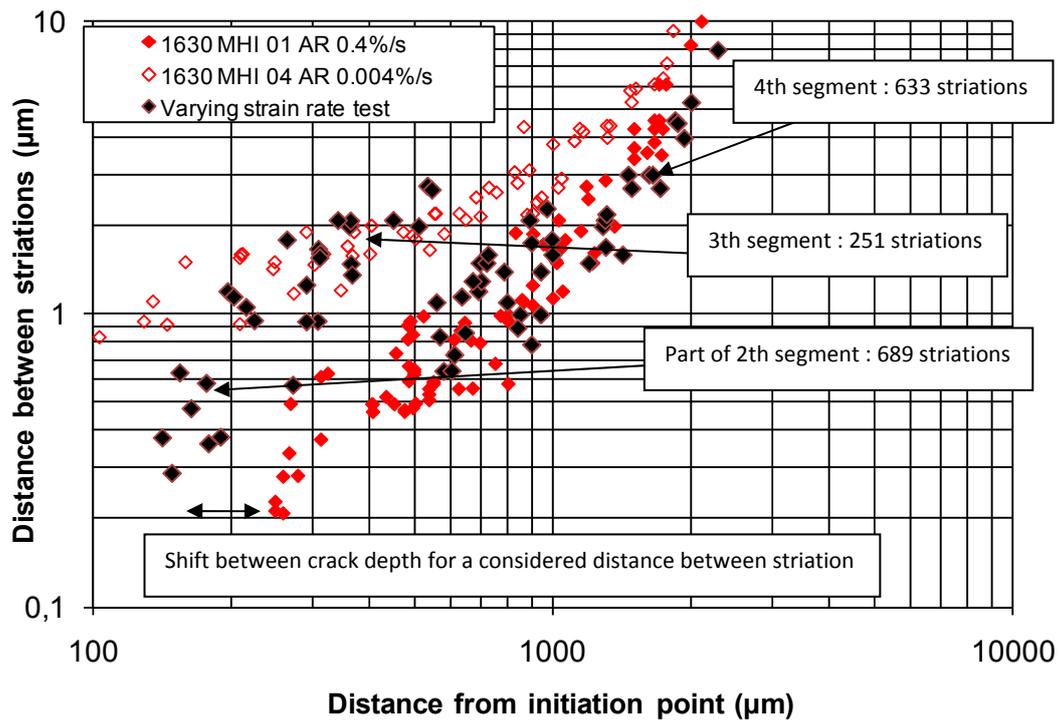
Figure 9 □ Effect of a varying strain rate test conditions on crack growth rate behavior, As-received conditions, 300°C, PWR primary environment.

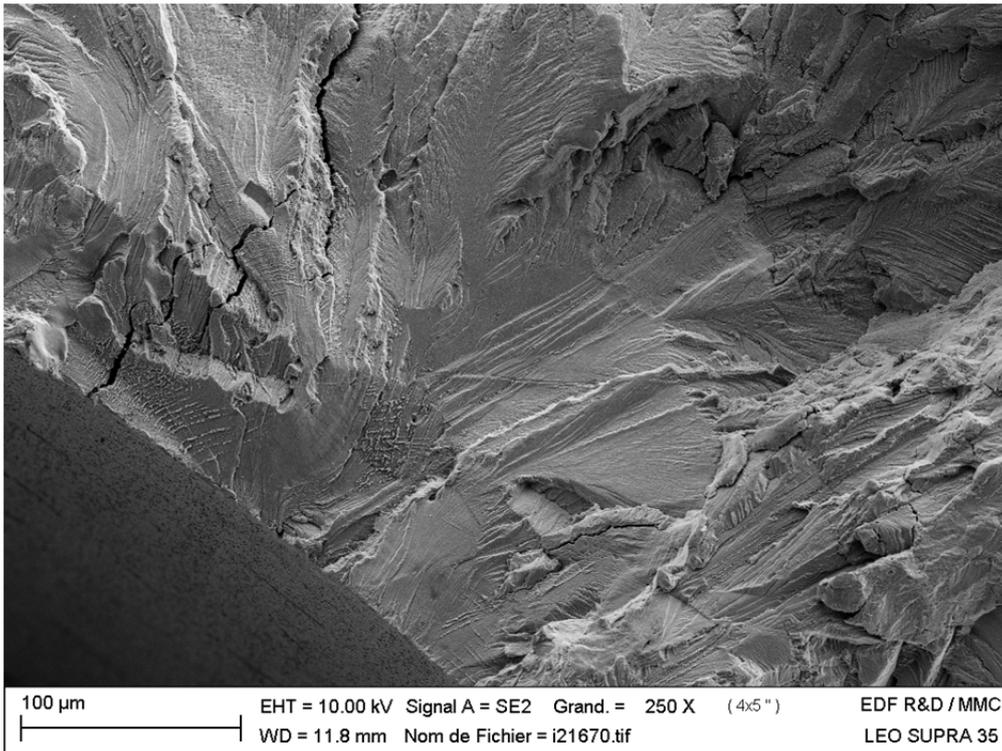
Figure 22 □ Fracture surface of 1630 MHI 01, $\Delta\epsilon/2=0.5\%$, $0.4\%/s$, as-recieved, PWR primary water at 300°C , initiation site.

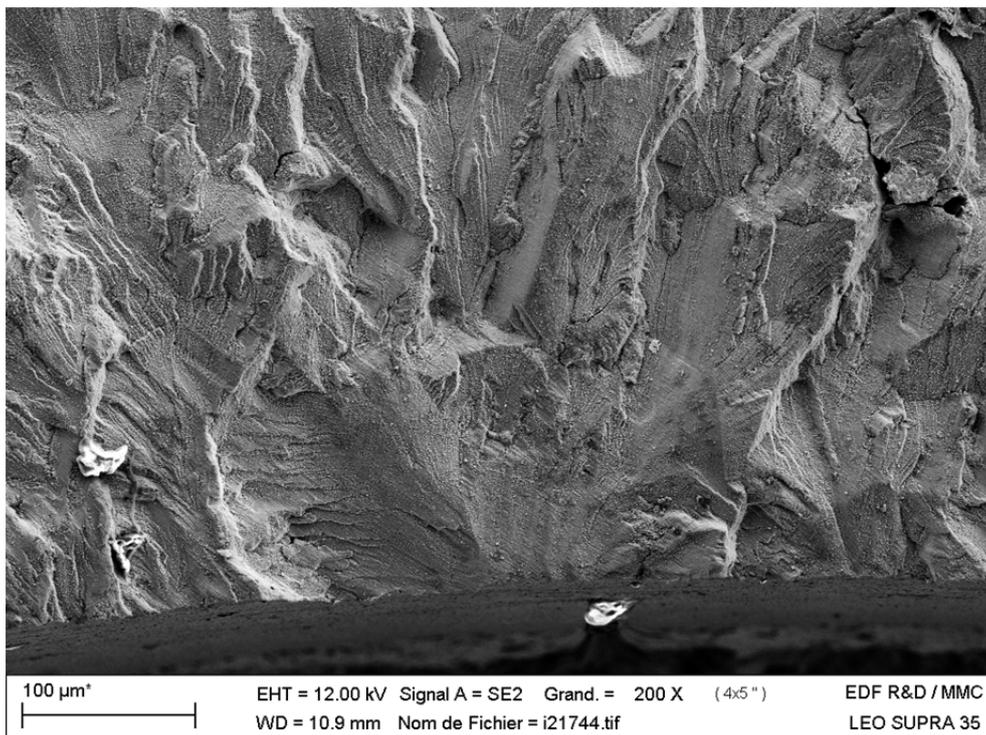
Figure 23 □ Fracture surface of 1630 MHI 03, $\Delta\epsilon/2=0.5\%$, $0.004\%/s$, 10% prior tensile strain, PWR primary water at 300°C , initiation site.

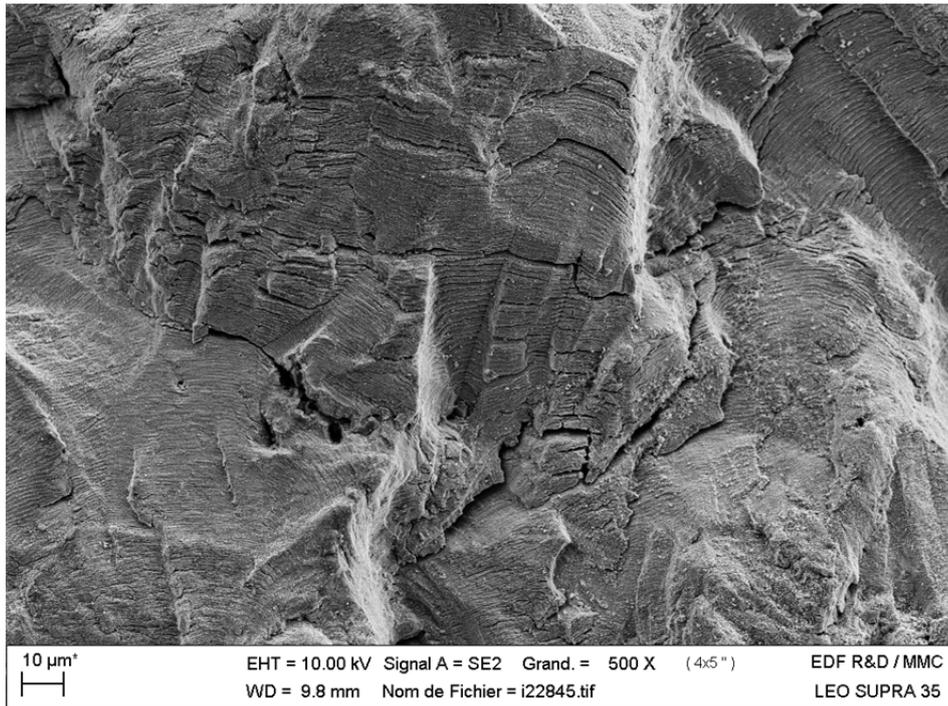
Figure 24 □ Fracture surface of 1630 MHI 01, $\Delta\epsilon/2=0.5\%$, $0.4\%/s$, 300°C . As-received 304L, PWR, branching.

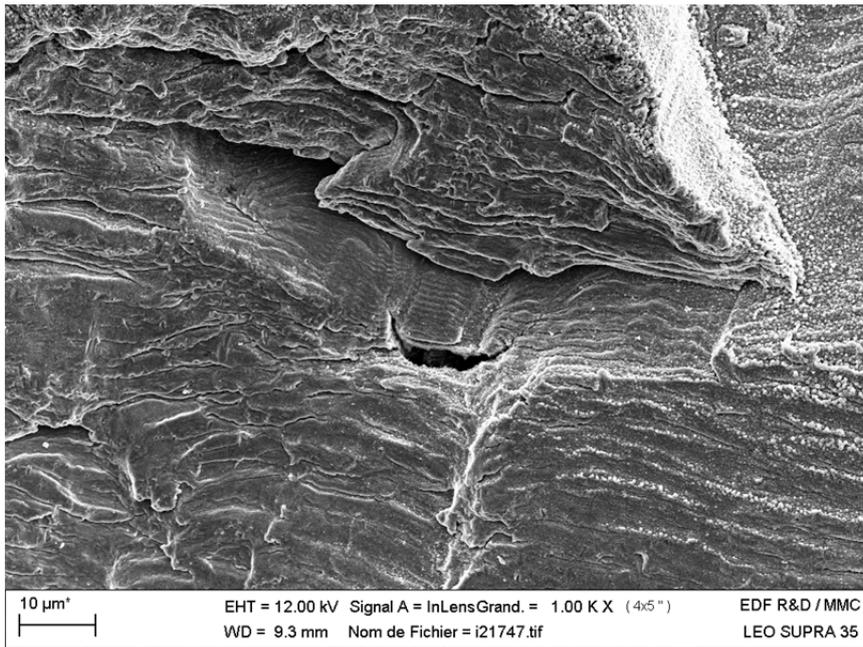
Figure 25 □ Fracture surface of 1630 MHI 04, $\Delta\epsilon/2=0.5\%$, $0.004\%/s$, 300°C . As-received 304L, PWR, branching with 2 crack growth rates.

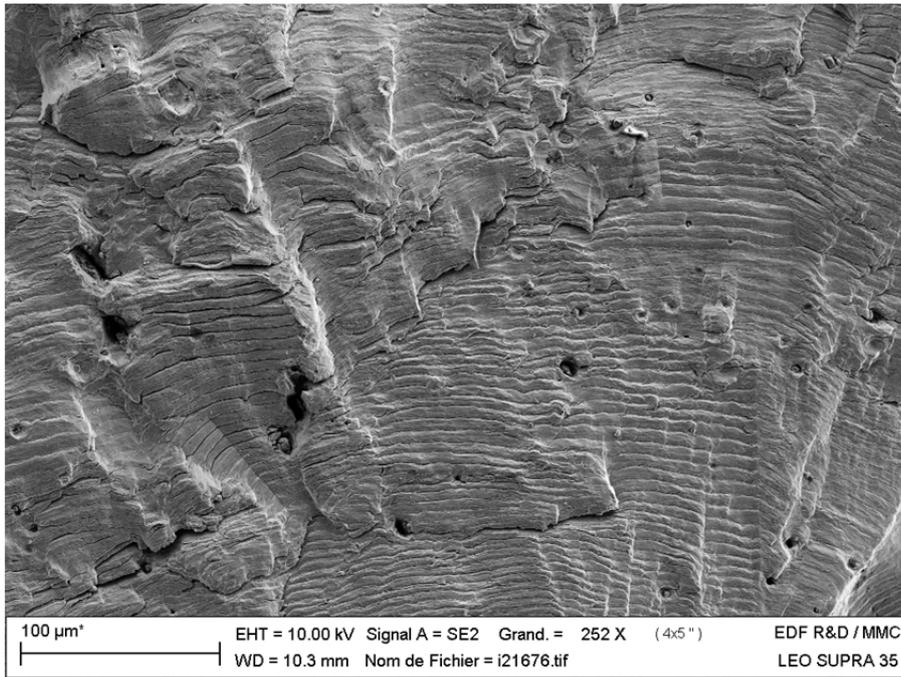
Figure 26 □ Fracture surface of 1630 MHI 01, $\Delta\epsilon/2=0.5\%$, $0.4\%/s$, 300°C . As-received 304L, branching.

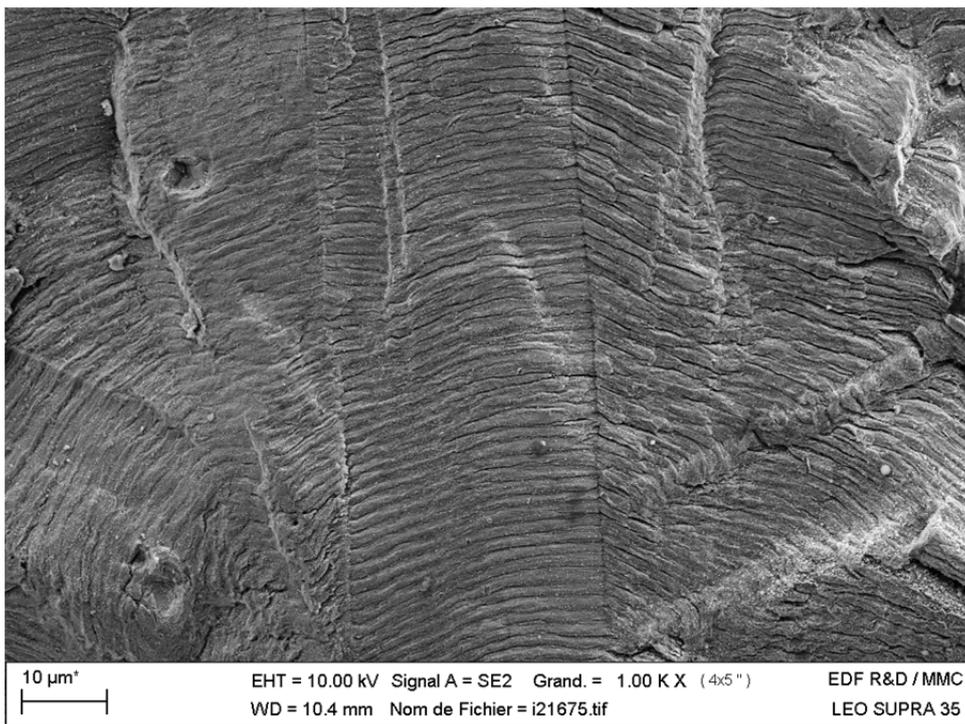
Figure 27 □ Fracture surface of 1630 MHI 02, $\Delta\epsilon/2=0.5\%$, $0.4\%/s$, 300°C . 10% tension, PWR, twin boundary.

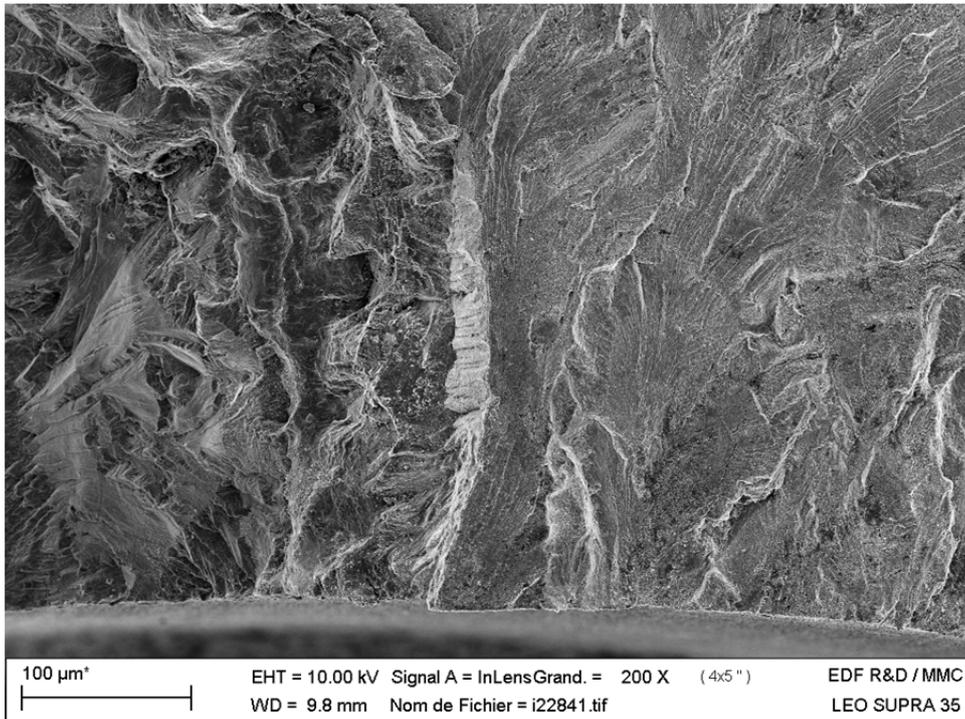
Figure 28 □ Fracture surface of 1630 MHI 04, $\Delta\epsilon_t/2=0.5\%$, $0.004\%/s$, 300°C . As-received 304L, PWR. Residual delta ferrite.

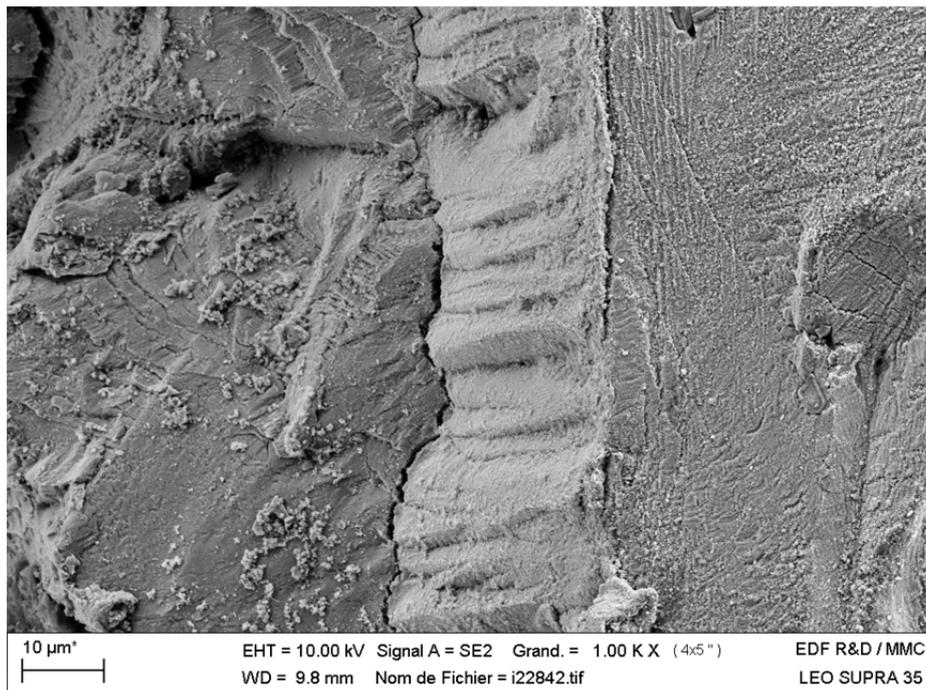
Figure 29 □ Fracture surface of 1630 MHI 04, $\Delta\epsilon_t/2=0.5\%$, $0.004\%/s$, 300°C . As-received 304L, PWR, focusing on the austenite/ferrite interface.
