EFFECT OF A DAMAGE TO MODAL PARAMETERS OF A WIND TURBINE BLADE

Gunner Chr. Larsen¹, Peter Berring¹, Dmitri Tcherniak², Per Hørlyk Nielsen¹, Kim Branner¹

ABSTRACT

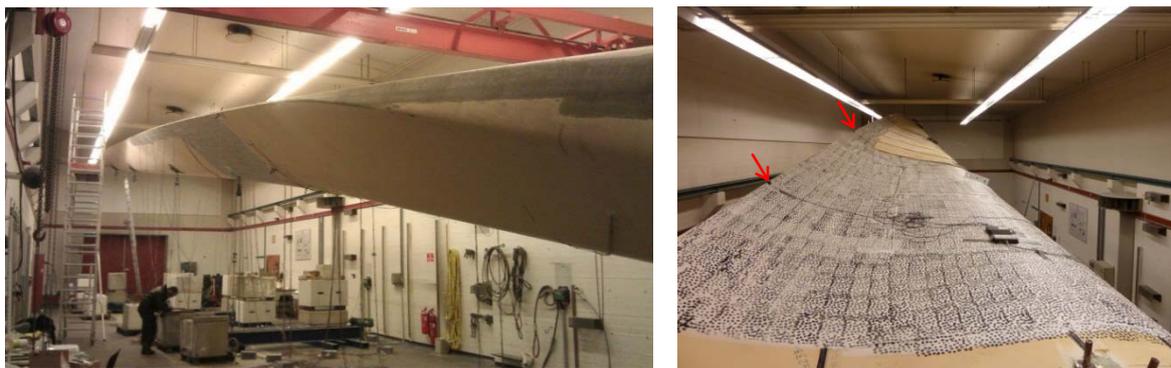
Figure 1: The 34m blade in the experimental Blade Test Facility at DTU Wind Energy. Left: Suction of blade. Right: Upper (pressure) side of blade. Accelerometers is marked with a red arrow

To study and compare the dynamic characteristics of a damaged wind turbine blade and the corresponding undamaged blade, a full-scale 34m blade, manufactured by SSP Technology A/S, was mounted to a test rig under laboratory conditions (cf. Figure 1). The blade was positioned horizontally with the suction side pointing towards the ground.

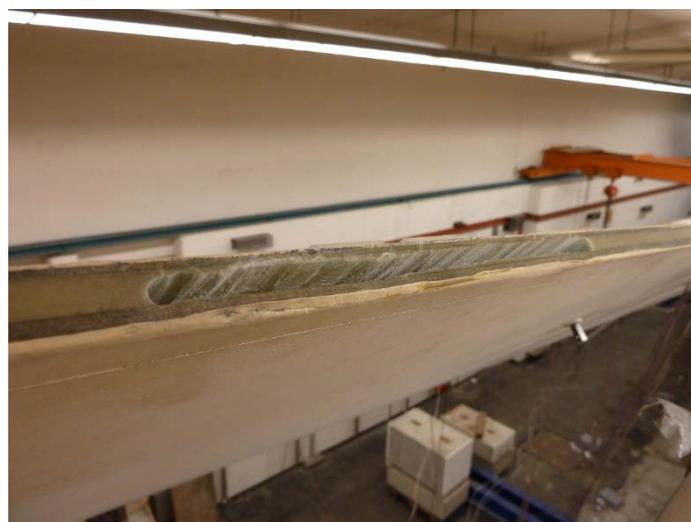
Figure 2: The artificial trailing edge damage introduced in the 34m blade

Several test campaigns were carried out throughout the experiment. The first test was carried out on the undamaged blade. This (reference) test was subsequently followed by tests, where artificial damages were introduced in the trailing edge 18,8m and onwards from the root. In the damaged part of the blade the adhesive between the upper and lower part of the shell was removed to mimic a crack in the trailing edge (cf. Figure 2). The first the damage had a length of 20cm along the blade, and this damage was progressively extended throughout the test campaigns, reaching a length of 120cm in the final test, and thus extending from 18,8m to 20,0m as measured from the blade root. The damaged part of the trailing edge was re-established after tests to enable the blade to be used for other experiments, and the first (reference) tests on the undamaged blade was repeated to investigate whether the re-established trailing edge had affected the dynamic properties of the blade.
