# Identification of a new pseudo-binary hydroxide during calendar corrosion of (La, Mg)<sub>2</sub>Ni<sub>7</sub>-type hydrogen storage alloys for Nickel-Metal Hydride batteries

## Abstract

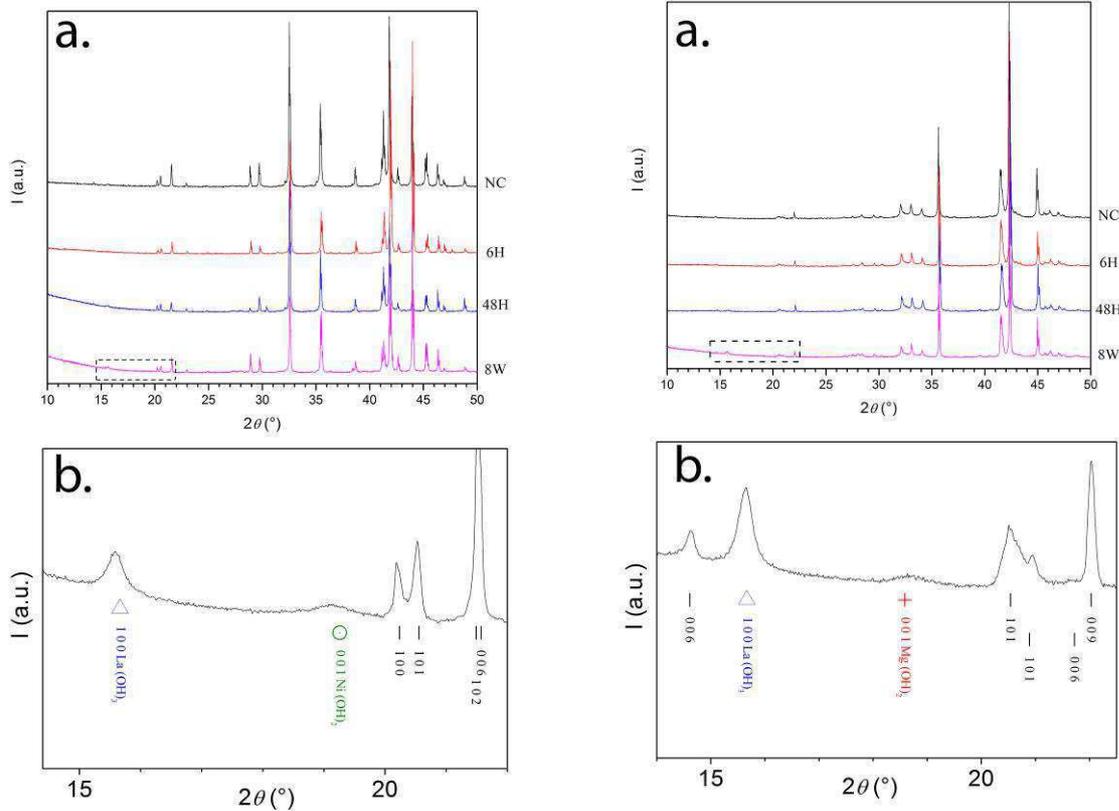
**Figure 1:** La<sub>2</sub>Ni<sub>7</sub> diffractograms after various immersion times in 8.7M KOH; a. from top to bottom: non corroded (NC), 6 hours (6H), 48 hours (48H) and 8 weeks (8W); b. low theta region shown in the dashed rectangle, with longer acquisition time for the sample soaked 8 weeks in 8.7M KOH. The (100) diffraction peak of La(OH)<sub>3</sub> (triangle; PDF n°00-036-1481) and the (001) diffraction peak of Ni(OH)<sub>2</sub> (circle; PDF n°04-012-5845) are shown beside the peaks of the main phase (vertical bars; Ce<sub>2</sub>Ni<sub>7</sub>-type).

**Figure 2:** La<sub>1.5</sub>Mg<sub>0.5</sub>Ni<sub>7</sub> diffractograms after various immersion times in 8.7M KOH; a. from top to bottom: non corroded (NC), 6 hours (6H), 48 hours (48H) and 8 weeks (8W); b. low theta region shown in the dashed rectangle, with longer acquisition time for the sample soaked 8 weeks in 8.7M KOH. The (100) diffraction peak of La(OH)<sub>3</sub> (triangle; PDF n°00-036-1481) and the (001) diffraction peak of Mg(OH)<sub>2</sub> (cross; PDF n° 00-007-0239) are shown beside the peaks of the main phases (vertical bars; Ce<sub>2</sub>Ni<sub>7</sub>- and Gd<sub>2</sub>Co<sub>7</sub>-type respectively).

Figures 1 and 2 show the XRD patterns recorded for La<sub>2</sub>Ni<sub>7</sub> and La<sub>1.5</sub>Mg<sub>0.5</sub>Ni<sub>7</sub>, respectively, after immersion in 8.7M KOH for different soaking times. Beside the alloy main diffraction peaks, these diffractograms enable to identify the presence of the La(OH)<sub>3</sub> phase, especially at longer soaking times (additional X-ray diagrams are available in the Supplementary Information Figure S1).

For a better phase identification, longer acquisition time (up to 24 hours) allowing better signal to noise ratio was performed for both samples. Ni(OH)<sub>2</sub> for the binary alloy, and Mg(OH)<sub>2</sub> for the pseudo-binary one are clearly observed after 8 weeks of soaking (Figure 1.b and 2.b).

To choose between these two hypotheses, the cell parameters have been derived from the X-ray diffractogram shown in the inset of Figure 2. They are presented in Table 2. The cell parameters for  $\text{Mg}(\text{OH})_2$ , as identified in the corroded pseudo-binary alloy, have intermediate values between those of pure  $\text{Mg}(\text{OH})_2$  and pure  $\text{Ni}(\text{OH})_2$ . The  $a$  parameters are very close for both phases, however the  $c$  parameters are significantly different. In the refined pattern, the main diffraction peak for  $\text{Mg}(\text{OH})_2$  is the (001) one, giving a value of the  $c$  parameter for the 8-weeks corroded pseudo-binary sample in between those of  $\text{Mg}(\text{OH})_2$  and  $\text{Ni}(\text{OH})_2$  favoring the second hypothesis. Considering the weak diffraction factor of Mg, and the low  $\text{Mg}(\text{OH})_2$  content in the sample, this result has to be considered with cautious but suggests that Ni is substituted within the  $\text{Mg}(\text{OH})_2$  lattice.

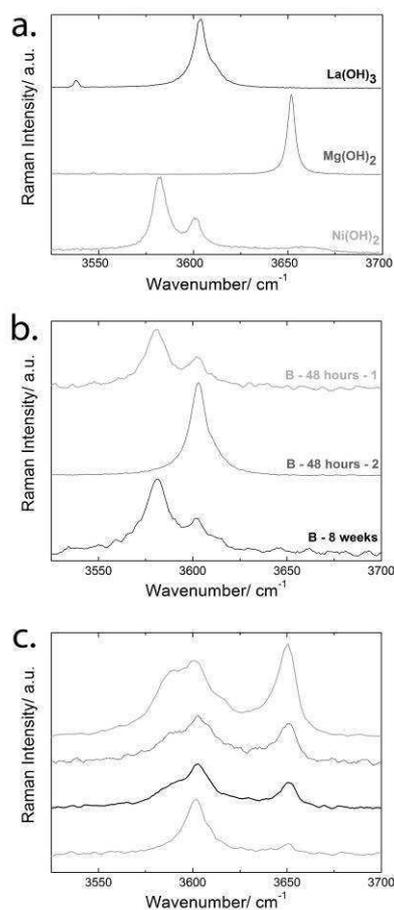
**Figure 3:** Micro-RS spectra recorded on a. La(OH)<sub>3</sub>, Ni(OH)<sub>2</sub> and Mg(OH)<sub>2</sub> references; b. La<sub>2</sub>Ni<sub>7</sub> corroded for 48 hours (2 points) and 8 weeks; c. La<sub>1.5</sub>Mg<sub>0.5</sub>Ni<sub>7</sub> corroded for 48 hours (4 points). Acquisition conditions 600 s.

Reference Raman spectra of O-H vibration of Ni(OH)<sub>2</sub> at 3582 cm<sup>-1</sup>, La(OH)<sub>3</sub> at 3600 cm<sup>-1</sup> and Mg(OH)<sub>2</sub> at 3650 cm<sup>-1</sup> are displayed in figure 3.a. Difference in wavenumber are large enough to distinguish between the different hydroxides. Raman spectra of La<sub>2</sub>Ni<sub>7</sub> soaked 48 hours and 12 weeks are given in Figure 3.b. For 48 hours the corrosion layer is formed of Ni(OH)<sub>2</sub> or La(OH)<sub>3</sub>, pure phases but not spatially homogeneous. For 12 weeks the corrosion layer is homogeneous and formed of a mixture of pure phases of Ni(OH)<sub>2</sub> and La(OH)<sub>3</sub>. In the presence of magnesium in the alloy, the Raman spectra are given in Figure 3.c for 8 weeks into KOH. The corrosion layer is spatially heterogeneous at the micrometer scale. A new band is appearing at 3650 cm<sup>-1</sup> and attributed to Mg(OH)<sub>2</sub>. The band corresponding to Ni(OH)<sub>2</sub> is shifted at 3690 cm<sup>-1</sup> and in some spectra an enlargement of the high wavenumber side of the band corresponding to La(OH)<sub>3</sub> is visible.

In the presence of magnesium, the Raman spectrum of lanthanum hydroxide is not modified but  $\text{Mg}(\text{OH})_2$  as pure phase is identified by the band at  $3650\text{ cm}^{-1}$ . The O-H vibration of  $\text{Ni}(\text{OH})_2$  is  $10\text{ cm}^{-1}$  shifted showing that  $\text{Ni}(\text{OH})_2$  as pure phase is not formed anymore. Solid solution of Ni/ Mg hydroxide has been studied by infrared spectroscopy and O-H vibration depends quite linearly on the Mg/ Ni content of the solid solution [14]. The spatial variation of the recorded Raman spectra at the micrometer scale clearly indicates that the corrosion product layer is formed from:  $\text{La}(\text{OH})_3$  and  $\text{Ni}_{1-x}\text{Mg}_x(\text{OH})_2$  with  $x$  varying from one point to another. The formation of Ni/ Mg hydroxide by coprecipitation technique has already been studied and different compositions can be formed depending on the process for the same solution content [15]. However the existence of a predominant defined composition in the corrosion layer cannot be excluded as Raman spectroscopy is not a quantitative technique.

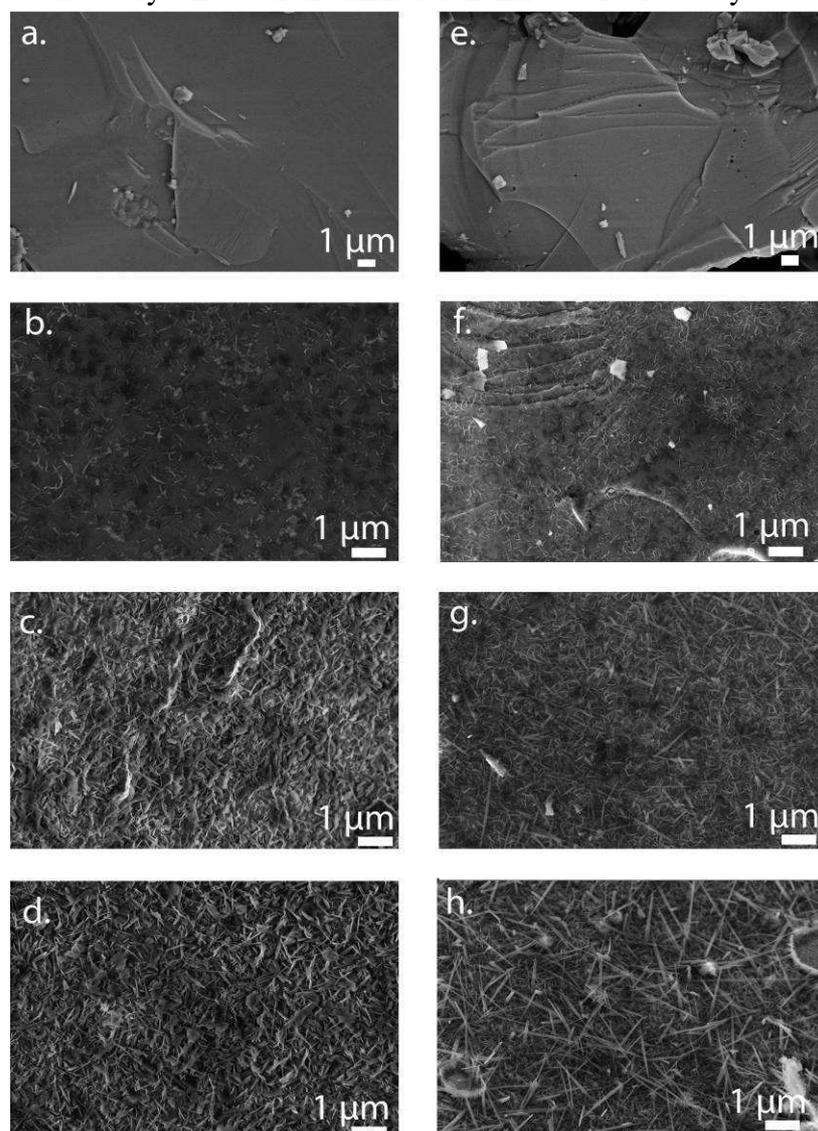
**Figure 4:** SEM micrographs at magnification 10k, in SE2 mode, of (a.) non corroded  $\text{La}_2\text{Ni}_7$  sample and  $\text{La}_2\text{Ni}_7$  sample corroded for (b.) 6h, (c.) 48h and (d.) 8 weeks; (e.) non corroded  $\text{La}_{1.5}\text{Mg}_{0.5}\text{Ni}_7$  sample and  $\text{La}_{1.5}\text{Mg}_{0.5}\text{Ni}_7$  sample corroded for (f.) 6h, (g.) 48h and (h.) 8 weeks.

The first morphologic characterisation of corrosion products was performed with systematic SEM analysis for each corrosion time. Some of the results are presented here for  $\text{La}_2\text{Ni}_7$  and  $\text{La}_{1.5}\text{Mg}_{0.5}\text{Ni}_7$  (Figure 4) for low magnification in SE2 mode (additional micrographs are available in the Supplementary Information Figure S2 and Figure S3). The  $\text{La}_2\text{Ni}_7$  surface is covered after 48 hours of immersion in 8.7M KOH. The  $\text{La}_{1.5}\text{Mg}_{0.5}\text{Ni}_7$  surface is covered after 4 days of immersion in 8.7M KOH. The corrosion product quantity seems quite the same for both alloys and do not vary whatever the immersion time over a few days.

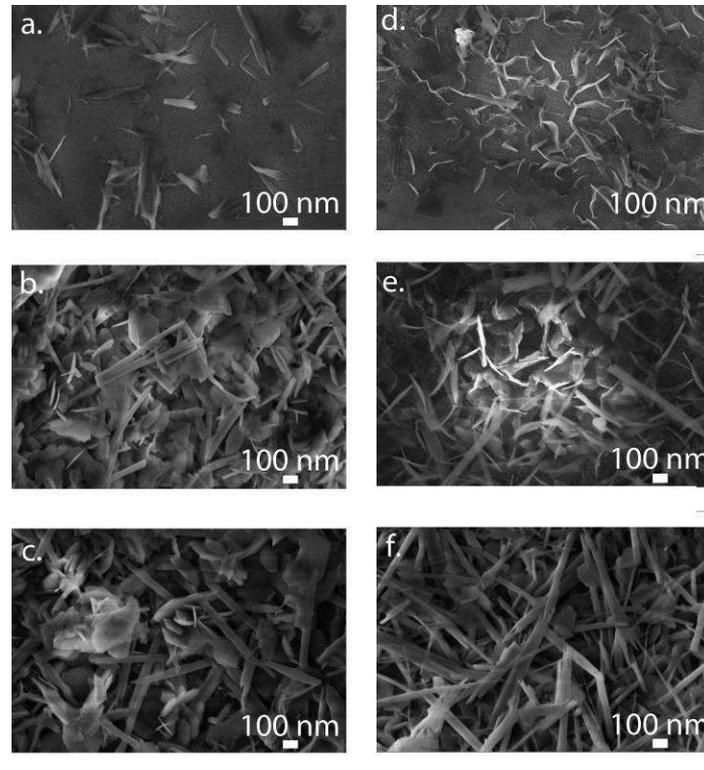
**Figure 5:** SEM micrographs at magnification 50k, in InLens mode, of  $\text{La}_2\text{Ni}_7$  sample corroded for (a.) 6h, (b.) 48h and (c.) 8 weeks on the left and  $\text{La}_{1.5}\text{Mg}_{0.5}\text{Ni}_7$  sample corroded for (d) 6h, (e.) 48h and (f) 8 weeks on the right.

Higher magnification micrographs in InLens mode (Figure 5) present the morphology of the corrosion products developed on both alloys.

Needle-like morphology corrosion products appear first for the  $\text{La}_2\text{Ni}_7$  alloy. Then hexagonal platelets appear. For the  $\text{La}_{1.5}\text{Mg}_{0.5}\text{Ni}_7$  alloy, both platelets and needle appear for 6h immersion in 8.7M KOH.

After 48 hours immersion two morphologies are confirmed for both alloys. The first one corresponds to little platelets without size growth. The second one develops needle-like morphology. It is particularly evidenced for the pseudo-binary alloy. In this case, the needles are quite large, up to a micronic size, and they have a well defined morphology. For the binary alloy, the needles are smaller and less defined.

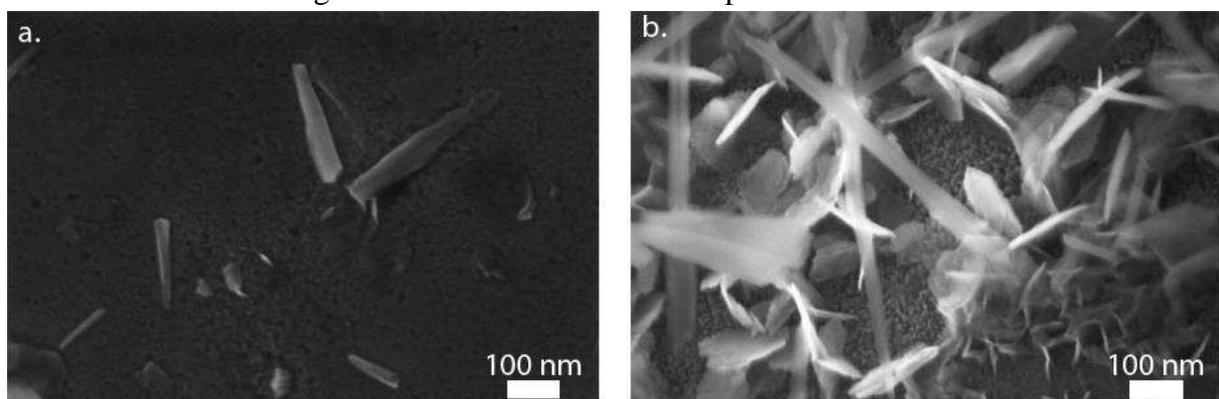
**Figure 6:** SEM micrographs, in InLens mode, of the metal/corrosion products interface for a.  $\text{La}_2\text{Ni}_7$  corroded for 6h in 8.7M KOH and b.  $\text{La}_{1.5}\text{Mg}_{0.5}\text{Ni}_7$  corroded for 24h in 8.7M KOH.

Figure 6 presents SEM micrographs of both samples, focusing on the interface between the alloy and the corrosion products. This interface, which is smooth for the non-corroded alloys, shows a nanometric roughness as soon as the corrosion process starts.

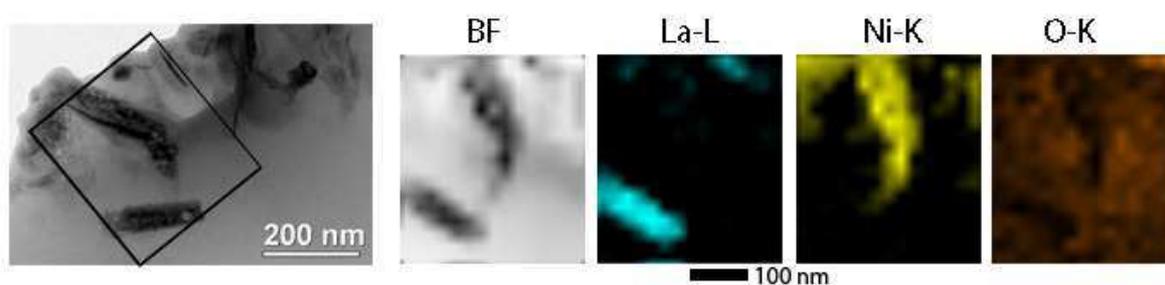
**Figure 7:** TEM micrograph and EDS-STEM elemental mapping of La, Ni and O for the  $\text{La}_2\text{Ni}_7$  sample corroded 48h in 8.7M KOH solution.

Characterisation was completed by TEM analysis for the 48-hours corroded samples. Figure 7 presents elemental mapping for the 48h corroded binary sample. The selected area shows two types of corrosion products. The one from the bottom, as can be seen in the TEM-mode micrograph, has a well-defined morphology with linear border despite its small size. This particle is associated with the La element. The corrosion particle in the upper part of the mapping is not so well defined, and is associated to the Ni element. La and Ni are segregated in the corrosion products, they form  $\text{La}(\text{OH})_3$  and  $\text{Ni}(\text{OH})_2$  hydroxides at different places and not in a single compound, as confirmed by electronic diffraction (see supplementary information Figure S5 and Table S1).

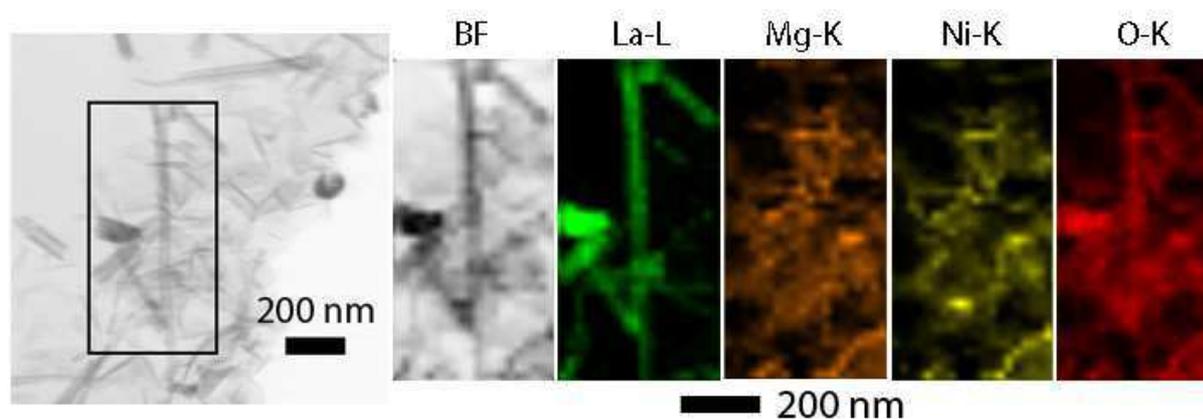
**Figure 8:** TEM micrograph and EDS-STEM elemental mapping of La, Mg, Ni and O on  $\text{La}_2\text{Mg}_{0.5}\text{Ni}_7$  sample corroded 48h in 8.7M KOH.

Figure 8 displays the elemental mapping for the 48h corroded pseudo-binary sample. Well defined particles with needle-shape morphology can be distinguished. They are outstandingly linked to the La element in the STEM-EDS elemental mapping. Beside these needles, the other corrosion products are very fine. They are associated to the Mg element, as well as the Ni one.

Considering the STEM-EDX elemental mapping of the pseudo-binary sample, two morphologies are identified: large needles composed of La and O, corresponding to the  $\text{La}(\text{OH})_3$  phase, and small particles. These are linked to the Mg element, as could be deduced from the XRD  $\text{Mg}(\text{OH})_2$  identification, but they are also related to the Ni element. Therefore two hypotheses are proposed for this observation.  $\text{Mg}(\text{OH})_2$  and  $\text{Ni}(\text{OH})_2$  hydroxides can both be present, finely mixed at the nanometric scale, or Mg can substitute Ni in the  $\text{Mg}(\text{OH})_2$  hydroxide, the only one identified by XRD analyses.

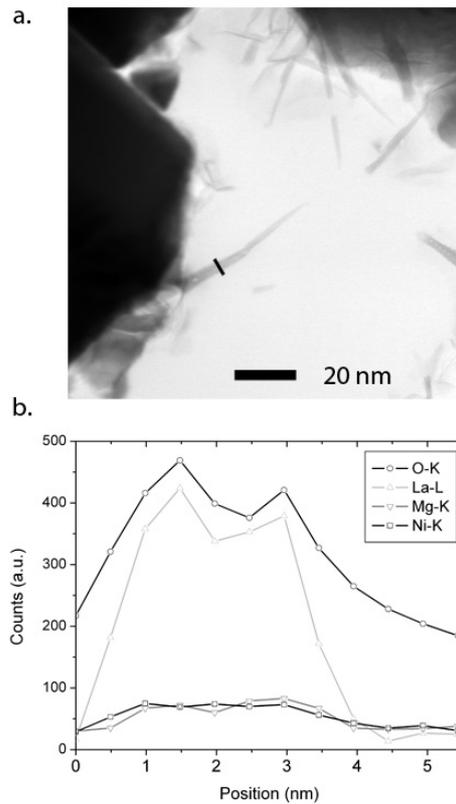
**Figure 9:** STEM micrograph and STEM-EDS elemental profile for the  $\text{La}_2\text{Mg}_{0.5}\text{Ni}_7$  sample corroded 6h in 8.7M KOH.

Moreover, a inner channel can be observed inside the core of the  $\text{La}(\text{OH})_3$  needles. Figure 9 presents the EDS profile of a  $\text{La}(\text{OH})_3$  needle for the pseudo-binary sample corroded 6 hours. The profile is recorded along the transversal part of the needle. A La and O depletion appears in the middle of the needle. This indicates the presence of a hollow channel with a diameter about 2 nm.

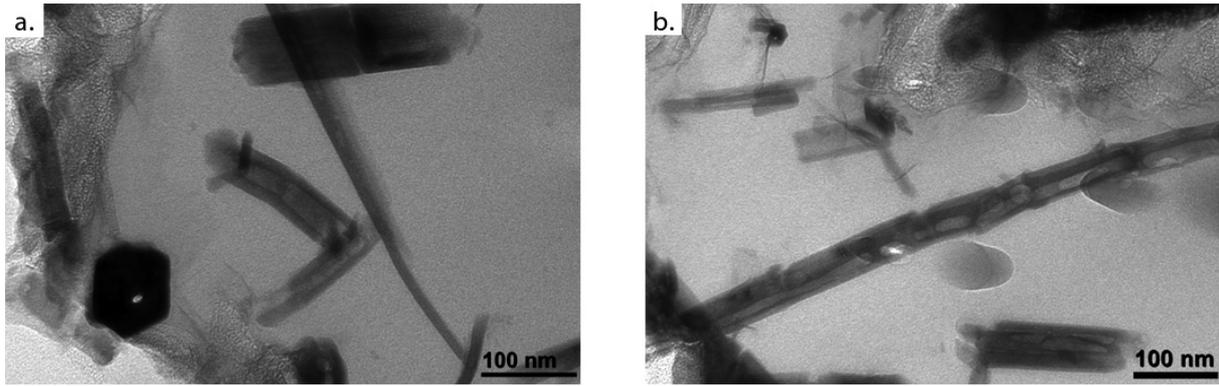
**Figure 10:** TEM micrograph showing the tubular structure on  $\text{La}_2\text{Mg}_{0.5}\text{Ni}_7$  sample corroded 8 weeks in 8.7M KOH.

Figure 10 presents the micrographs for the 8-weeks pseudo-binary corroded sample. The large needles show a density variation in their central part. At the bottom of Figure 10.a, a hexagonal particle is observed with a small hole in its central part. EDS analysis indicates that these hexagonal particles are composed of La and O, identifying them as the  $\text{La}(\text{OH})_3$  needles in a transversal view. The diameter of the hole is about 10 nm diameter though this value should be taken with caution as part of the hole can be covered during the ultra-microtome preparation. It indicates however that the size of the hole might vary depending of the immersion time.

Finally, the rare earth hydroxide needles show a channel in their central part. Maurel *et al.* showed that these channels play a role in the growth mechanism [6]. These holes have nanometric dimensions, varying from 2-3 nm for the pseudo-binary sample corroded during 6 hours up to 10 nm for the sample corroded 8 weeks. It is worth to note that those “nanochannels” have their diameter size growing with the needle size. This point is in contradiction with the previous work [6] on  $AB_5$  sample for which they reported that the hole size staid constant for various immersion times.

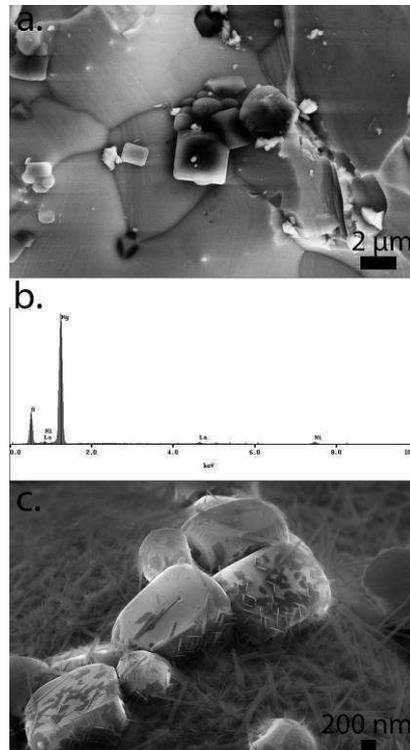
**Figure 11:** a. SEM micrograph and b. SEM-EDS analysis on  $\text{La}_2\text{Mg}_{0.5}\text{Ni}_7$  sample non-corroded, focusing on cubic crystal of MgO. c. SEM micrograph showing MgO crystals being transformed into  $\text{Mg}(\text{OH})_2$  in the  $\text{La}_2\text{Mg}_{0.5}\text{Ni}_7$  sample corroded 48 hours in 8.7M KOH.

Beside the general corrosion process detailed in this paper, small cubic particles have been also observed by SEM (Figure 11.a). The particle size is about 2  $\mu\text{m}$ . EDS spectra performed on these particles indicate the presence of O and Mg (Figure 11.b). These elements, combined with the morphology observation, indicate that MgO crystals are present in the initial pseudo-binary alloy. These MgO crystals are attributed to Mg corrosion taking place at high temperature during the elaboration process. They disappear after two weeks in 8.7M KOH. As suggested by the SEM micrograph (Figure 11.c) they probably turn into  $\text{Mg}(\text{OH})_2$  hexagonal platelets, thermodynamically favoured at such basic pH. These MgO particles are not identified in the XRD analysis, due to their very low concentration in the sample, and the low diffraction structure factors of Mg and O.

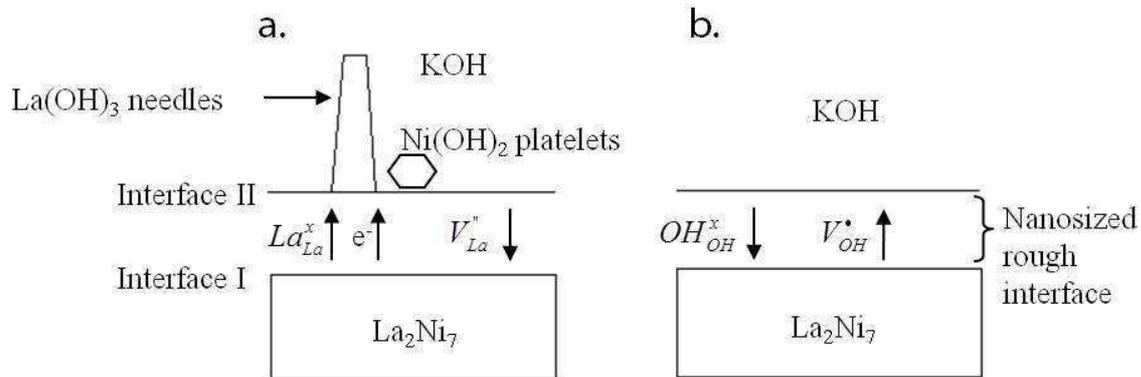
**Figure 12:** Corrosion mechanisms by a. cationic and b. anionic transport as proposed by Maurel *et al.*[6], modified (this work) to introduce the presence of the  $\text{Ni}(\text{OH})_2$  platelets.

Unlike Maurel *et al* [6], we evidenced the presence of  $\text{Ni}(\text{OH})_2$  that they did not point out. That could be explained by the low diffraction power of nickel hydroxide, and by the absence of Raman spectroscopy in their study. The rough interface layer formation can be explained by the internal oxidation mechanism. This layer is commonly associated to a metallic nickel amorphous layer which catalyses the surface electrochemical reaction, as suggested in [6]

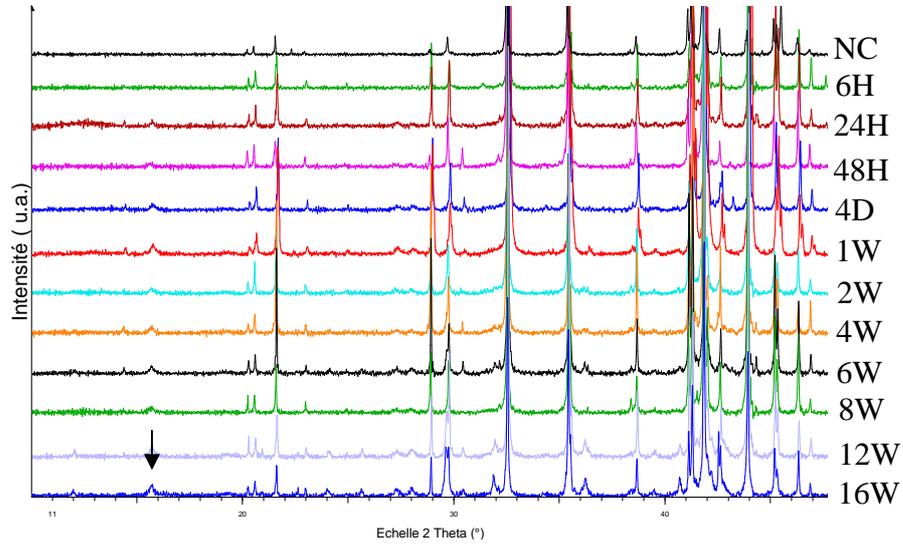
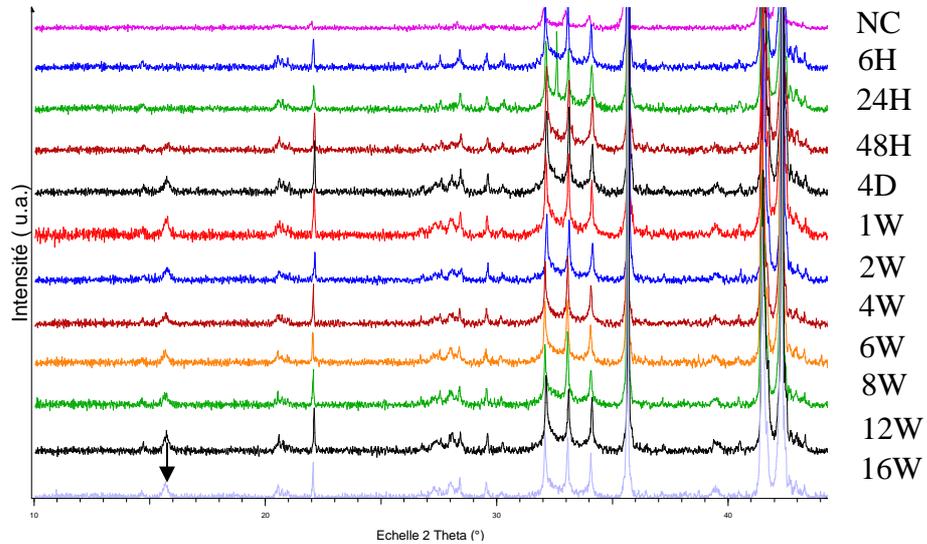
**Figure S1:** a.  $\text{La}_2\text{Ni}_7$  and b.  $\text{La}_{1.5}\text{Mg}_{0.5}\text{Ni}_7$  diffractograms after various immersion times in 8.7M KOH: from top to bottom : non corroded, 6 hours, 24 hours, 48 hours, 4 days, 1 week ; 2 weeks, 4 weeks, 6 weeks, 8 weeks, 12 weeks, 16 weeks. The black arrow corresponds to the (100) diffraction peak of the  $\text{La}(\text{OH})_3$  phase (PDF n° 00-036-1481 ; NC = non corroded, H = hour(s), D = day(s), W = week(s))

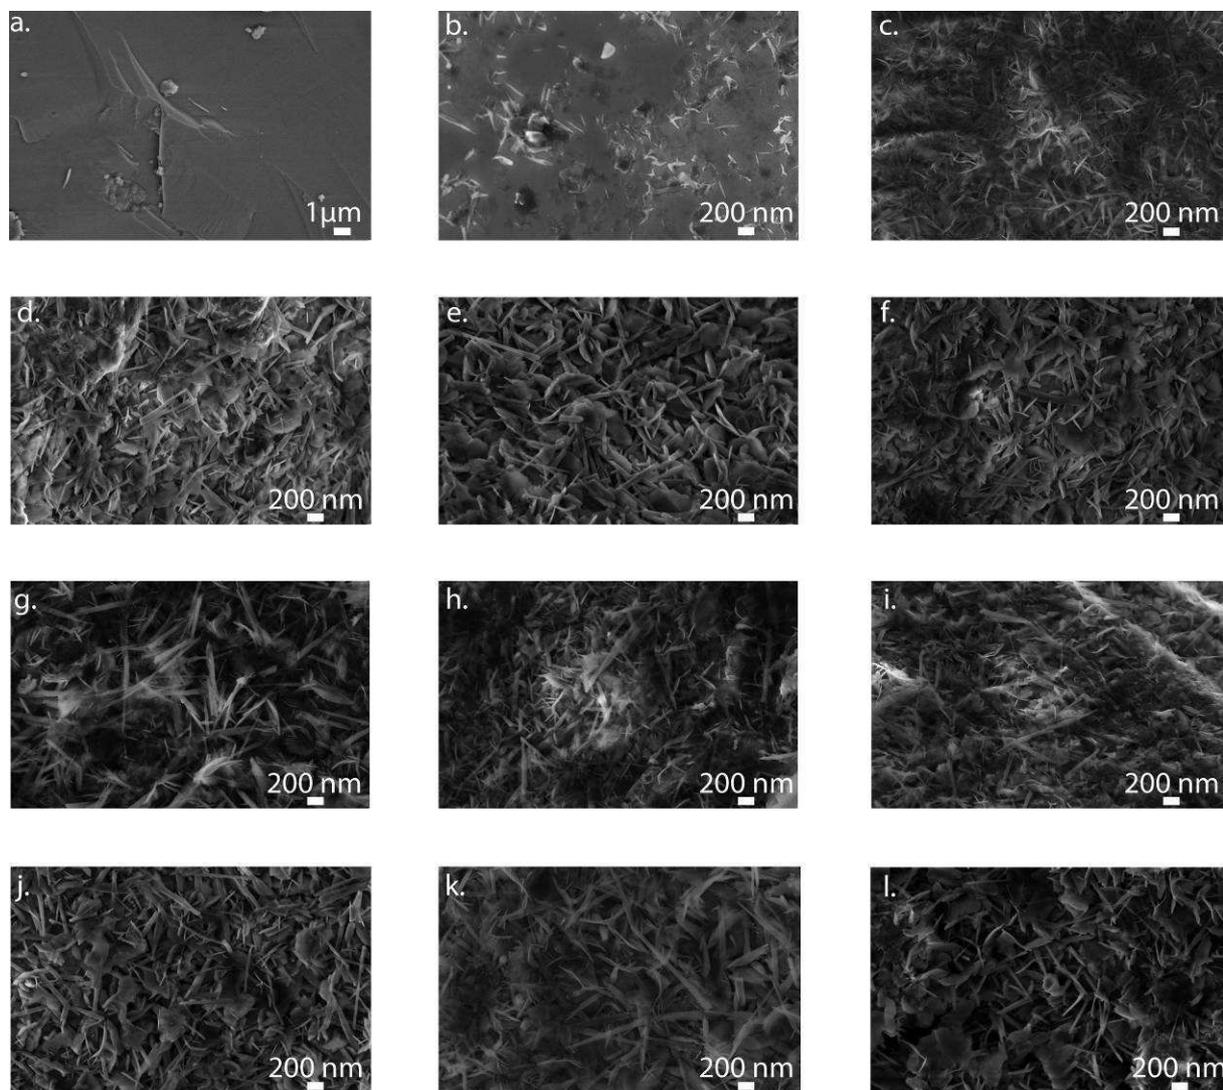
**Figure S2:** SEM micrography, in InLens mode, of La<sub>2</sub>Ni<sub>7</sub> sample (a;) non corroded and corroded for (b.) 6h, (c.) 24h, (d.) 48h, (e.) 4 days, (f.) 1 week, (g.) 2 weeks, (h.) 4 weeks, (i.) 6 weeks, (j.) 8 weeks, (k.) 12 weeks, and (l.) 16 weeks

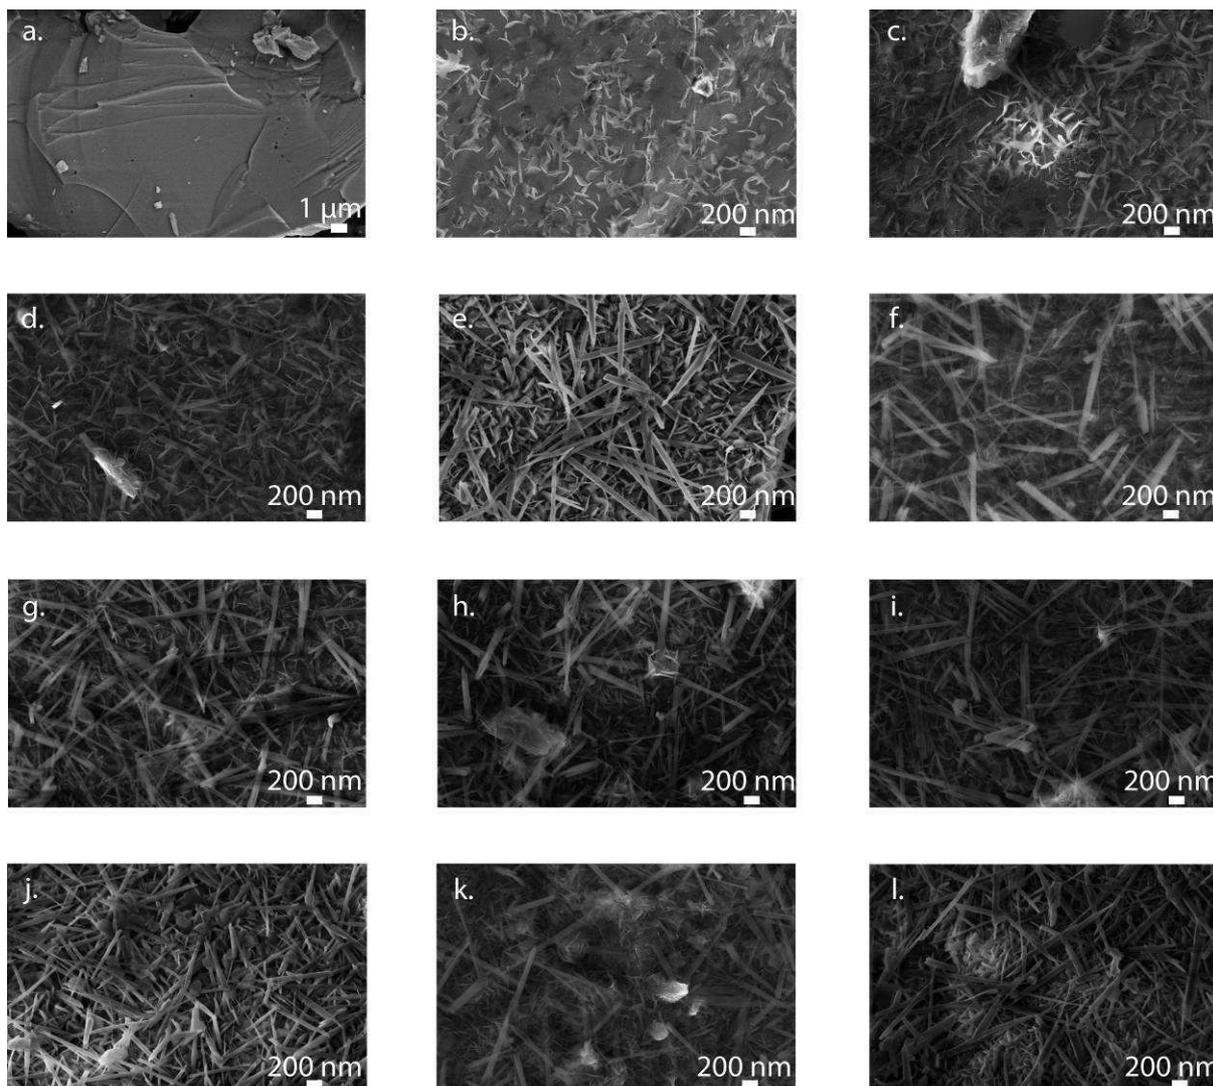
**Figure S3:** SEM micrography, in InLens mode, of  $\text{La}_{1.5}\text{Mg}_{0.5}\text{Ni}_7$  sample (a;) non corroded and corroded for (b.) 6h, (c.) 24h, (d.) 48h, (e.) 4 days, (f.) 1 week, (g.) 2 weeks, (h.) 4 weeks, (i.) 6 weeks, (j.) 8 weeks, (k.) 12 weeks, and (l.) 16 weeks

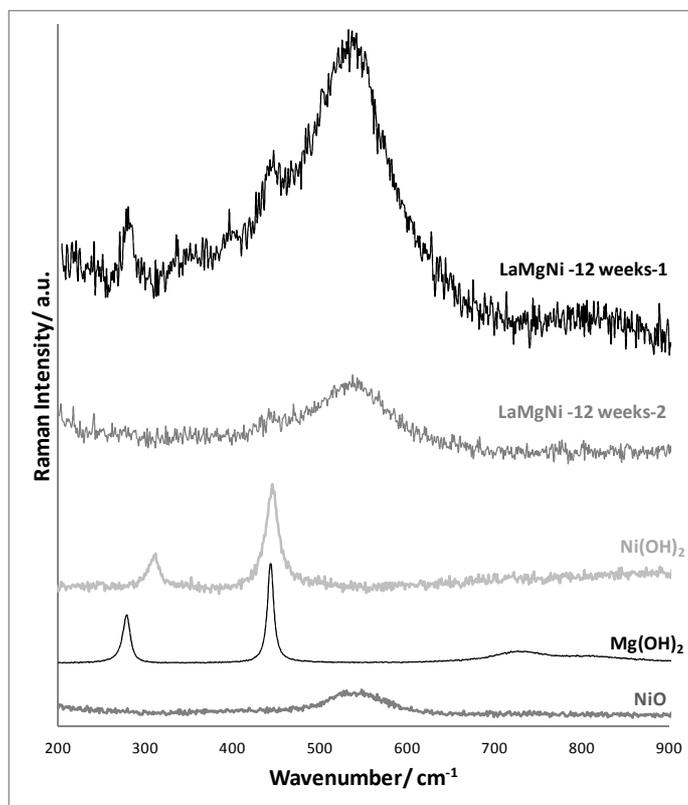
**Figure S4:** Raman spectra of  $\text{La}_{1.5}\text{Mg}_{0.5}\text{Ni}_7$  sample corroded for 12 weeks compared to  $\text{Ni}(\text{OH})_2$ ,  $\text{NiO}$  and  $\text{Mg}(\text{OH})_2$  references. Acquisition conditions : 600sec.

The low frequency spectra (see supplementary information Figure S4) recorded for the 12-weeks corroded sample indicate also the presence of Mg(OH)<sub>2</sub>, but a very broad band around 540 cm<sup>-1</sup> is also present, which could be attributed to a NiO or MgO oxide phase.

The micro-RS low frequency spectra recorded for the 12-weeks corroded sample indicates also the presence of  $\text{Mg}(\text{OH})_2$ , as well as a very broad band around  $540\text{ cm}^{-1}$ , which could be attributed to an oxide. Neither NiO nor MgO structures display a Raman signal as they have both face centered cubic structure. However, these crystals frequently include some impurities, or are non-stoichiometric with  $\text{Ni}_{1-x}\text{O}$  or  $\text{Mg}_{1-x}\text{O}$  formulae. In these cases, a broad band around  $540\text{ cm}^{-1}$  appears. The presence of NiO or MgO oxides in our system could result from the dehydration of the hydroxide phases, leading to oxide formation. This dehydration is likely to appear under the Raman laser beam.

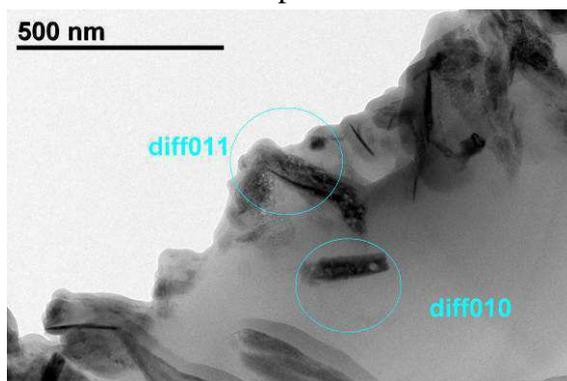
**Figure S5:** TEM bright field micrograph and electronic diffraction scanning area on  $\text{La}_2\text{Ni}_7$  sample corroded 48h on 8.7M KOH

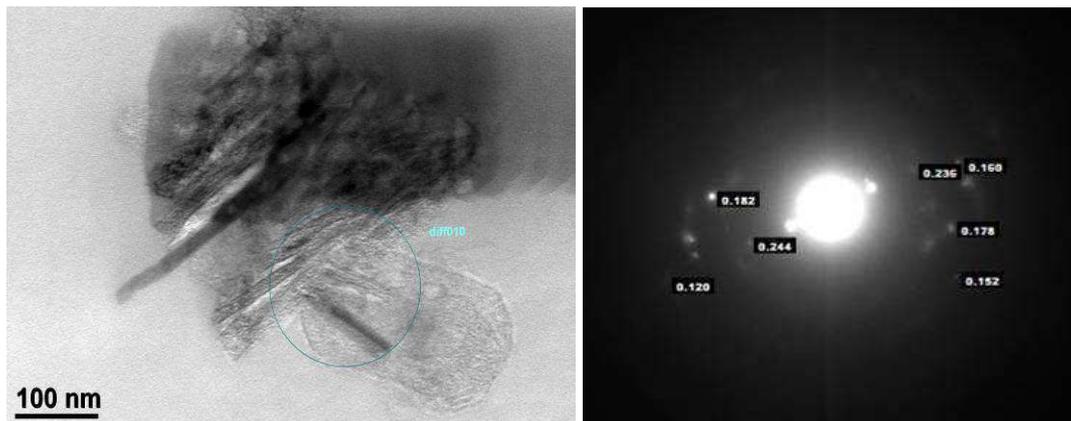
**Figure S6:** TEM bright field micrograph and electronic diffraction pattern related to the circle, for the sample  $\text{La}_{1.5}\text{Mg}_{0.5}\text{Ni}_7$  corroded for 8 weeks in 8.7M KOH . Interplanar distances are indicated on the diffraction pattern.

Electronic diffraction allows to assign  $\text{La}(\text{OH})_3$  as the well-defined large needles. For the Ni and Mg containing area, no single crystallized area was found to allow measuring diffraction angles and interplanar distances with enough accuracy to differentiate between  $\text{Ni}(\text{OH})_2$  and  $\text{Mg}(\text{OH})_2$  hydroxides (see supplementary information Figure S6 and Table S2).
