HIGH SPEED, IN-FLIGHT STRUCTURAL HEALTH MONITORING SYSTEM FOR MEDIUM ALTITUDE LONG ENDURANCE UNMANNED AIR VEHICLE

I. Kressel¹, J. Balter¹, N. Mashiach², I. Sovran³, O. Shapira⁴, N.Y. Shemesh⁴
B. Glam⁴, A. Dvorjetski², T. Yehoshua³, M. Tur³

¹*IAI Engineering Division, Ben Gurion International Airport Israel*

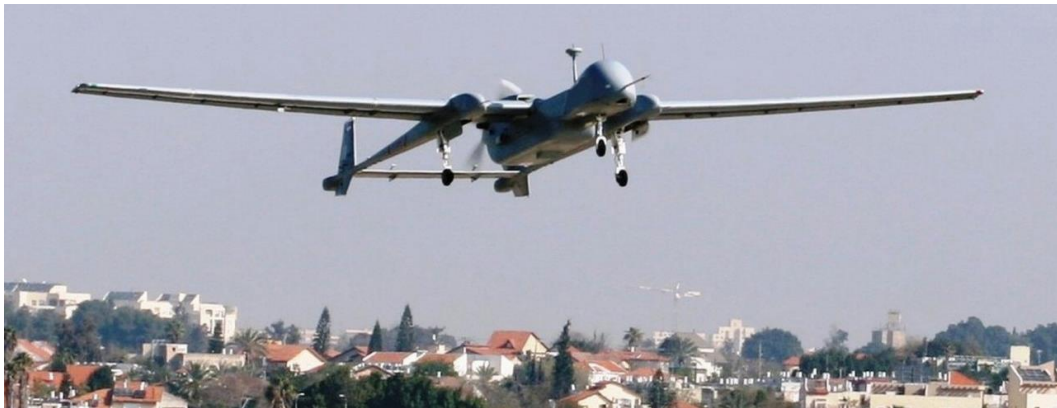
Figure 1: One of IAI's UAVs after takeoff. In the current project two fibers were embedded on each boom and wing, see Fig. 2 for details

AMALE UAV (Figure 1), designed and manufactured in Israel by Israel Aerospace Industries was selected by the Israeli Air Force as the test-bed for the evaluation of this fiber-optic based HUMS concept in operational real-field environment. Each of the two tail booms is a composite beam

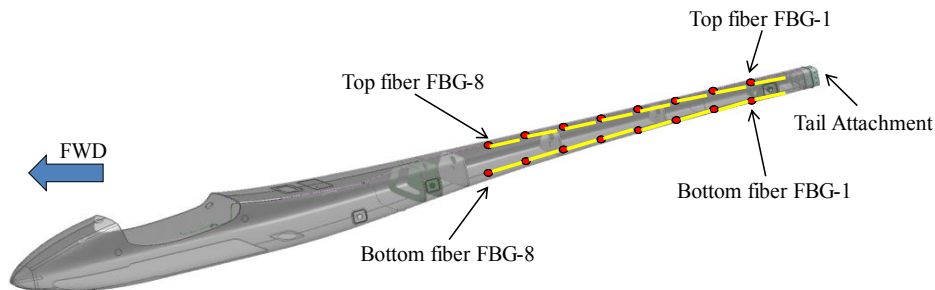
Figure 2: Boom general layout and the routing of the embedded optical fibers in the boom. 16 FBGs were located at points of interest (RHS boom shown. LHS is similar.)

structure attached to the wing in the front and at the back holds the empennage, comprising a horizontal tail (with elevator) and two vertical tails and rudders. Each boom is basically a cantilever beam with a relatively large mass at the back end. The main boom loading condition is vertical bending. In order to track these loading conditions, two fibers were embedded at the center of the boom ("Top" and "Bottom" in Figure 2). Eight FBG sensors were imprinted on each fiber. Thus, eight section of the boom are monitored by two FBGs; one on top and another on the bottom (Figure 2). For such a sensing net arrangement, the two fibers are only sensitive to vertical bending. Since the cross-section of the boom is not symmetrical with respect to the horizontal plane, vertical bending will introduce non-identical but opposite strains in corresponding top and bottom FBGs.

The optical fibers were polyimide-coated to ensure good bonding to the composite structure during embedment. To successfully solve the ingress/egress issue, a special pre-cured composite protective patch, made of glass fabric was used for each pair of fibers at the egress point providing good shielding for the bare fiber as it leaves the structure and enters the protective (3 mm) sleeve strengthened by Kevlar fibers. The patch was located at the front of the boom, where it is attached to the wing. For accurate sensor placement, a pre-fabricated glass-fiber composite sensing mat, containing the polyimide-coated optical fiber, was fabricated. This sensing mat was then bonded to the UAV structure, minimizing the risk of optical fiber damage and FBG sensor reflection attenuation. The shielded fibers were internally routed inside the UAV from each boom and wing to the interrogation and logging unit located in the payload bay. FC/APC connectors were used to enable wing and booms disassembly. Similarly the wing fibers monitor the outer wing attachment and track the wing bending moment at the center.

The first flight with the system fully operational was on October 2013. Typical FBG readings of boom mounted FBG (Top and bottom FBG-8, see Figure 2) is seen in Figure 5. The effect of engine start, takeoff, touch and go landing, acceleration to maximum speed and landing are clearly depicted by the FBG sensors. The effect of temperature is also seen as the UAV climbs to high altitude.

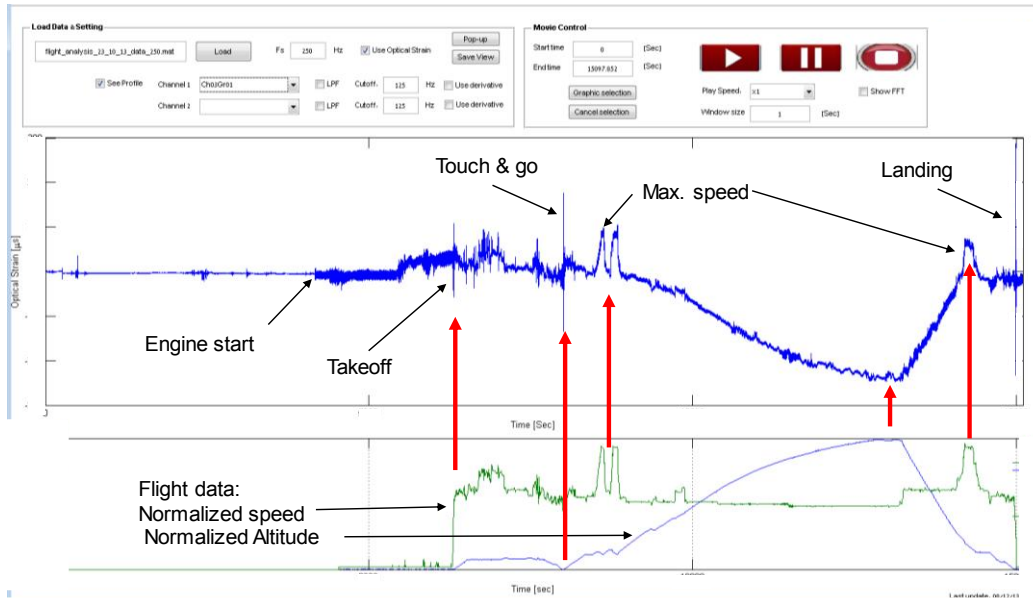
Figure 3: Flight data GUI; Typical Boom FBG readings during flight. Note the 'touch & go', maneuver and landing

A solid-state, high sampling rate (2.5kHz) FBG interrogation unit was used, capable of simultaneously tracking 4 fibers, having multiple FBGs on each. The interrogation included a data-logging system was placed in the UAV payload bay, and was powered by the UAV electrical system. While the data logger had significant processing power, all data analysis reported here was done offline. The interrogator containing data-logger unit has been successfully subjected to environmental testing fully compatible with the environmental requirements of the MALE UAV. The sensors data were also integrated with the flight parameters on a single GUI, Figure 3, for visual and quantitative correlation of the sensors readings and flight manoeuvres. Based on the data obtained, it is now possible to track this UAV actual load spectrum and its impact on UAV structural integrity.

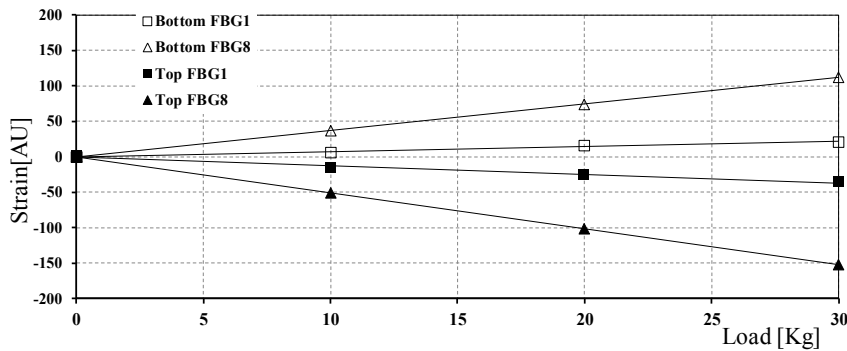
Figure 4: Typical Boom FBG calibration. At identical boom stations, top and bottom FBGs will have different strain magnitude

Static calibration tests were performed in order to correlate the embedded FBG readings with the boom loading under vertical bending load. Tail loadings were applied at the boom end near the tail, up to 30Kg. FBG readings were taken at 10Kg increments. Typical calibration results are presented in Figure 4, demonstrating the linearity of the FBG readings with respect to the applied load as expected.

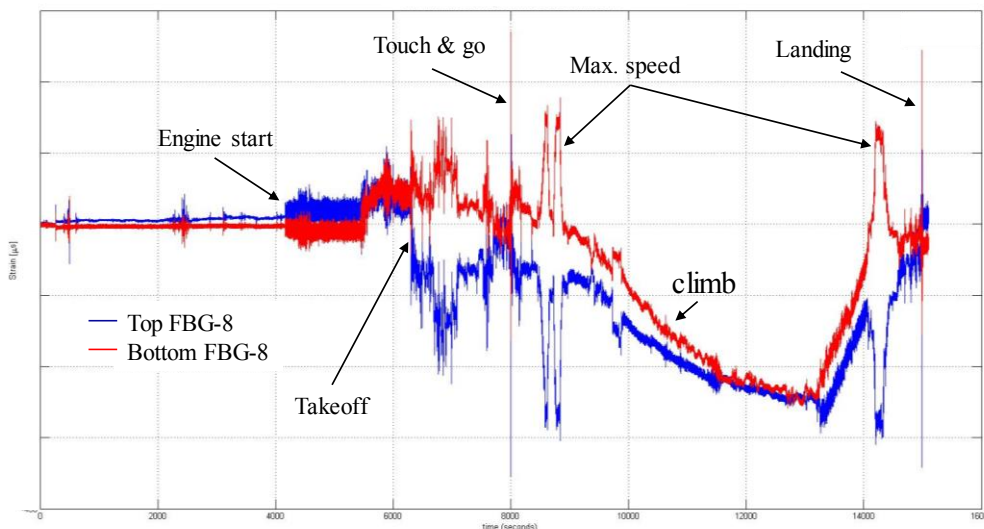
Figure 5: Typical FBG readings of boom mounted FBG (Top and bottom sensors)

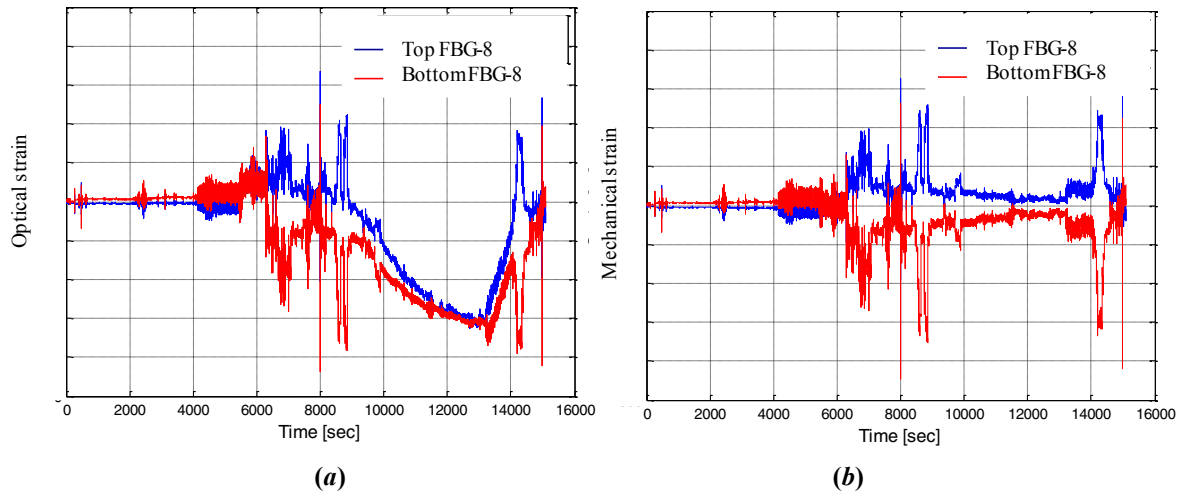
Figure 6: Boom FBG calibration. (a) Original FBG optical strain data. (b) Mechanical strain

By using Equation 1, the mechanical bending moment can be calculated and the individual mechanical strain at each sensor pair can be derived, as can be seen in Figure 6.

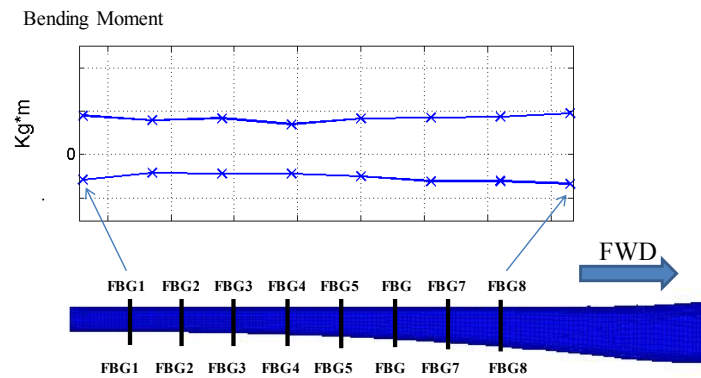
Figure 7: Boom bending moment envelope during landing

Typical boom bending moments derived from a specific landing are presented in Figure 7. The almost constant distribution of the bending moment along the boom indicates a complex loading condition, associated to its dynamic behavior.
