Alfredo Güemes, Antonio Fernandez-Lopez, Patricia Fernandez. Damage Detection in Composite Structures from Fibre Optic Distributed Strain Measurements. Le Cam, Vincent and Mevel, Laurent and Schoefs, Franck. EWSHM - 7th European Workshop on Structural Health Monitoring, Jul 2014, Nantes, France. 2014.

DAMAGE DETECTION IN COMPOSITE STRUCTURES FROM FIBRE OPTIC DISTRIBUTED STRAIN MEASUREMENTS

Alfredo Güemes¹, Antonio Fernandez-Lopez¹, Patricia Fernandez¹

¹ *Dpt Aeronautics, Universidad Politecnica de Madrid, 28040 MADRID-SPAIN*

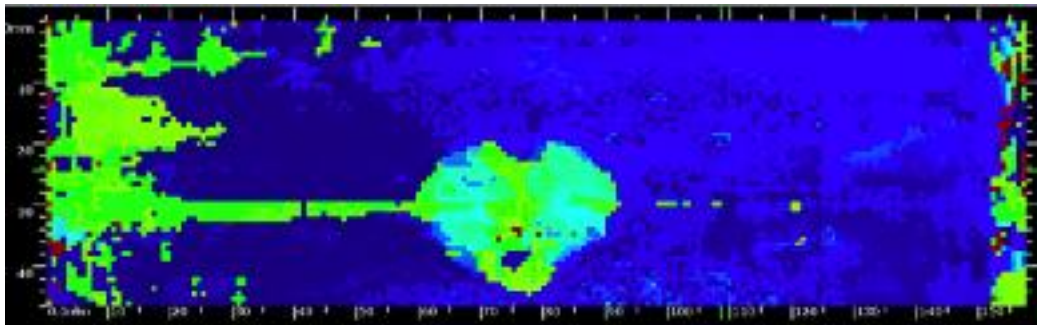
Figure 3: Ultrasonic inspection C-Scan after 2.4 J impact

The first plate was subject to a 2.4 J impact at the middle of the plate. With this energy level, fiber C-1 (embedded in the opposite side to the impact) was broken. The strain readings at the other two fibers show a peak in damage location with similar strain level. In Figure 3 the ultrasonic C-Scan inspection after the damage can be observed. The strain field is mainly affected in the delamination area, with a maximum of nearly $500 \mu\epsilon$. The fibre embedded in the middle of the plate, between the 90° plies, presents a strain field variation limited to the delamination area. With an impact of 4.4 J, all the fibers were broken. Test performed with fibers with acrylate coating of $250 \mu\text{m}$ did not show an improvement of resistance to impacts.

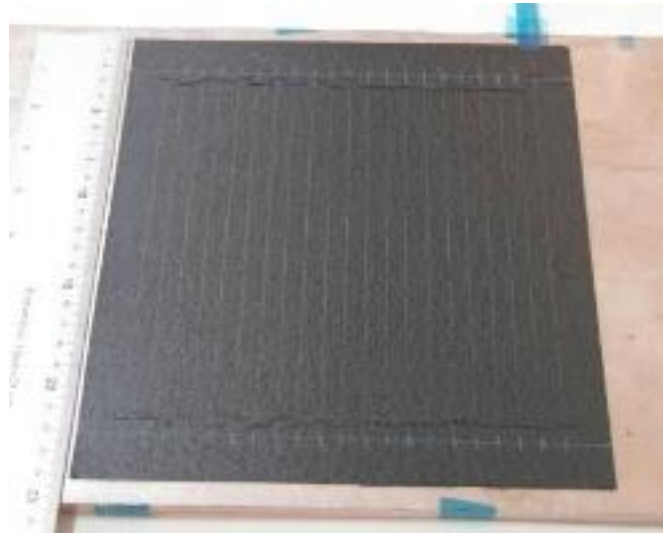
Figure 5: Optical fiber to be embedded with a crooked path in a composite laminate

Strain measurements obtained from the total surface can be used to create a strain map of the structure. In case that damage have promoted a change in the strain field, it is possible to obtain an image that represents the state of the structure. Figure 6 shows the effect of a delamination in a cross ply laminate of 200x200 mm. Strain data was obtained from a fiber in a crooked configuration that covered one of the sides.

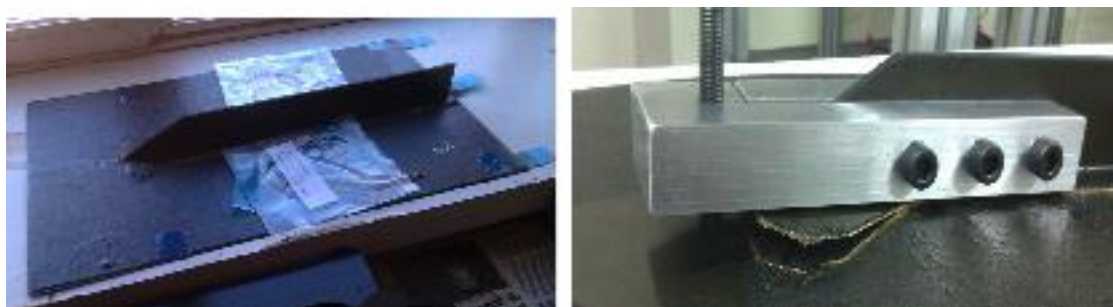
Figure 7 Manufacturing a cobonded stiffened panel with an embedded optical fibre (left), and artifact to promote a progressive debonding (right).

A flat laminate with an embedded optical fibre, similar to the one presented at figure 4, was prepared, the stiffener was added and the whole set was cured (fig 7, left). To promote a progressive debonding, a mechanical artifact was attached (fig 7 right). With the screw, the crack was grown, then unloaded again.

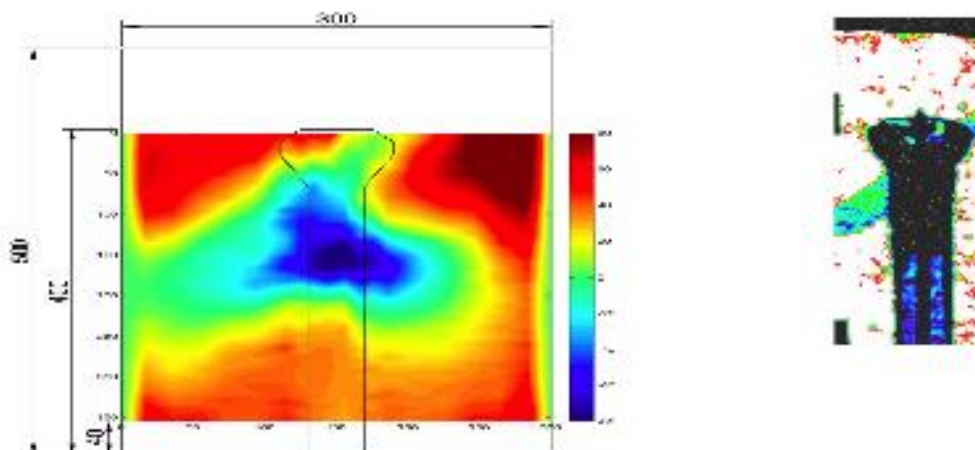
Figure 8 Map of the strains (left) and C-Scan image of the ultrasonic inspection (right)

The occurrence of the crack has locally changed the strain state at the flat laminate, as measured by the embedded fibre and plotted at figure 8, left. The debonding has created an area of compressive strains just below the stringer, the maximum value not very high (-80 MPa), but clearly detectable. The crack front is clearly defined, and it is coincident with the findings obtained by ultrasonic inspection (figure 8, right). Similar results are obtained at every step of the crack growth, which demonstrates the reliability of the technique.

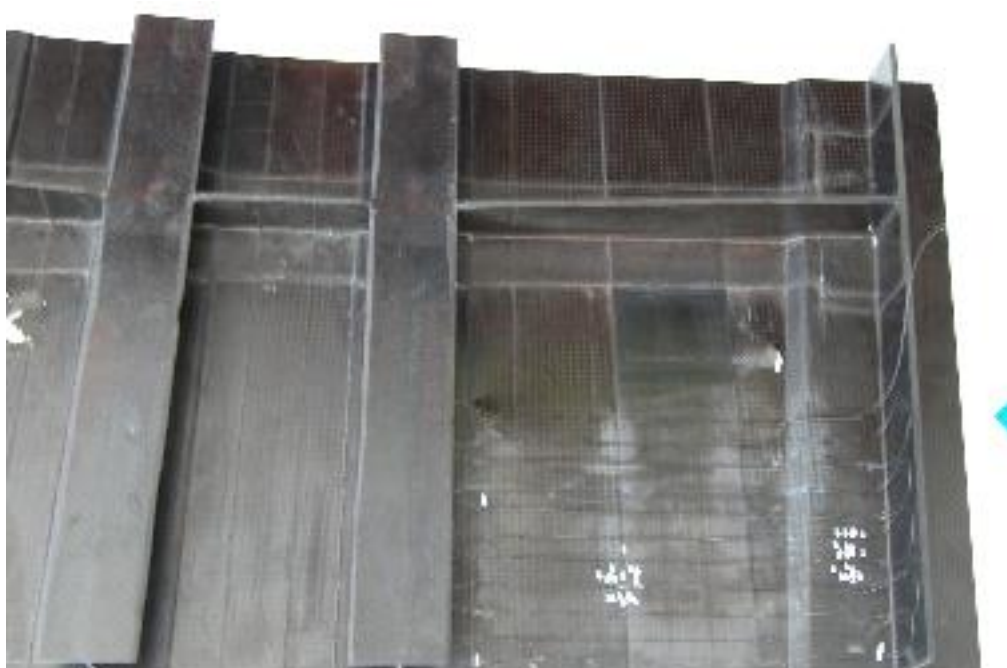
Figure 9 Cured CFRP structure, with bonded optical fibre

Figure 9 shows a part of a real aircraft structure, done in CFRP. An optical fibre was bonded at the internal surface, with loops of radii higher than 2 cm, to avoid optical losses. A BVID (Barely Visible Impact Damage) was done on the external surface, just below the stiffener foot, at the positions marked with dotted white spots; occurrence of a delamination was verified by ultrasounds, figure 10 (right) shows the B-Scan of the area, the debonding of the stiffener foot is seen as a intermediate green line. On figure 10 (right) the change in the strain field is plotted, always for the unloaded structure, identifying the area were the impact was given.

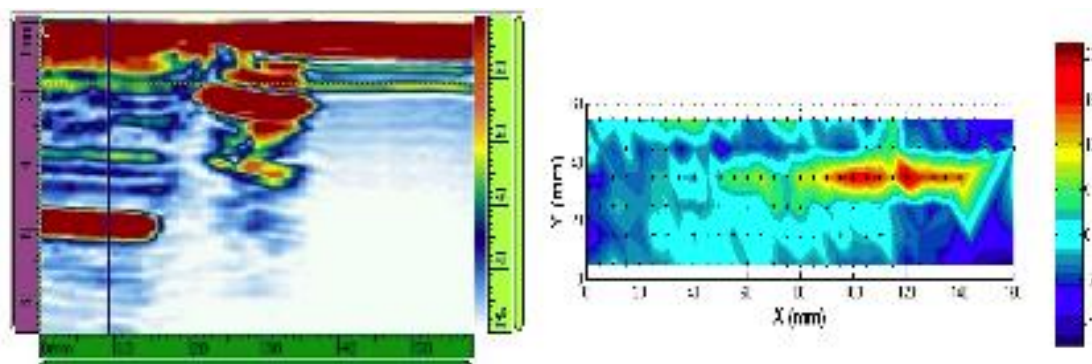
Figure 10 Map of the strains (left) and C-Scan image of the ultrasonic inspection (right)
