Damage Detection in Composite Structures from Fibre Optic Distributed Strain Measurements

Alfredo Güemes, Antonio Fernandez-Lopez, Patricia Fernandez. Damage Detection in Composite Structures from Fibre Optic Distributed Strain Measurements. Le Cam, Vincent and Mevel, Laurent and Schoefs, Franck. EWSHM - 7th European Workshop on Structural Health Monitoring, Jul 2014, Nantes, France. 2014. <hal-01020392>

DAMAGE DETECTION IN COMPOSITE STRUCTURES FROM FIBRE OPTIC DISTRIBUTED STRAIN MEASUREMENTS

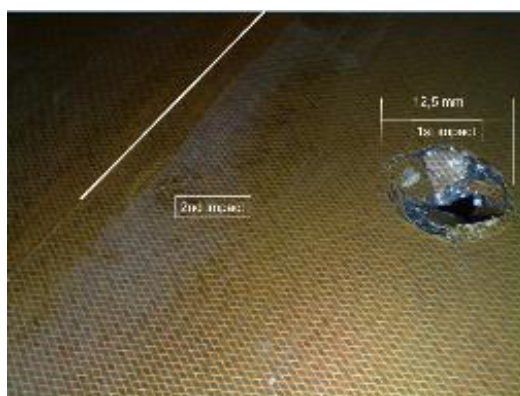
Figure 1. Damage detection from strain measurements is only possible when damage changes the strain field at the sensor

Looking at the physical damage done in the laminate (figure 1), the 40 Joules impact was strong enough to penetrate the laminate, but it did not caused a change in the strains 40 mm away. The other two impacts of 30 Joules only produced a barely visible indentation at the laminate, and a permanent change in the residual strains, affecting a zone 20 mm around the impacts.

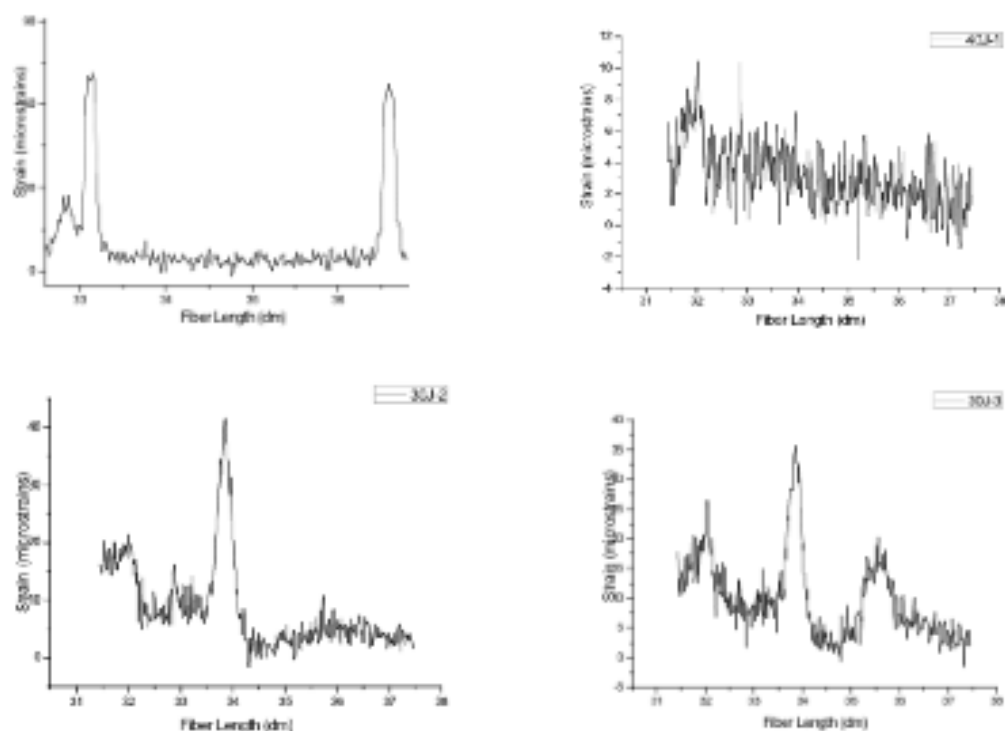
Figure 2. Strains along the optical fibre. Upper left: Local temp increase by two fingers, for localization. Upper right: Residual strains after a 40 J impact, 40 mm away from the fibre. Lower left: residual strains after a impact 30 J, 10 mm away form the fibre. Lower right: Strains after a second impact of 30 J

SHM is defined as the process of acquiring and analyzing data from on-board sensors to evaluate the health of a structure [2]. Damages are local cracks that will act as the failure initiation point, but do not change strongly the overall strain field, only a few cms around the crack are affected. Fiber optic sensors act primarily as strain sensors, so unless damage happens very close to the sensor location, damage may easily go undetected. Several articles were written on the changes in the shape of the spectral peak of an embedded FBG as consequence of cracks happening on top of the fiber, but these are not realistic structural damage cases. To highlight the situation, at figure 1 it is shown the damage done in a composite laminate by an impact, the surface had a bonded optical fibre only 40 mm away from the damage. The permanent strains at the optical fibre were not changed after the impact, and consequently this significant damage would not be detected by the OF. Only when the impact happened closer (10 mm), it produces a change in the strain field of the fibre that would then be detected. It is unconceivable to cover the whole surface of the aircraft with optical fibres, so some procedures have to be developed for doing damage predictions from strain measurements (at figure 2 the readings of residual strains after the impacts are given).

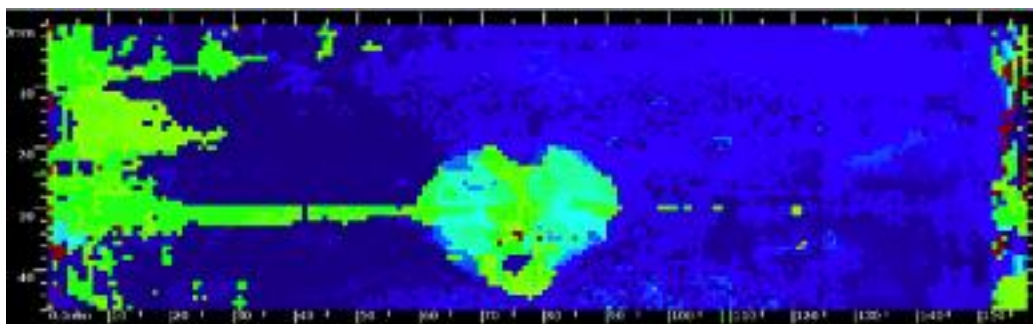
Figure 3: Ultrasonic inspection C-Scan after 2.4 J impact

The first plate was subject to a 2.4 J impact at the middle of the plate. With this energy level, fiber C-1 (embedded in the opposite side to the impact) was broken. The strain readings at the other two fibers show a peak in damage location with similar strain level. In Figure 3 the ultrasonic C-Scan inspection after the damage can be observed. The strain field is mainly affected in the delamination area, with a maximum of nearly $500 \mu\epsilon$. The fibre embedded in the middle of the plate, between the 90° plies, presents a strain field variation limited to the delamination area. With an impact of 4.4 J, all the fibers were broken. Test performed with fibers with acrylate coating of $250 \mu\text{m}$ did not show an improvement of resistance to impacts.

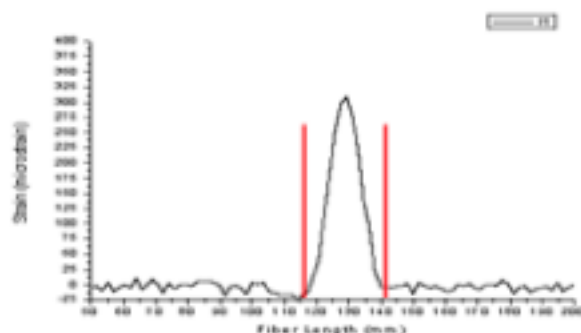
Figure 4. Measurements of the residual strains after the impact with optical fibers

A flat laminate with an embedded optical fibre, similar to the one presented at figure 4, was prepared, the stiffener was added and the whole set was cured (fig 7, left). To promote a progressive debonding, a mechanical artifact was attached (fig 7 right). With the screw, the crack was grown, then unloaded again.

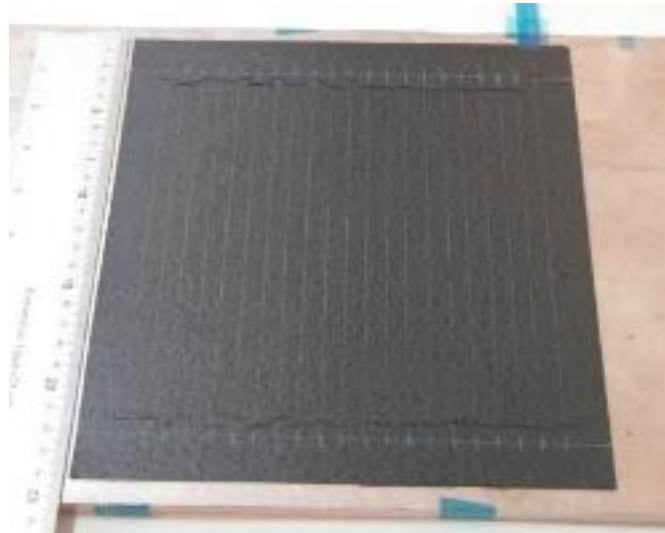
Figure 5: Optical fiber to be embedded with a crooked path in a composite laminate

Strain measurements obtained from the total surface can be used to create a strain map of the structure. In case that damage have promoted a change in the strain field, it is possible to obtain an image that represents the state of the structure. Figure 6 shows the effect of a delamination in a cross ply laminate of 200x200 mm. Strain data was obtained from a fiber in a crooked configuration that covered one of the sides.

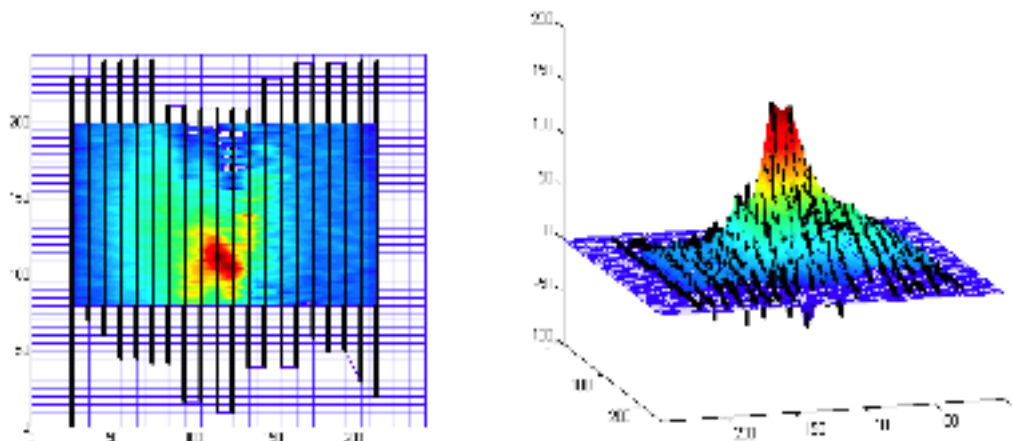
Figure 6: Strain map due to a delamination in 2D (left), and 3D (right)

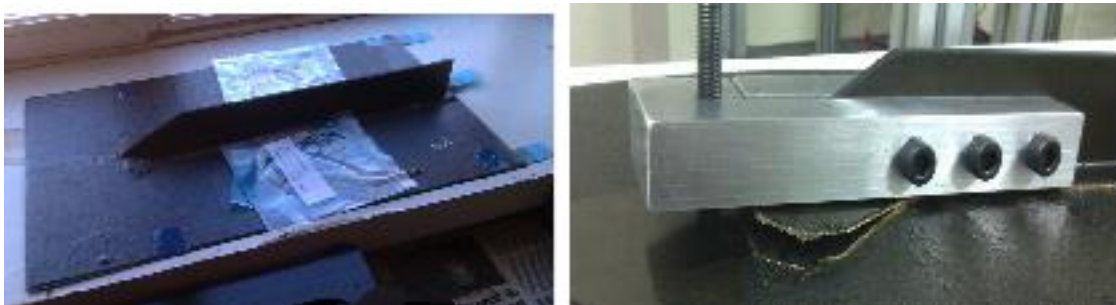
Figure 7 Manufacturing a cobonded stiffened panel with an embedded optical fibre (left), and artifact to promote a progressive debonding (right).

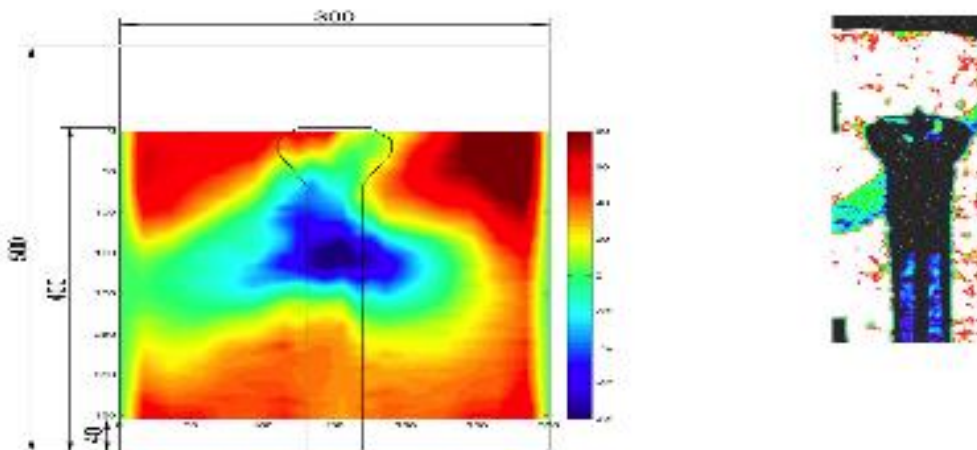
Figure 8 Map of the strains (left) and C-Scan image of the ultrasonic inspection (right)

The occurrence of the crack has locally changed the strain state at the flat laminate, as measured by the embedded fibre and plotted at figure 8, left. The debonding has created an area of compressive strains just below the stringer, the maximum value not very high (-80 MPa), but clearly detectable. The crack front is clearly defined, and it is coincident with the findings obtained by ultrasonic inspection (figure 8, right). Similar results are obtained at every step of the crack growth, which demonstrates the reliability of the technique.

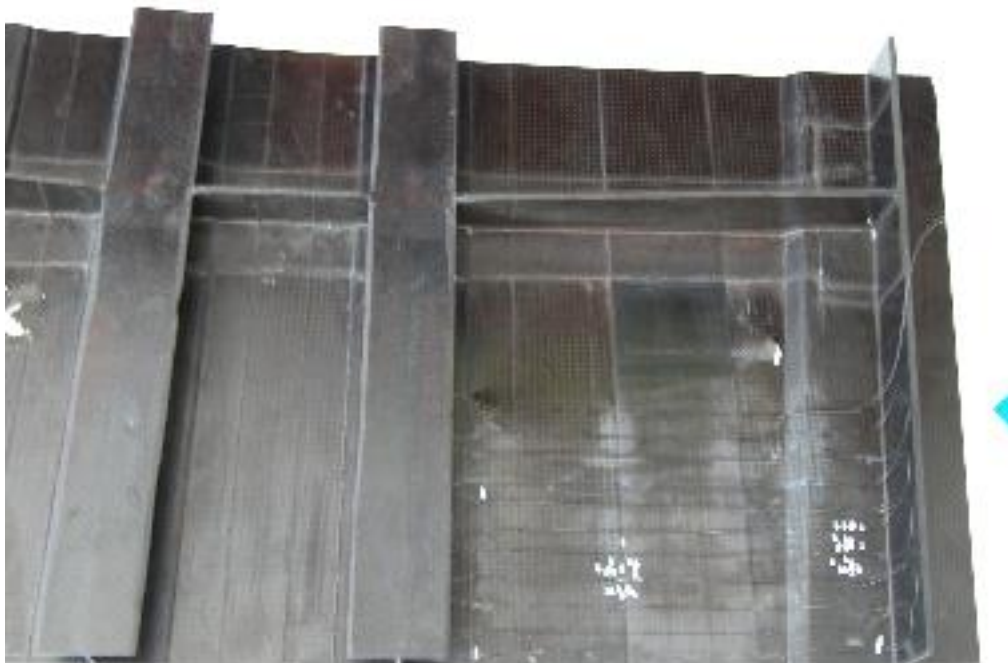
Figure 9 Cured CFRP structure, with bonded optical fibre

Figure 9 shows a part of a real aircraft structure, done in CFRP. An optical fibre was bonded at the internal surface, with loops of radii higher than 2 cm, to avoid optical losses. A BVID (Barely Visible Impact Damage) was done on the external surface, just below the stiffener foot, at the positions marked with dotted white spots; occurrence of a delamination was verified by ultrasounds, figure 10 (right) shows the B-Scan of the area, the debonding of the stiffener foot is seen as a intermediate green line. On figure 10 (right) the change in the strain field is plotted, always for the unloaded structure, identifying the area were the impact was given.

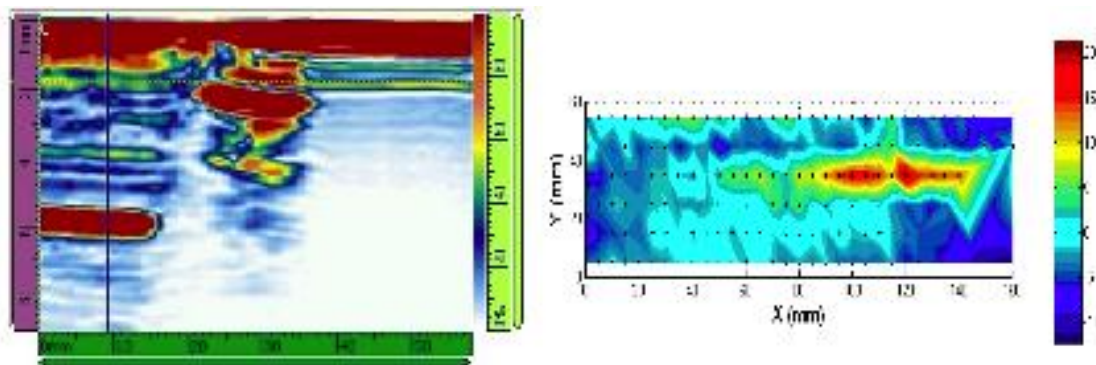
Figure 10 Map of the strains (left) and C-Scan image of the ultrasonic inspection (right)
