Damage Detection in Composite Structures from Fibre Optic Distributed Strain Measurements

Alfredo Güemes, Antonio Fernandez-Lopez, Patricia Fernandez. Damage Detection in Composite Structures from Fibre Optic Distributed Strain Measurements. Le Cam, Vincent and Mevel, Laurent and Schoefs, Franck. EWSHM - 7th European Workshop on Structural Health Monitoring, Jul 2014, Nantes, France. 2014. <hal-01020392>

DAMAGE DETECTION IN COMPOSITE STRUCTURES FROM FIBRE OPTIC DISTRIBUTED STRAIN MEASUREMENTS

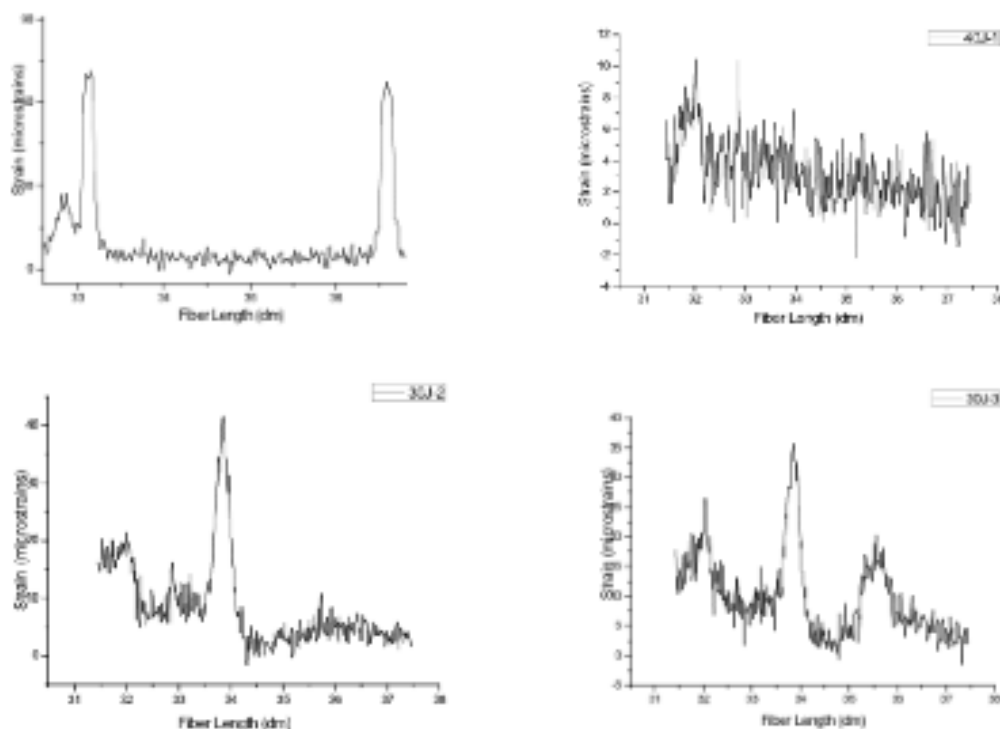
Figure 2. Strains along the optical fibre. Upper left: Local temp increase by two fingers, for localization. Upper right: Residual strains after a 40 J impact, 40 mm away from the fibre. Lower left: residual strains after a impact 30 J, 10 mm away form the fibre. Lower right: Strains after a second impact of 30 J

SHM is defined as the process of acquiring and analyzing data from on-board sensors to evaluate the health of a structure [2]. Damages are local cracks that will act as the failure initiation point, but do not change strongly the overall strain field, only a few cms around the crack are affected. Fiber optic sensors act primarily as strain sensors, so unless damage happens very close to the sensor location, damage may easily go undetected. Several articles were written on the changes in the shape of the spectral peak of an embedded FBG as consequence of cracks happening on top of the fiber, but these are not realistic structural damage cases. To highlight the situation, at figure 1 it is shown the damage done in a composite laminate by an impact, the surface had a bonded optical fibre only 40 mm away from the damage. The permanent strains at the optical fibre were not changed after the impact, and consequently this significant damage would not be detected by the OF. Only when the impact happened closer (10 mm), it produces a change in the strain field of the fibre that would then be detected. It is unconceivable to cover the whole surface of the aircraft with optical fibres, so some procedures have to be developed for doing damage predictions from strain measurements (at figure 2 the readings of residual strains after the impacts are given).

Looking at the physical damage done in the laminate (figure 1), the 40 Joules impact was strong enough to penetrate the laminate, but it did not caused a change in the strains 40 mm away. The other two impacts of 30 Joules only produced a barely visible indentation at the laminate, and a permanent change in the residual strains, affecting a zone 20 mm around the impacts.

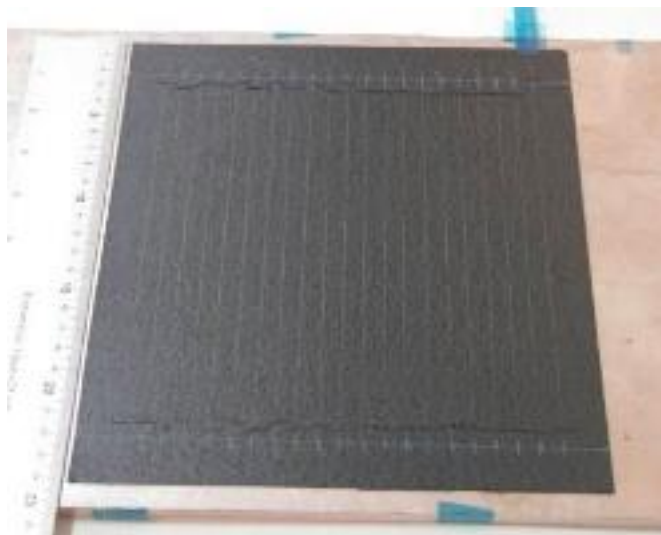
Figure 5: Optical fiber to be embedded with a crooked path in a composite laminate

Strain measurements obtained from the total surface can be used to create a strain map of the structure. In case that damage have promoted a change in the strain field, it is possible to obtain an image that represents the state of the structure. Figure 6 shows the effect of a delamination in a cross ply laminate of 200x200 mm. Strain data was obtained from a fiber in a crooked configuration that covered one of the sides.

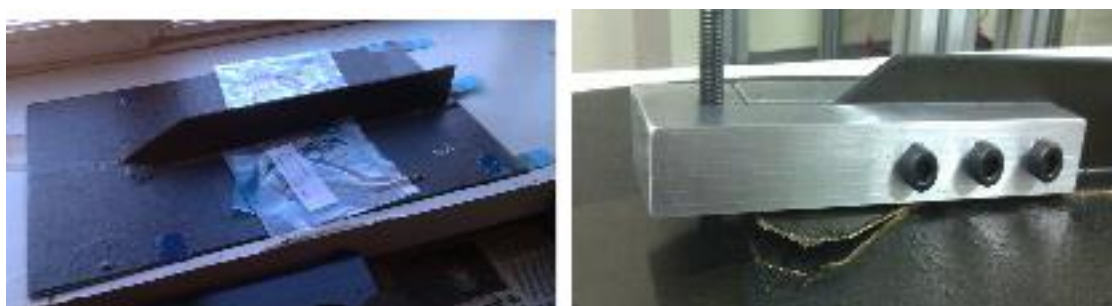
Figure 7 Manufacturing a cobonded stiffened panel with an embedded optical fibre (left), and artifact to promote a progressive debonding (right).

A flat laminate with an embedded optical fibre, similar to the one presented at figure 4, was prepared, the stiffener was added and the whole set was cured (fig 7, left). To promote a progressive debonding, a mechanical artifact was attached (fig 7 right). With the screw, the crack was grown, then unloaded again.

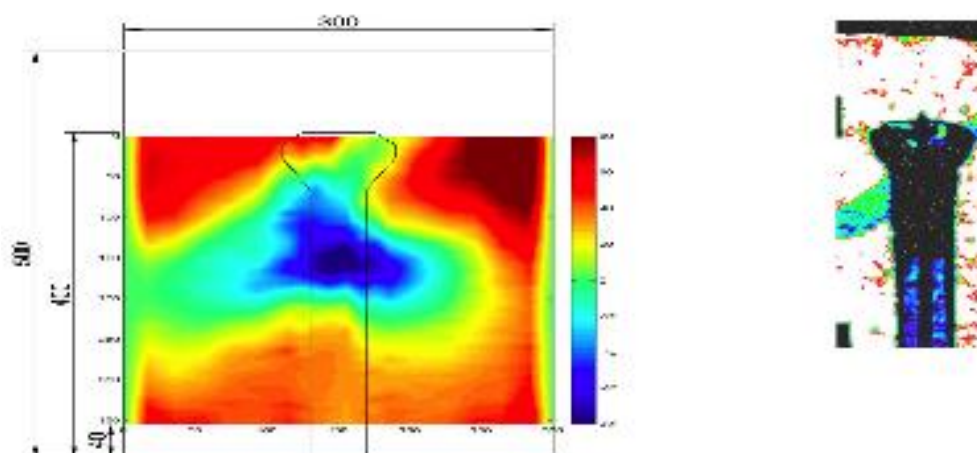
Figure 8 Map of the strains (left) and C-Scan image of the ultrasonic inspection (right)

The occurrence of the crack has locally changed the strain state at the flat laminate, as measured by the embedded fibre and plotted at figure 8, left. The debonding has created an area of compressive strains just below the stringer, the maximum value not very high (-80 MPa), but clearly detectable. The crack front is clearly defined, and it is coincident with the findings obtained by ultrasonic inspection (figure 8, right). Similar results are obtained at every step of the crack growth, which demonstrates the reliability of the technique.
