Damage Detection in Composite Structures from Fibre Optic Distributed Strain Measurements

Alfredo Güemes, Antonio Fernandez-Lopez, Patricia Fernandez. Damage Detection in Composite Structures from Fibre Optic Distributed Strain Measurements. EWSHM - 7th European Workshop on Structural Health Monitoring, IFFSTTAR, Inria, Université de Nantes, Jul 2014, Nantes, France. hal-01020392

DAMAGE DETECTION IN COMPOSITE STRUCTURES FROM FIBRE OPTIC DISTRIBUTED STRAIN MEASUREMENTS

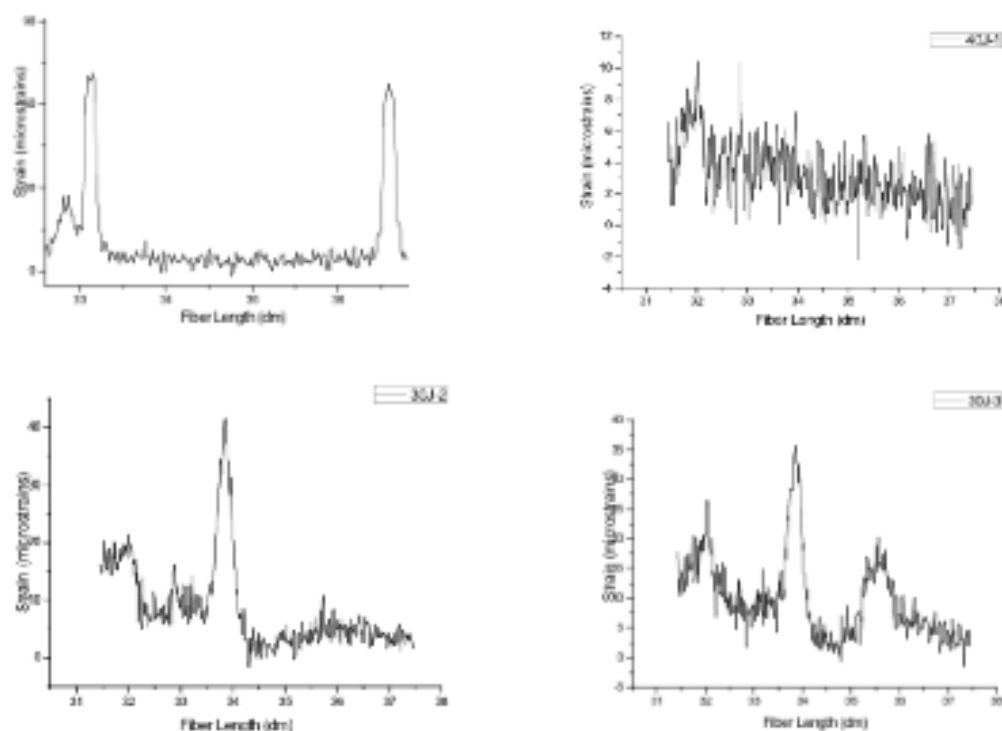
Figure 2. Strains along the optical fibre. Upper left: Local temp increase by two fingers, for localization. Upper right: Residual strains after a 40 J impact, 40 mm away from the fibre. Lower left: residual strains after a impact 30 J, 10 mm away form the fibre. Lower right: Strains after a second impact of 30 J

SHM is defined as the process of acquiring and analyzing data from on-board sensors to evaluate the health of a structure [2]. Damages are local cracks that will act as the failure initiation point, but do not change strongly the overall strain field, only a few cms around the crack are affected. Fiber optic sensors act primarily as strain sensors, so unless damage happens very close to the sensor location, damage may easily go undetected. Several articles were written on the changes in the shape of the spectral peak of an embedded FBG as consequence of cracks happening on top of the fiber, but these are not realistic structural damage cases. To highlight the situation, at figure 1 it is shown the damage done in a composite laminate by an impact, the surface had a bonded optical fibre only 40 mm away from the damage. The permanent strains at the optical fibre were not changed after the impact, and consequently this significant damage would not be detected by the OF. Only when the impact happened closer (10 mm), it produces a change in the strain field of the fibre that would then be detected. It is unconceivable to cover the whole surface of the aircraft with optical fibres, so some procedures have to be developed for doing damage predictions from strain measurements (at figure 2 the readings of residual strains after the impacts are given).

Looking at the physical damage done in the laminate (figure 1), the 40 Joules impact was strong enough to penetrate the laminate, but it did not caused a change in the strains 40 mm away. The other two impacts of 30 Joules only produced a barely visible indentation at the laminate, and a permanent change in the residual strains, affecting a zone 20 mm around the impacts.

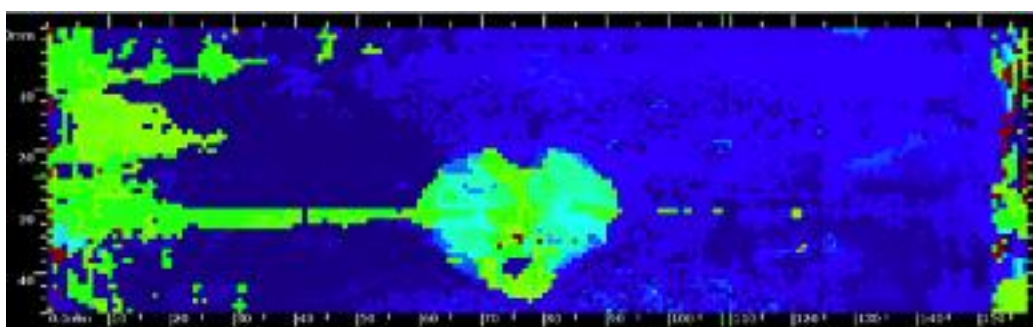
Figure 3: Ultrasonic inspection C-Scan after 2.4 J impact

The first plate was subject to a 2.4 J impact at the middle of the plate. With this energy level, fiber C-1 (embedded in the opposite side to the impact) was broken. The strain readings at the other two fibers show a peak in damage location with similar strain level. In Figure 3 the ultrasonic C-Scan inspection after the damage can be observed. The strain field is mainly affected in the delamination area, with a maximum of nearly $500 \mu\epsilon$. The fibre embedded in the middle of the plate, between the 90° plies, presents a strain field variation limited to the delamination area. With an impact of 4.4 J, all the fibers were broken. Test performed with fibers with acrylate coating of $250 \mu\text{m}$ did not show an improvement of resistance to impacts.
