Damage Detection on a Cable Stayed Bridge Using Wave Propagation Analysis

DAMAGE DETECTION ON A CABLE STAYED BRIDGE USING WAVE PROPAGATION ANALYSIS

Juan Quintana¹, Francisco Carrion¹, Saul Crespo¹

¹ *Instituto Mexicano del Transporte, Km 12 Carretera Querétaro Galindo, Colonia Sanfandila, Querétaro, 76703 México.*

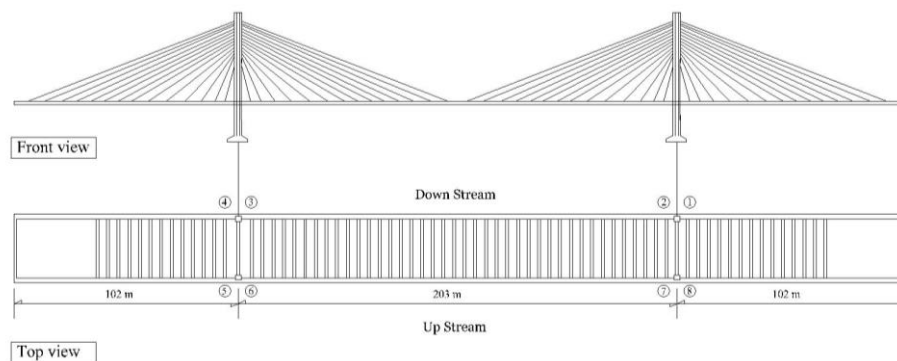
The Rio Papaloapan Bridge is located in the La Tinaja-Acayucan highway, in the state of Veracruz, Mexico. It was commissioned in 1995, and it is a stayed bridge with a span of 203 meters and an overall length of 407 meters. The bridge has 112 cables in 8 semi-harps with 14 cables each; semi-harps are numbered from 1 to 8 (figure 1), and cables are also identified from 1 to 14, starting with the shortest [1]. After 5 years of service, the upper anchorage element of cable 11, semi-harp 7, failed in 2000. In this case, a full fracture took place under normal operational conditions near the weld joint of the anchorage and the A-50 structural steel plate (embedded in the concrete tower).

Figure 1: Rio Papaloapan Bridge layout.

Figure 4a shows variations on the dynamic responses for sensor 11; the Y axis represents the difference between the experimental and simulated responses, while the X axis is the position of the cable with respect to the bridge deck from left to right (figure 1) so that, for example, cable 1 of semi-harp 6 is number 15. Here 3 curves are observed: the first (squares) represents the upstream cables; the second (diamonds), denotes the downstream cables; and the third (line) symbolizes the actual position of the removed cable.

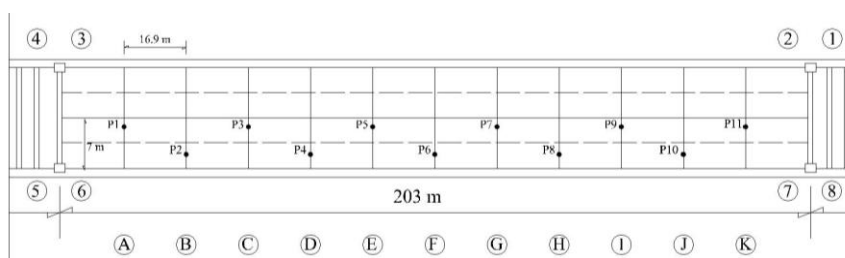
The second test consisted on dynamic tests where a controlled impact forces was applied at different points on the bridge deck. In this second case, 11 accelerometers on the deck were located on one side of the bridge between the two towers as indicated in figure 2. The impact forces were applied without traffic with a Dynatest falling weight deflectometer at different points on the deck. For this set of dynamic tests, a 2000 Hz sampling rate during 2 seconds was used for all sensors simultaneously; the experimental procedure was as follows:

Figure 2: Experimental arrangement for dynamic testing.

A set of dynamic tests was done at 10 different impact points on the deck before freeing the cable, and a similar set of 10 impacts was also done after release. At each point, the test was done 3 times for statistical analysis. The previous set of tests was used for calibration, while the second was used to evaluate the GSM.

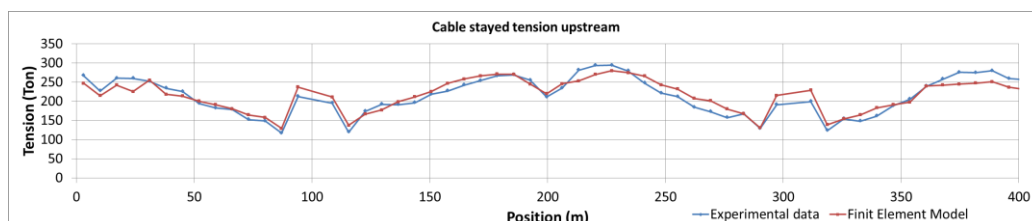
The unknown structural parameters were calculated using the dynamic responses or the initial condition, the pre-calibrated model and the software StrIdent [7,10], which is a StaDyn complementary software that solves inverse problems [11]. The model was considered as calibrated when tensions were within 10% from the experimental values with dead loads only. Figure 3 shows the comparison of the experimental tensions to those from the calibrated model.

Figure 3: Experimental and FEM Tensions.

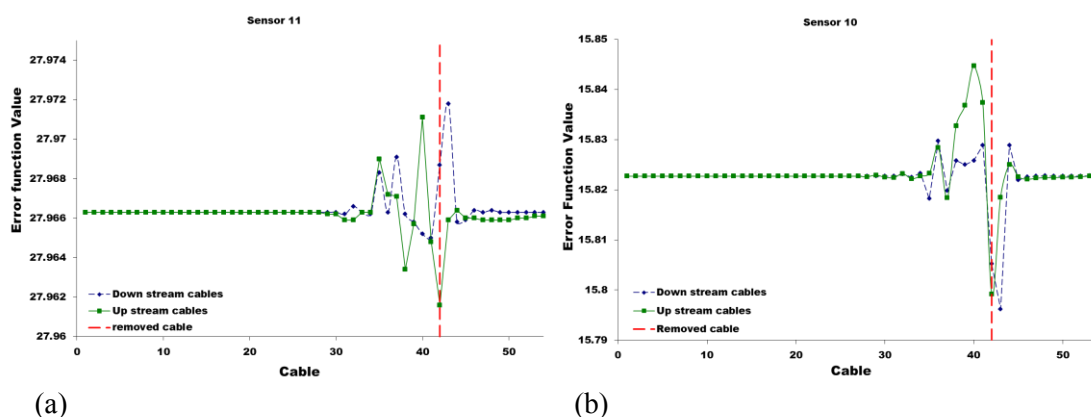
Dynamic response of sensor 11 is minimized at position 42 of the upstream cable figure 4a, which corresponds to the actual damage scenario. Figure 4b shows the same for sensor 10, where the minimum does not correspond to the real damage position and indicates the cable 1 of semi-harp 1 (position 43 of downstream cable), and the second minimum effectively corresponds to the actual damage position. It is important to note that, although the sensor 10 is not precise, it locates damage close to the actual position. When comparing sensor 10 with 11, clearly sensor 11 has higher sensitivity as it is closer to the damage location (4 meters of sensor 11 to 17 meters of sensor 10).

Figure 4: Objective function Values generated by the GSM. (a) Using sensor 11 data. (b) Using sensor 10 data.

In the case of sensor 9, it is different to sensors 10 and 11, since it is not able to locate the damage and even shows no error where it should be; minimums are indicated close or next, but not at the actual damaged position. Results from sensor 8 indicate damage adequately by the error function as it was for sensor 11, and somehow for sensor 10. At last, if the optimization of the error

function includes simultaneously the 4 sensor (8, 9, 10 and 11); again, the minimum location agrees with the position of the removed cable.

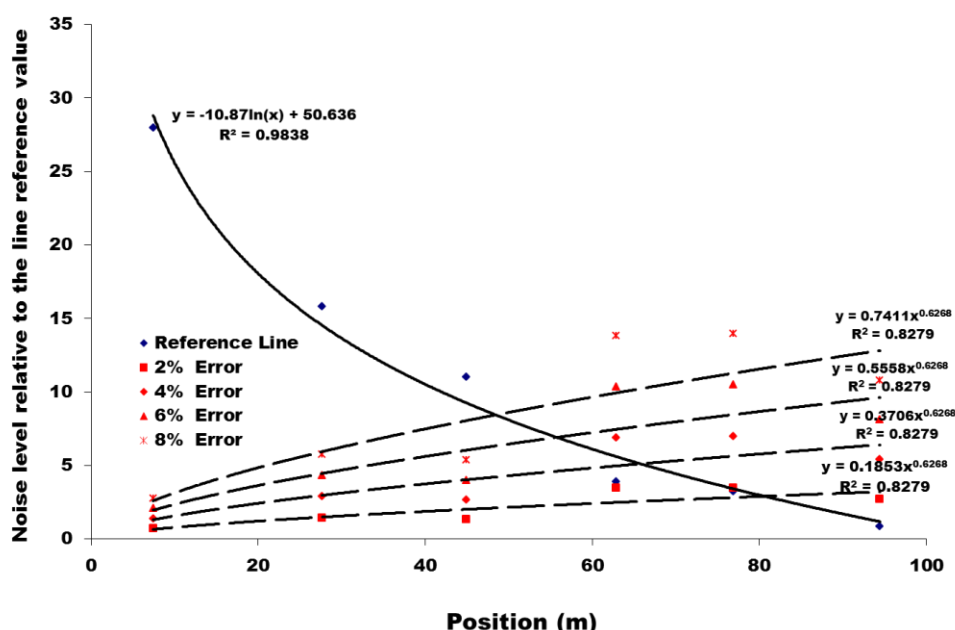
To analyze the GSM sensitivity with respect to the sensors position, the model calibration and the electronic noise, an overall noise was calculated with respect to the actual responses magnitude and normalized to the highest value of the reference line from the optimization process of the error function; which is the average of the optimized error of all positions. Then, the reference value is plotted to the distance and compared to different 2%, 4%, 6% and 8% noise levels, which are typical values obtained experimentally (figure 5). Clearly, from figure 5 it can be noticed that sensors 45 meters farther (like sensor 9), have little sensitivity with respect to noise and are not well suited for damage analysis of the particular simulated damage of cable 1. At the same time, if noise is reduced, including a better calibration and model response, the sensitivity increases in terms of amplitude and distance.

Figure 5: GSM sensitivity with respect to the sensors position.

The Global Search Method proved to be a useful tool for damage evaluation; its sensitivity depends on three main aspects: the FE model calibration, the sensor position with respect to damage and impact position, and the noise level in the experimental tests. For the Rio Papaloapan Bridge, this distance should be no more than 65 meters due to dispersion of the dynamic responses, the present noise and the sensors sensitivity. All these factors decrease the GSM sensitivity to the point that is not possible to measure differences between a damaged and undamaged condition, regardless it is a significant change like the rupture of a cable.
