# Damage Identification in a Benchmark Cable-Stayed Bridge Using the Interpolation Method

Marco Domaneschi, Maria Pina Limongelli, Luca Martinelli

Marco Domaneschi, Maria Pina Limongelli, Luca Martinelli. Damage Identification in a Benchmark Cable-Stayed Bridge Using the Interpolation Method. Le Cam, Vincent and Mevel, Laurent and Schoefs, Franck. EWSHM - 7th European Workshop on Structural Health Monitoring, Jul 2014, Nantes, France. 2014. <hal-01022077>

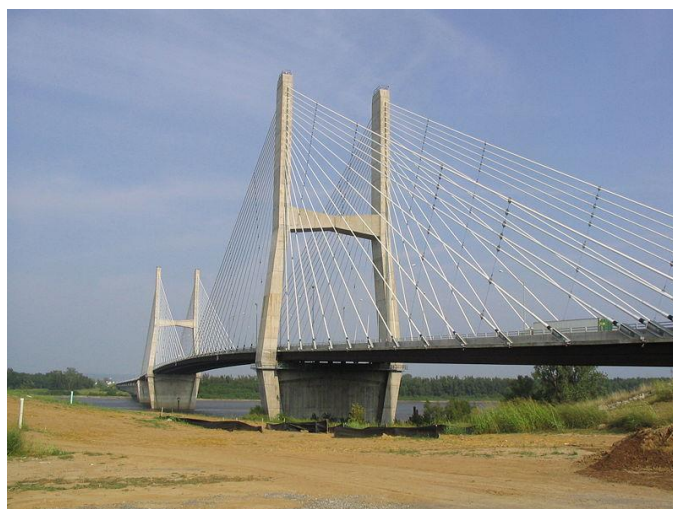
Figure 2: The Bill Emerson Memorial Bridge (Framerotblues, 2007; with permission)

This bridge at the base of this study is a fan-type cable stayed bridge (Figure 1) which crosses the Mississippi River near Cape Girardeau (USA) with a composite concrete-steel deck stiffened by two longitudinal steel girders (Figure 2).

The bridge is 1206 m long with a main span length of 350.6 m. One hundred and twenty eight stays, made of high-strength, low-relaxation steel, are arranged according to a fan-type distribution. The smallest cable area is  $28.5 \text{ cm}^2$  and the largest cable area is  $76.3 \text{ cm}^2$ . The deck is supported by two towers in the cable-stayed spans. Twelve additional piers support the Illinois approach spans. Each tower has a solid section below the cap beam, and a hollow section in the upper portion
