Surface Distresses Detection of Pavement Based on Digital Image Processing

Aiguo Ouyang, Chagen Luo, Chao Zhou

Abstract. Pavement crack is the main form of early diseases of pavement. The use of digital photography to record pavement images and subsequent crack detection and classification has undergone continuous improvements over the past decade. Digital image processing has been applied to detect the pavement crack for its advantages of large amount of information and auto detection. The application of digital image processing was reviewed in pavement detection, pavement distresses classification and evaluation. The key problems were analyzed, such as image enhancement, image segmentation and edge detection. Some of the latest algorithms and their applications were tested in this paper. The results forcefully supported following conclusion: noise in pavement is effectively removed median filtering, the histogram modification technique is a useable segmentation approach, canny edge detection is the optimum identification of pavement distresses.

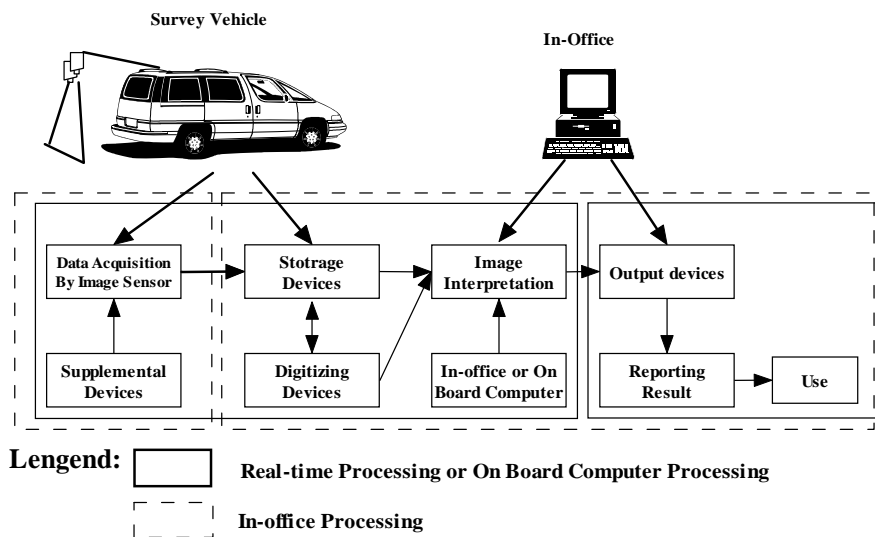
Fig. 1. Elements of a pavement imaging system.

In the wake of tedious manual measurements and safety issues, a variety of types of methods have been devised to identify the cracks on pavements apart from the crude process of manual inspection. Image processing, ultrasonic detection and infrared detection, the most widely reported of the automated methods is that known as WiseCrax. Wisecrax [3] is an example of a commercially available device that uses infrared imaging to detect cracks on pavements. A camera is mounted on a vehicle with that takes pictures of the pavements continuously. Images are processed off-line overnight at the office workstation by a unique open architecture process using advanced image recognition software. Typical survey vehicle configuration consists of one or more downward-facing video cameras, at least one forward facing camera for perspective, and any number of additional cameras for the capture of right-of-way, shoulder, signage, and other information depending on agency requirements (as shown in Figure 1).

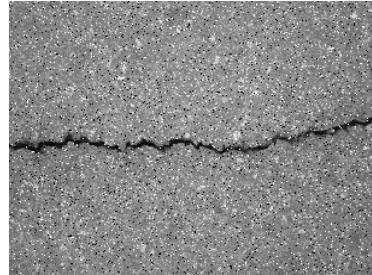
Fig. 3. Grayscale image with salt and pepper.

Image enhancement is applied in an attempt to remove noise in pavement images. Noise reduction is one aspect of preprocessing phase of crack detection process. Filtering is the most common form of noise reduction. Median filtering is one of the most commonly used preprocessing techniques for crack detection today. Median filtering is therefore applied as pavement image enhancement technique as suggested by Jitprasithsiri [12]. The median is much less sensitive than the mean to extreme values. Median filtering is better able to remove these outliers without reducing the sharpness of the image. Such a property of median filtering was explained by a classic example of salt and pepper noise which was a random addition of black and white pixels into a gray scale image. The result of median filtering in figure 6 indicated that noise was removed aptly by the median filtering compared with other operators.

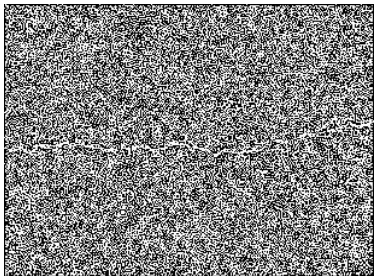
Fig.4. Laplacian operator

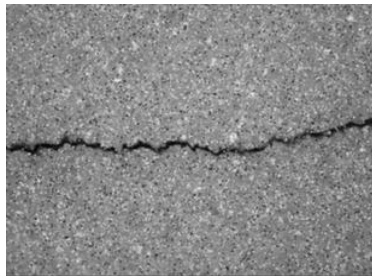
Fig.5. Gaussian operator

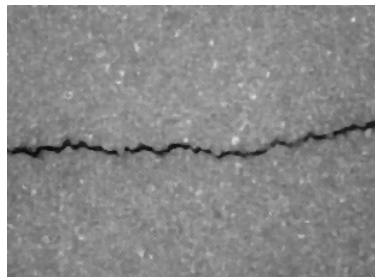
Fig. 6. Result of median filtering

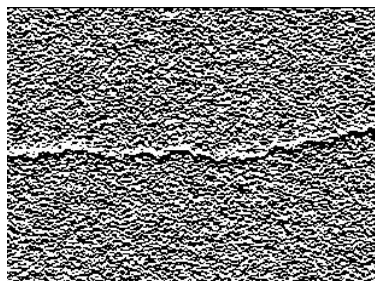
Fig.8. Sobel operator

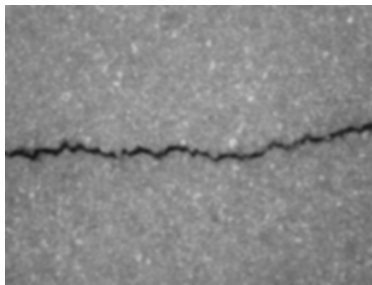
Fig. 13. Grayscale image by gaussian filtering

The Canny edge detector is a good edge detector among traditional edge detection algorithms [14]. The gray scale pavement image was first smoothed using a Gaussian filter with a specified standard deviation to reduce noise (see figure 13), then

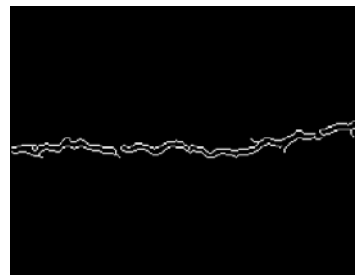
Fig. 14. Threshold value=0.5.

gradients were calculated to determine edge points. Using two threshold values 0.5 and 0.4, different correlated edge points were linked together. The strength of the method is its ability to detect edges in the presence of noise and to detect weak edges. Preliminary results from canny edge detection in figure 14~16 showed that the optimum identification of distress was dependent on the parameters used in the algorithm and that the optimum parameters varied with each image. There was a problem of coming up with false distress boundaries when a very high standard deviation in Gaussian filtering was used. The distress may seem wider than it actually was resulting in false severity level detection.

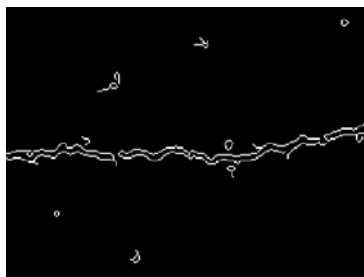
Fig. 15. Threshold value=0.4
